**ARVAL**  
BNP PARIBAS GROUP

## INSPECTION REPORT

End of contract

| Make | Mercedes A 180 Business Line A |

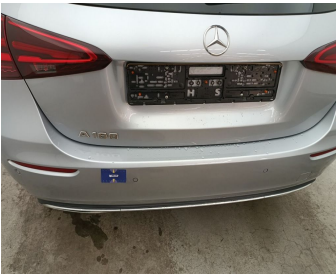
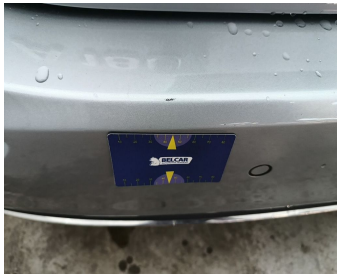
| Damages | Type | Acceptable |
|---|---|---|
| 133 | Bumper Rear // Painting | Y |

Bumper Rear // Painting-scratch

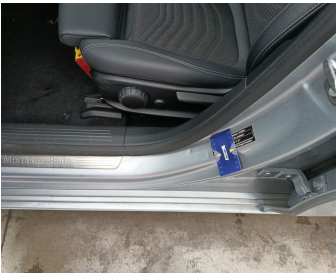
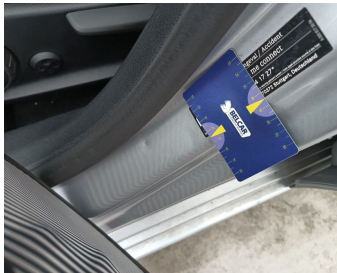
| Damages | Type | Acceptable |
|---|---|---|
| 91 | Rocker Panel Left // Smart Repair Medium | Y |

Rocker Panel Left // Smart Repair Medium-scratch + dent

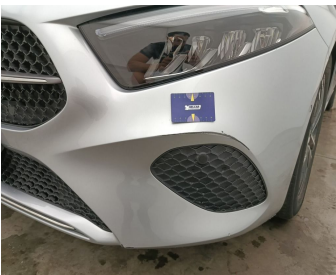
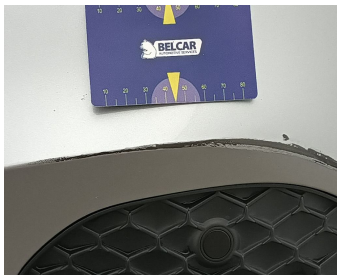
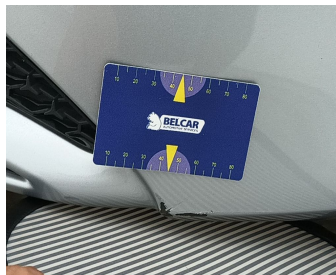
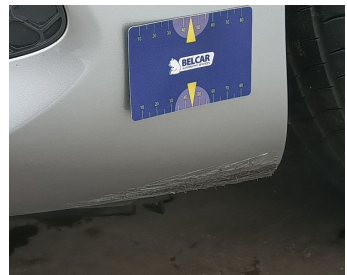
| Damages | Type | Acceptable |
|---|---|---|
| 14 | Bumper Front // Repair & Painting | N |

Bumper Front // Repair & Painting-scratch + dent
