# INSPECTION REPORT

End of contract

| License plate | 2CFE671 |
| Make | Opel Crossland 1.2 81kW Elegan |

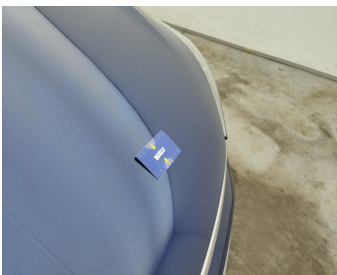
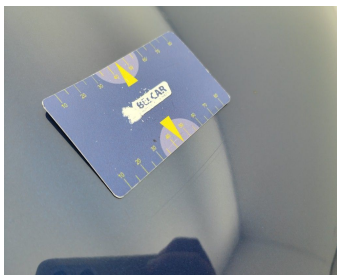
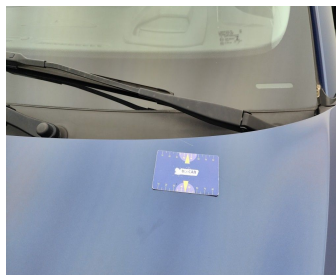
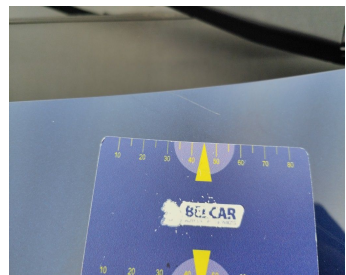
| Damages | Type | Acceptable |
|---|---|---|
| 35 | Front Bonnet // Polish | Y |

Front Bonnet // Polish-scratch

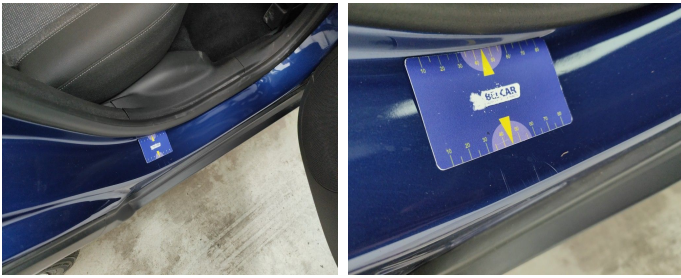
| Damages | Type | Acceptable |
|---|---|---|
| 201 | Rocker Panel Right // Smart Repair Medium | Y |

Rocker Panel Right // Smart Repair Medium-scratch

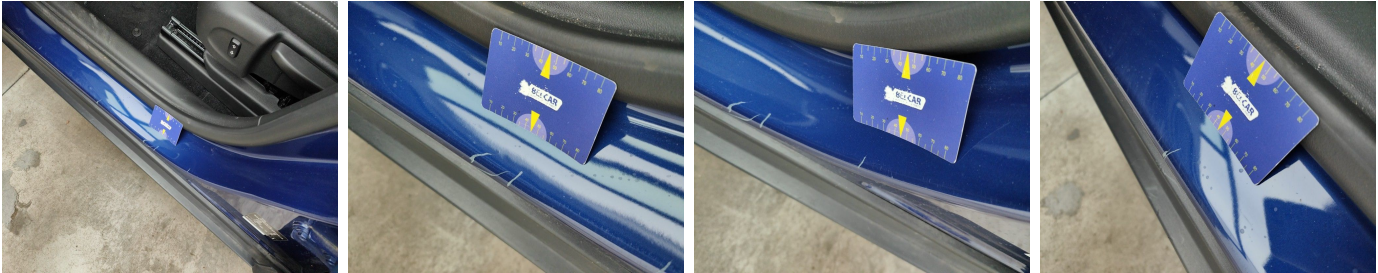
| Damages | Type | Acceptable |
|---|---|---|
| 91 | Rocker Panel Left // Smart Repair Medium | Y |

Rocker Panel Left // Smart Repair Medium-scratch

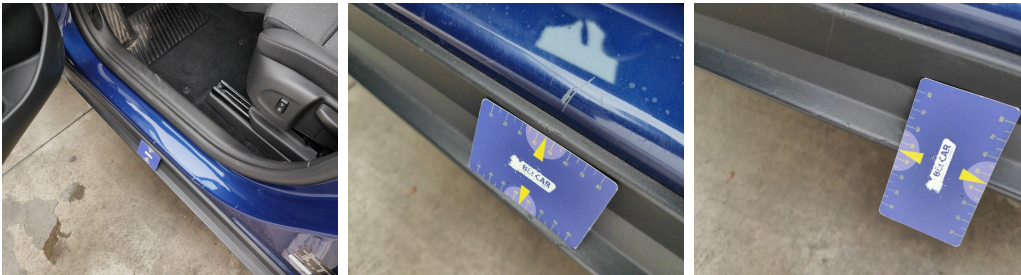
| Damages | Type | Acceptable |
|---|---|---|
| 98 | Rocker Panel Left / Cover Not Painted / Replace | Y |

Rocker Panel Left / Cover Not Painted / Replace-scratch

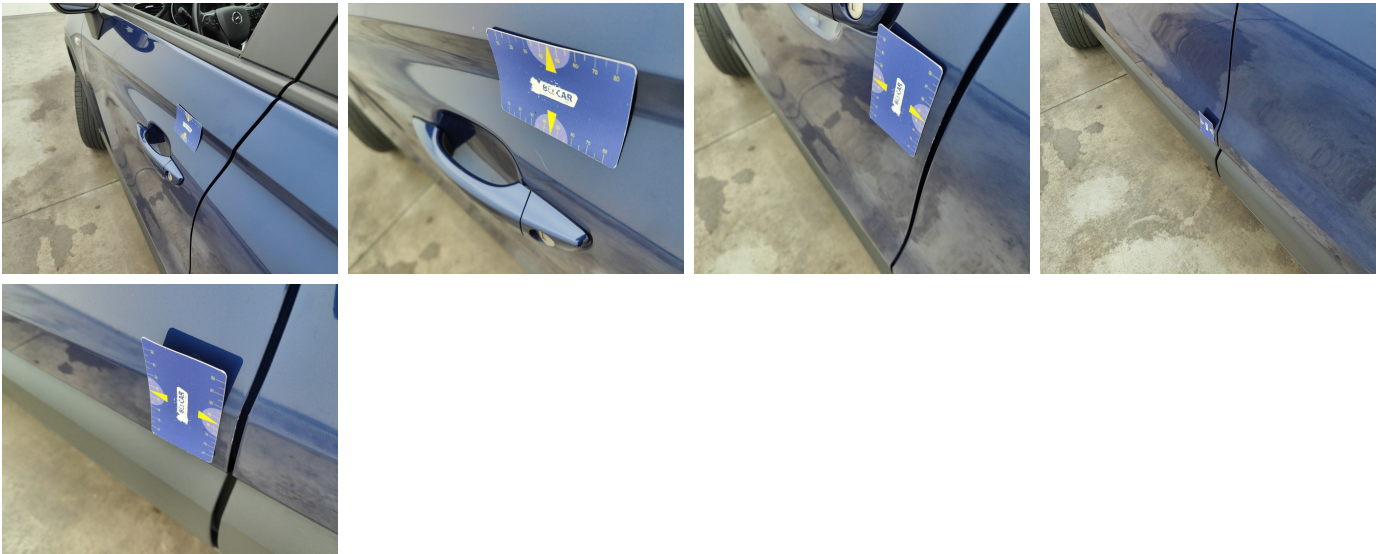
| Damages | Type | Acceptable |
|---|---|---|
| 83 | Door Front Left // Painting | Y |

Door Front Left // Painting-scratch

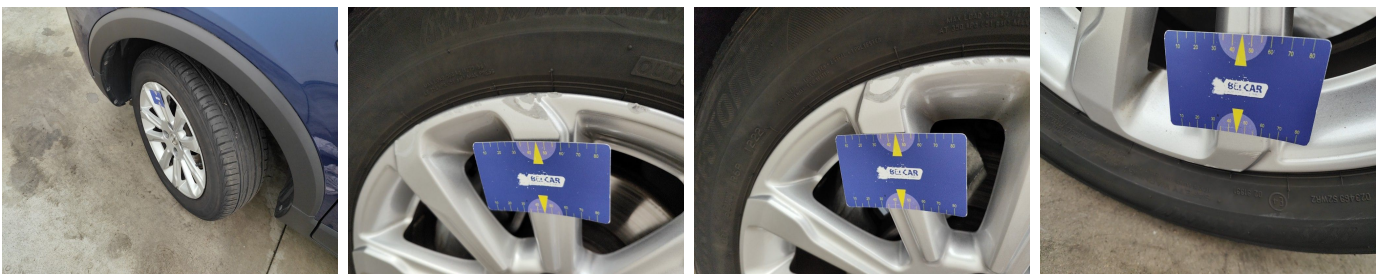
| Damages | Type | Acceptable |
|---|---|---|
| 311 | Wheel Alloy Front Left // Repair | N |

Wheel Alloy Front Left // Repair-scratch

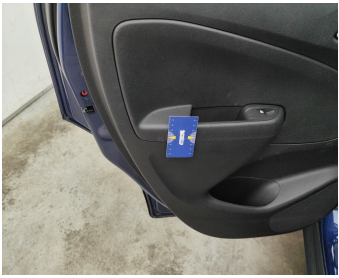
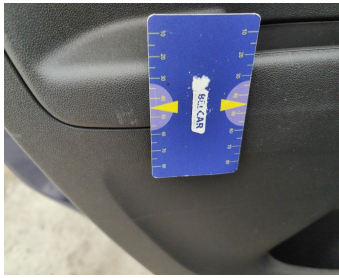
| Damages | Type | Acceptable |
|---|---|---|
| 631 | Rear Left Door Interior Coating // Repair | N |

Rear Left Door Interior Coating // Repair-scratch

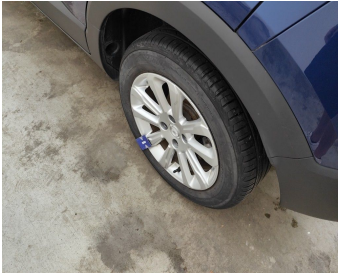
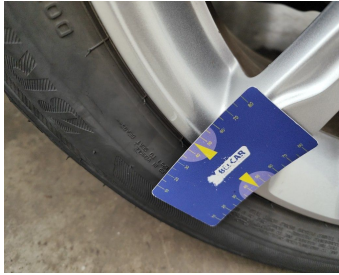
| Damages | Type | Acceptable |
|---|---|---|
| 321 | Wheel Alloy Rear Left // Repair | Y |

Wheel Alloy Rear Left // Repair-scratch

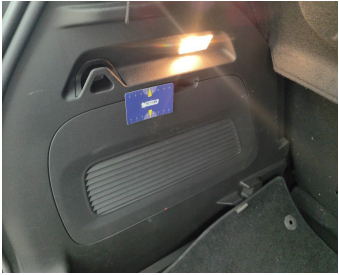
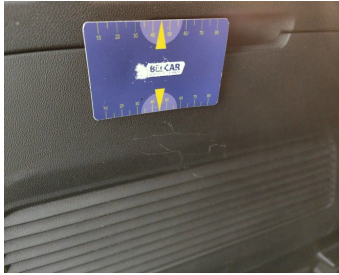
| Damages | Type | Acceptable |
|---|---|---|
| 532 | Trunk Compartment / Side Cover Left / Replace | Y |

Trunk Compartment / Side Cover Left / Replace-scratch

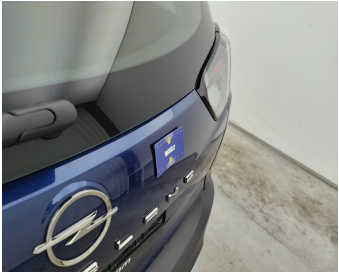
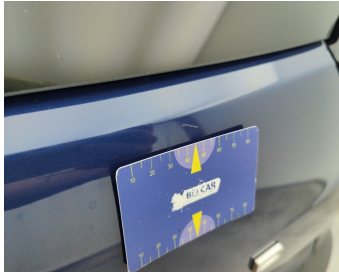
| Damages | Type | Acceptable |
|---|---|---|
| 153 | Rear Bonnet // Painting | Y |

Rear Bonnet // Painting-scratch

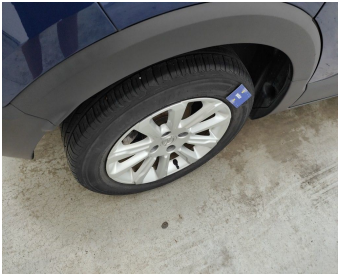
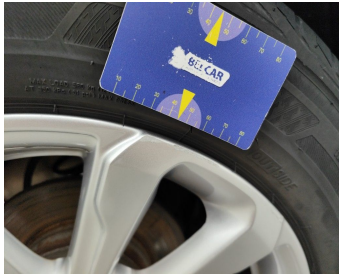
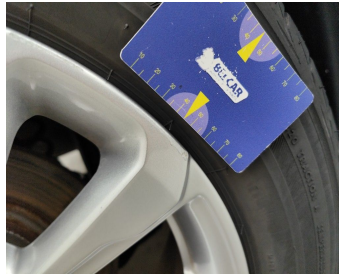
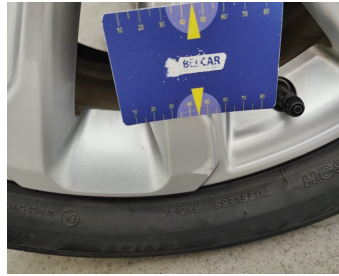
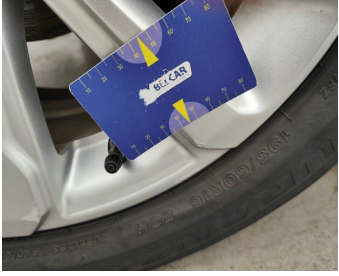
| Damages | Type | Acceptable |
|---|---|---|
| 331 | Wheel Alloy Rear Right // Repair | N |

Wheel Alloy Rear Right // Repair-scratch

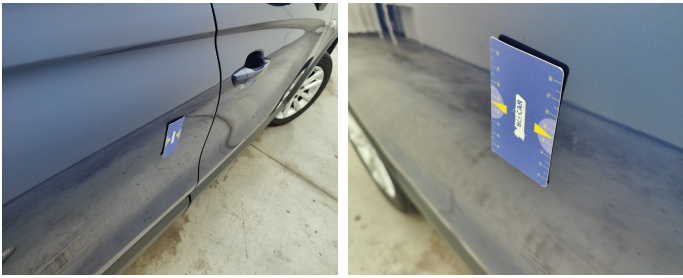
| Damages | Type | Acceptable |
|---|---|---|
| 196 | Door Rear Right // Polish | Y |

Door Rear Right // Polish-scratch

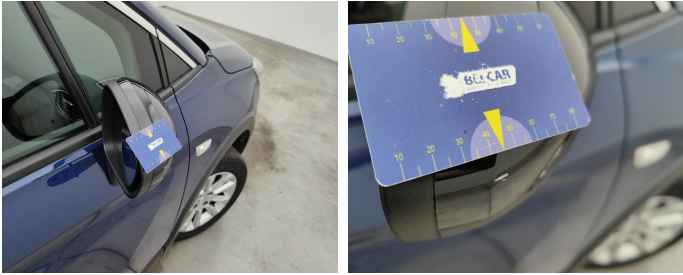
| Damages | Type | Acceptable |
|---|---|---|
| 225 | Side View Mirror Right // Polish | Y |

Side View Mirror Right // Polish-scratch

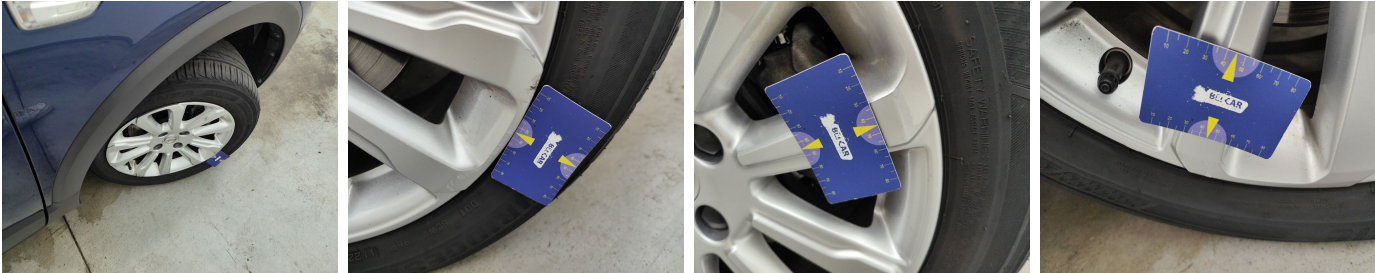
| Damages | Type | Acceptable |
|---|---|---|
| 341 | Wheel Alloy Front Right // Repair | N |

Wheel Alloy Front Right // Repair-scratch

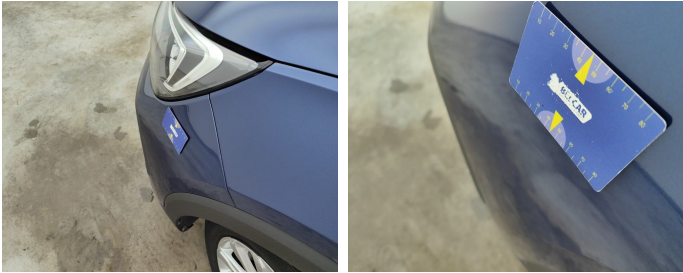
| Damages | Type | Acceptable |
|---|---|---|
| 16 | Bumper Front // Polish | Y |

Bumper Front // Polish-scratch

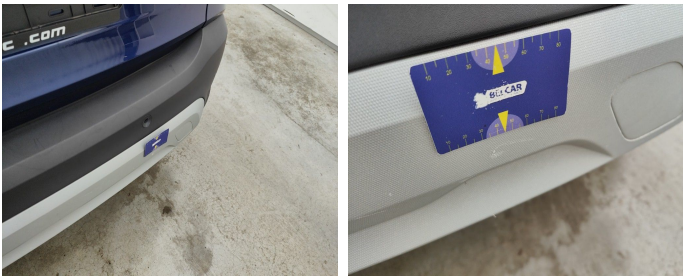
| Damages | Type | Acceptable |
|---|---|---|
| 139 | Bumper Rear / Spoiler / Replace | Y |

Bumper Rear / Spoiler / Replace-scratch

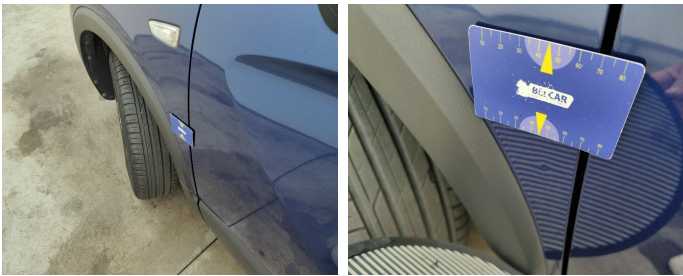
| Damages | Type | Acceptable |
|---|---|---|
| 61 | Wing Front Left // Smart Repair Medium | Y |

Wing Front Left // Smart Repair Medium-scratch + dent

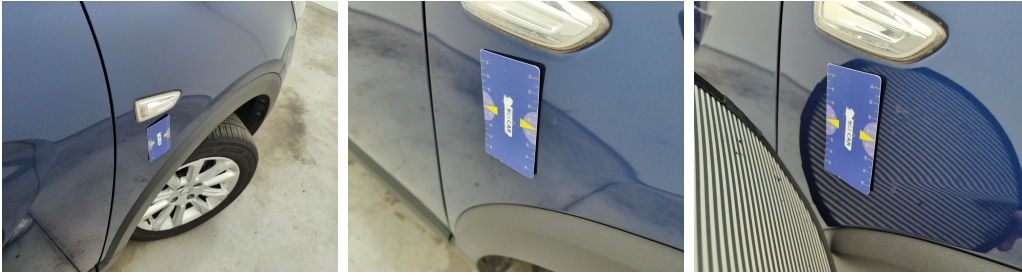
| Damages | Type | Acceptable |
|---|---|---|
| 233 | Wing Front right // Painting | N |

Wing Front right // Painting-bad repair
