# INSPECTION REPORT

**End of contract**

| License plate | 2DFA389 |
| Make | Volvo V90 T6 PHEV Core A |

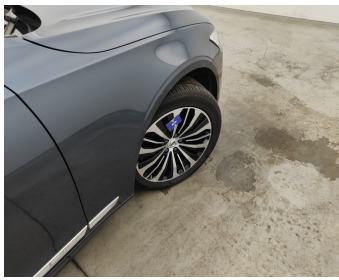
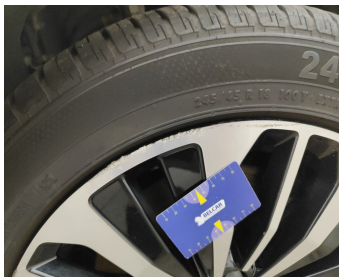
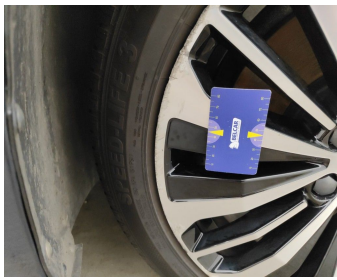
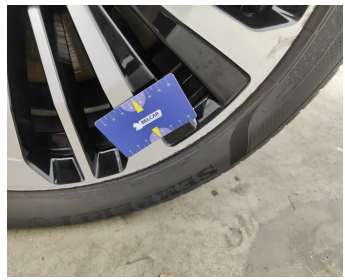
| Damages | Type | Acceptable |
|---|---|---|
| 340 | Wheel Two Tone Front Right // Repair | N |

Wheel Two Tone Front Right // Repair-scratch

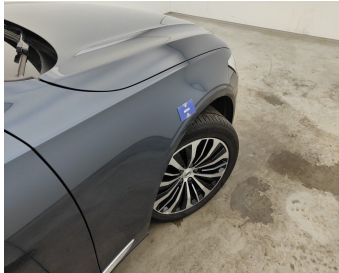
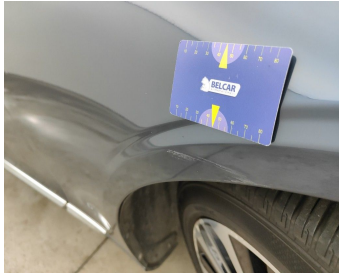
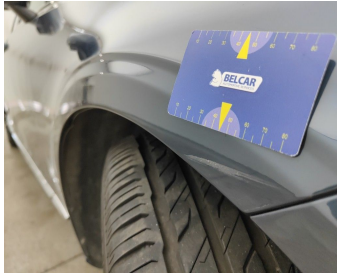
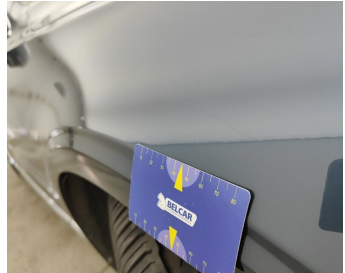
| Damages | Type | Acceptable |
|---|---|---|
| 233 | Wing Front right // Painting | N |

Wing Front right // Painting-scratch

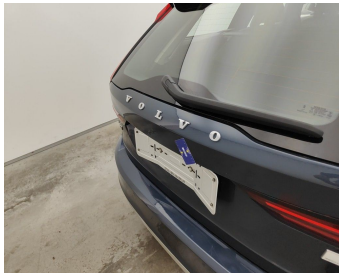
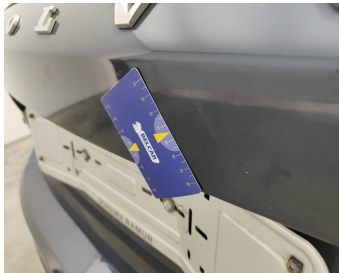
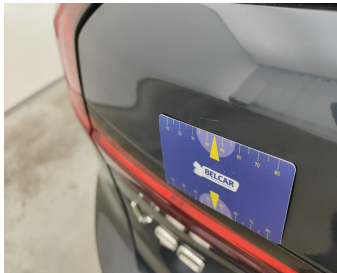
| Damages | Type | Acceptable |
|---|---|---|
| 153 | Rear Bonnet // Painting | Y |

Rear Bonnet // Painting-scratch

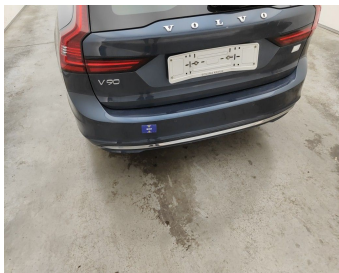
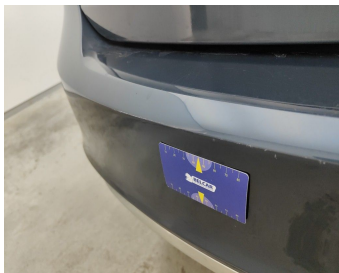
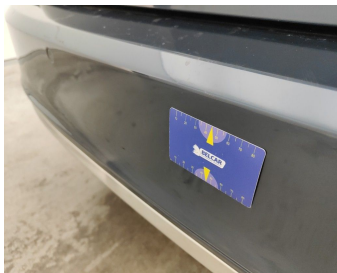
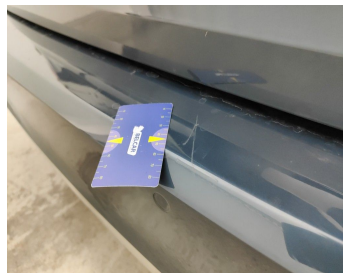
| Damages | Type | Acceptable |
|---|---|---|
| 133 | Bumper Rear // Painting | N |

Bumper Rear // Painting-scratch

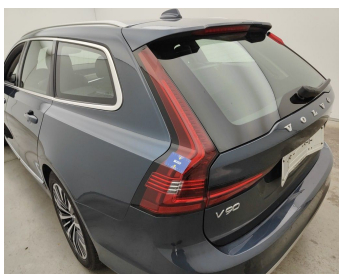
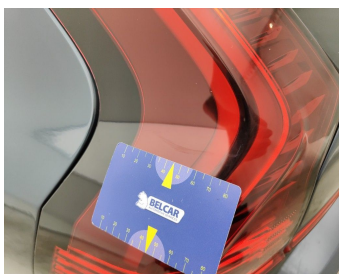
| Damages | Type | Acceptable |
|---|---|---|
| 124 | Light / Rear left / Replace | Y |

Light / Rear left / Replace-scratch

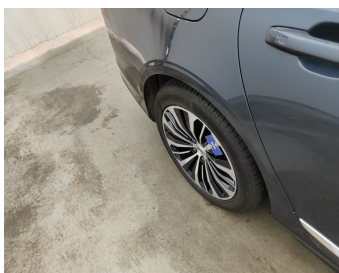
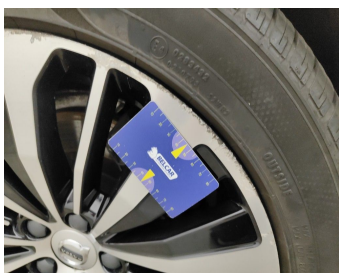
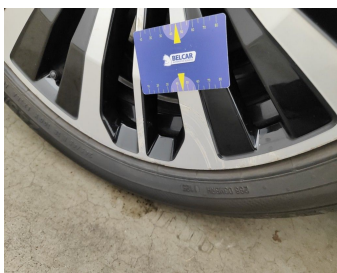
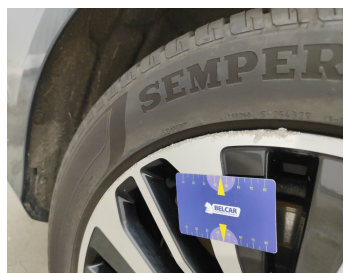
| Damages | Type | Acceptable |
|---|---|---|
| 330 | Wheel Two Tone Rear Right // Repair | N |

Wheel Two Tone Rear Right // Repair-scratch

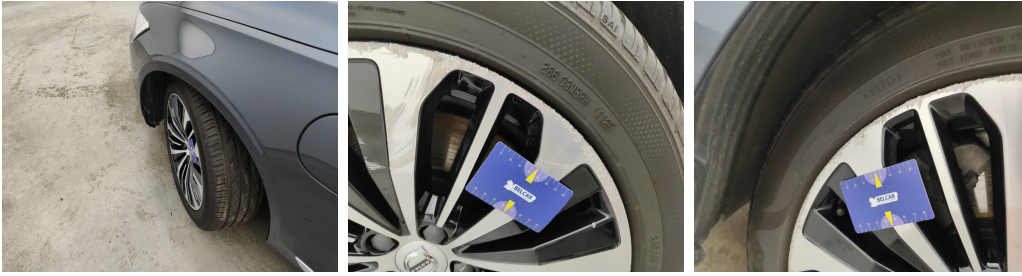
| Damages | Type | Acceptable |
|---|---|---|
| 310 | Wheel Two Tone Front Left // Repair | N |

Wheel Two Tone Front Left // Repair-scratch

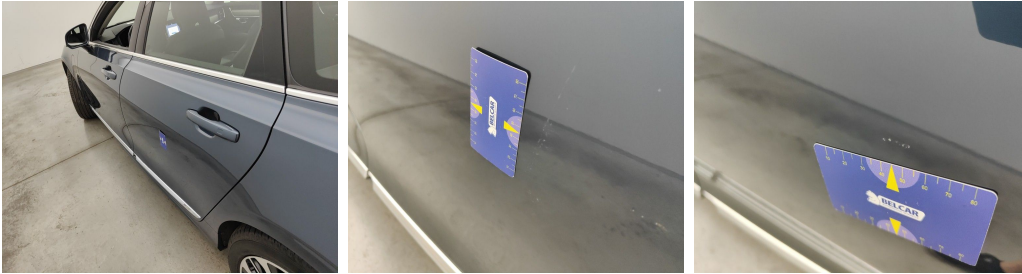
| Damages | Type | Acceptable |
|---|---|---|
| 106 | Door Rear Left // Polish | Y |

Door Rear Left // Polish-scratch

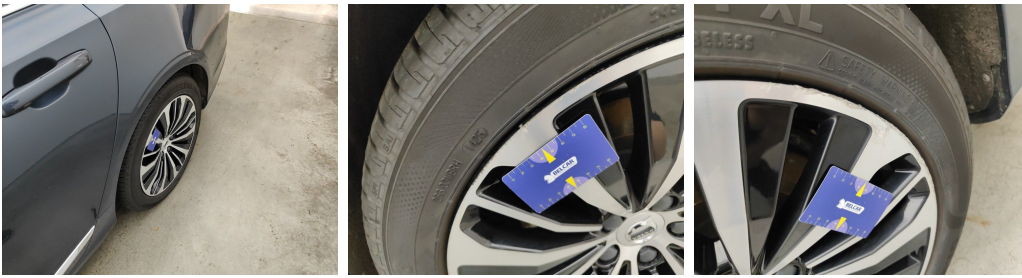
| Damages | Type | Acceptable |
|---|---|---|
| 320 | Wheel Two Tone Rear Left // Repair | N |

Wheel Two Tone Rear Left // Repair-scratch

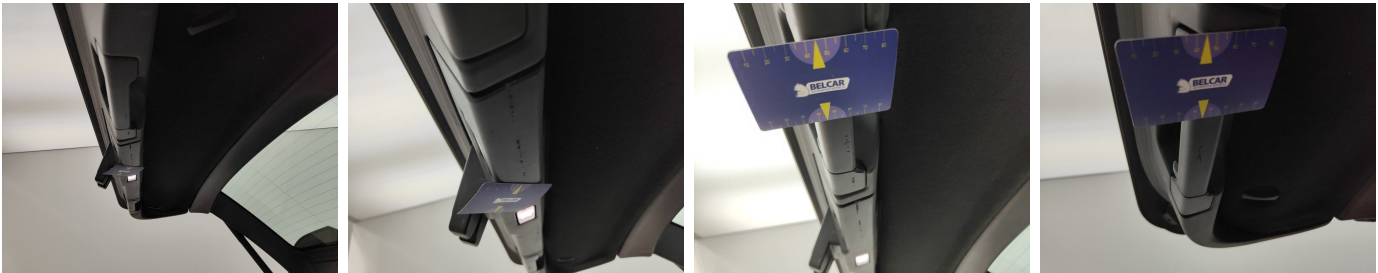
| Damages | Type | Acceptable |
|---|---|---|
| 594 | Trunk Lid Interior Coating / Complete Panel / Replace | Y |

Trunk Lid Interior Coating / Complete Panel / Replace-scratch

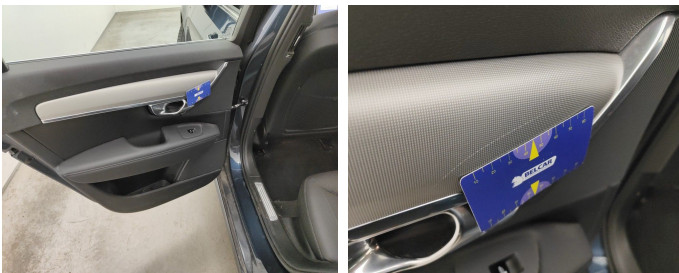
| Damages | Type | Acceptable |
|---|---|---|
| 631 | Rear Left Door Interior Coating // Repair | N |

Rear Left Door Interior Coating // Repair-scratch

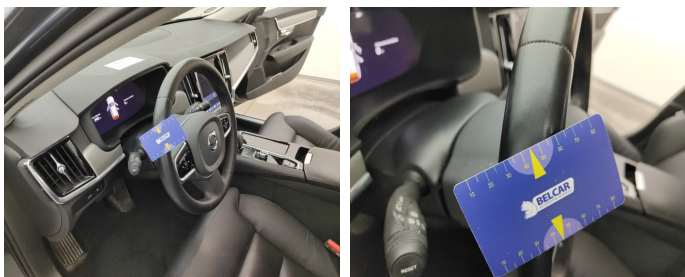
| Damages | Type | Acceptable |
|---|---|---|
| 569 | Dashboard / Steering Wheel / Replace | Y |

Dashboard / Steering Wheel / Replace-scratch

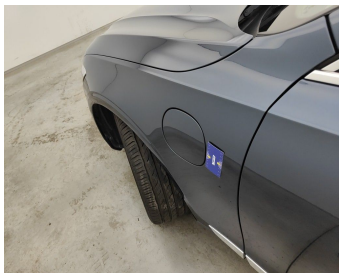
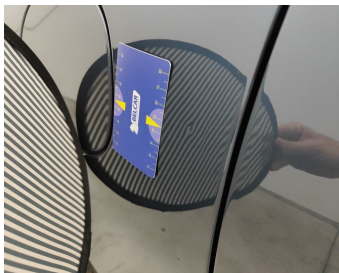
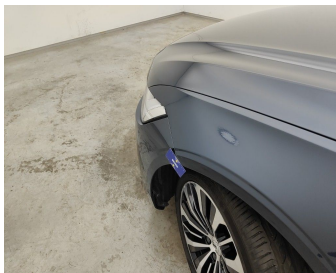
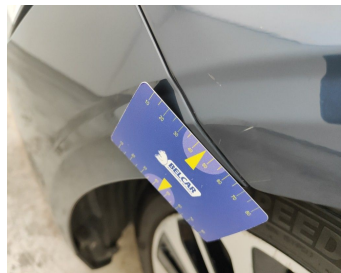
| Damages | Type | Acceptable |
|---|---|---|
| 60 | Wing Front Left // Smart Repair Small | Y |

Wing Front Left // Smart Repair Small-dent

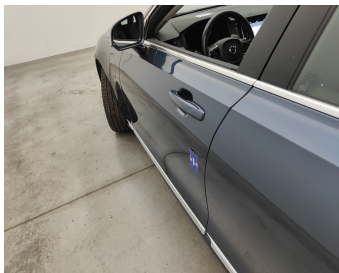
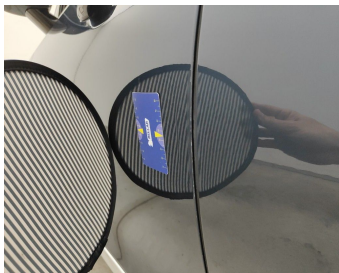
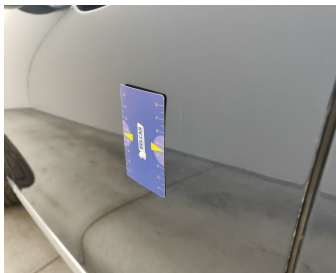
| Damages | Type | Acceptable |
|---|---|---|
| 84 | Door Front Left // Repair & Painting | N |

Door Front Left // Repair & Painting-scratch + dent

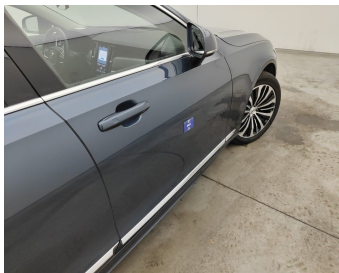
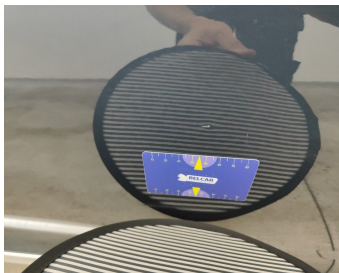
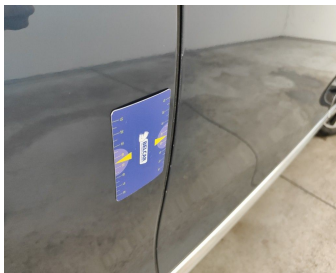
| Damages | Type | Acceptable |
|---|---|---|
| 214 | Door Front Right // Repair & Painting | Y |

Door Front Right // Repair & Painting-scratch + dent

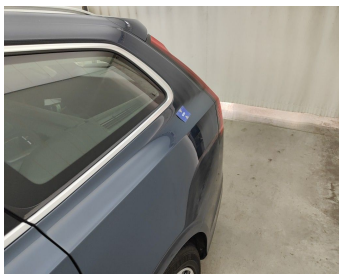
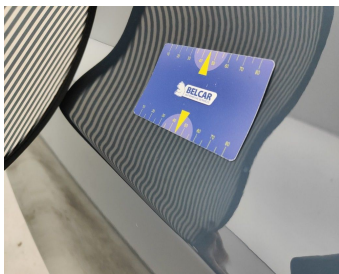
| Damages | Type | Acceptable |
|---|---|---|
| 113 | Wing Rear Left // Painting | N |

Wing Rear Left // Painting-bad repair

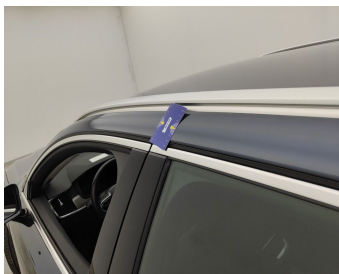
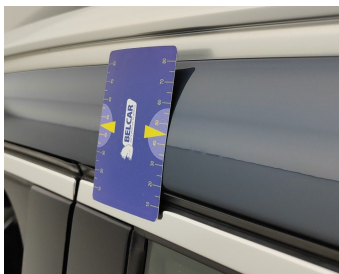
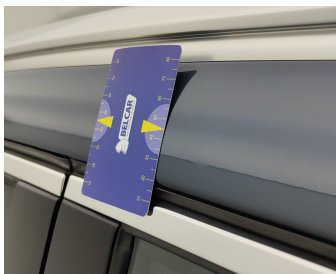
| Damages | Type | Acceptable |
|---|---|---|
| 165 | Roof // Polish | Y |

Roof // Polish-Chemical reaction

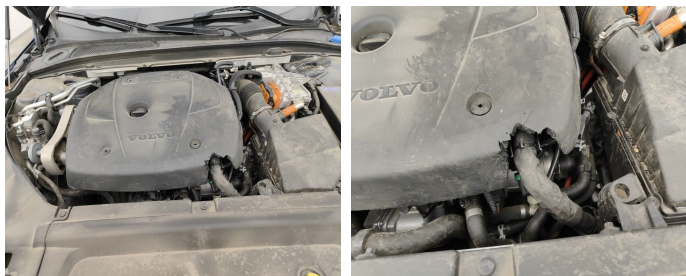
| Damages | Type | Acceptable |
|---|---|---|
| 38 | Front Bonnet / Insulation / Replace | N |

Front Bonnet / Insulation / Replace-tear

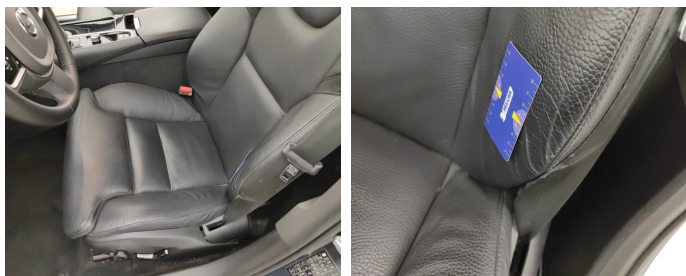
| Damages | Type | Acceptable |
|---|---|---|
| 413 | Seat Front Left / Rear Coating / Replace | Y |

Seat Front Left / Rear Coating / Replace-worn

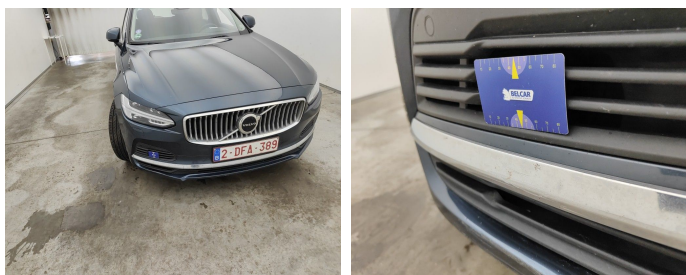
| Damages | Type | Acceptable |
|---|---|---|
| 272 | Bumper Front / Trim Right / Replace | N |

Bumper Front / Trim Right / Replace-scratch

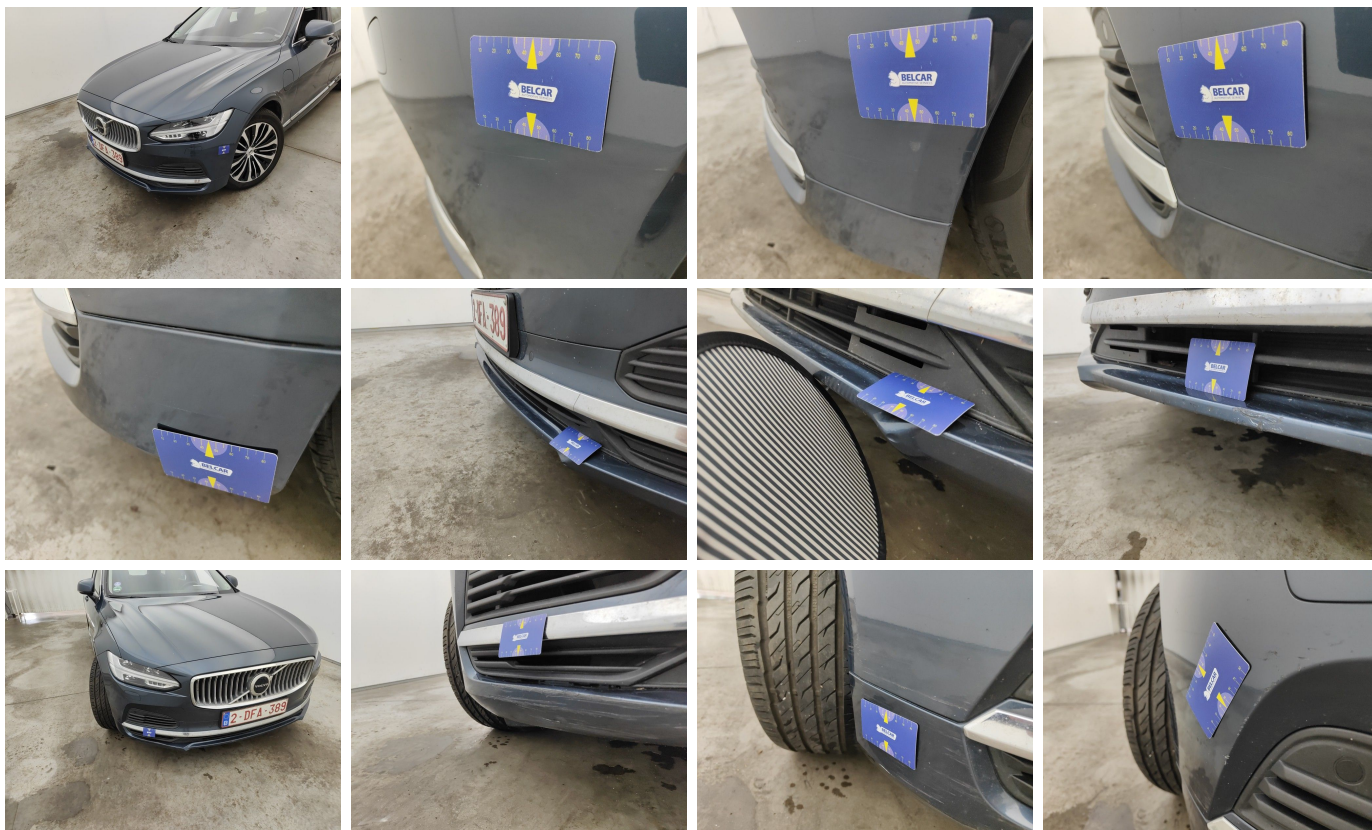
| Damages | Type | Acceptable |
|---|---|---|
| 14 | Bumper Front // Repair & Painting | N |

Bumper Front // Repair & Painting-scratch + dent

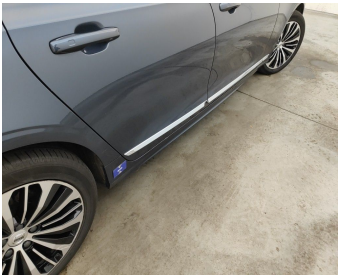
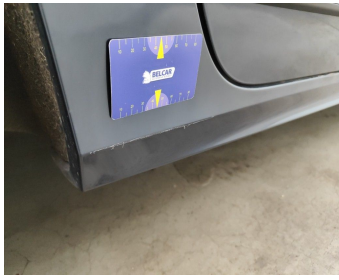
| Damages | Type | Acceptable |
|---|---|---|
| 208 | Rocker Panel Right / Cover Not Painted / Replace | N |

Rocker Panel Right / Cover Not Painted / Replace-scratch

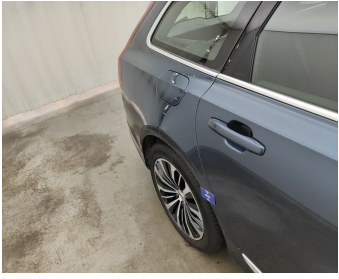
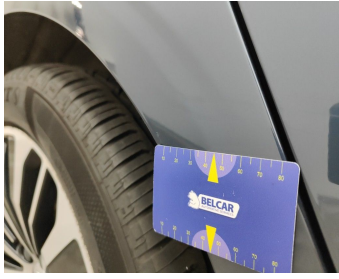
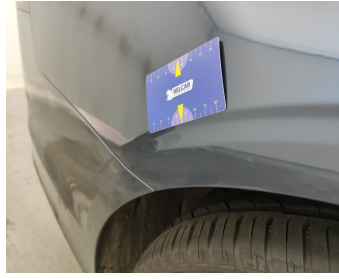
| Damages | Type | Acceptable |
|---|---|---|
| 186 | Wing Rear Right // Polish | N |

Wing Rear Right // Polish-scratch

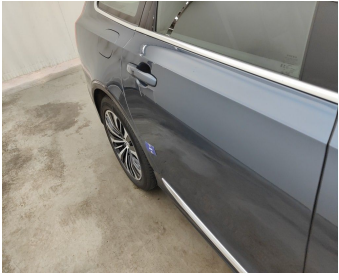
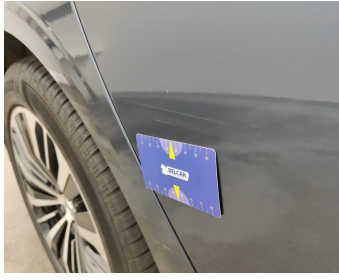
| Damages | Type | Acceptable |
|---|---|---|
| 193 | Door Rear Right // Painting | N |

Door Rear Right // Painting-scratch
