# INSPECTION REPORT

End of contract

| License plate | 2BBL218 |
| Make | Hyundai Tuc.T-GDi 48V 110kW Fe |

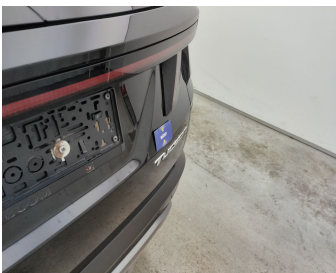
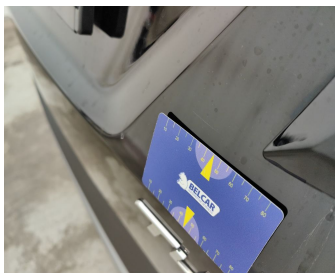
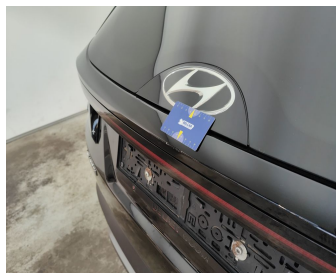
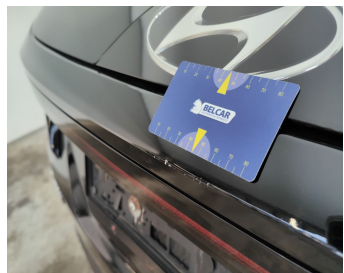
| Damages | Type | Acceptable |
|---|---|---|
| 153 | Rear Bonnet // Painting | Y |

Rear Bonnet // Painting-scratch

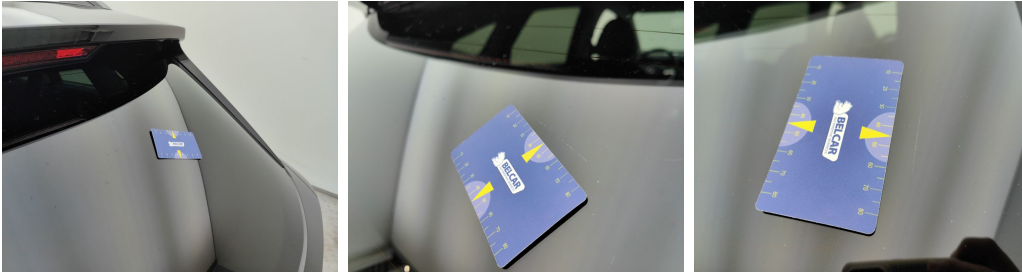
| Damages | Type | Acceptable |
|---|---|---|
| 159 | Rear Bonnet / Rear Window / Replace | Y |

Rear Bonnet / Rear Window / Replace-scratch

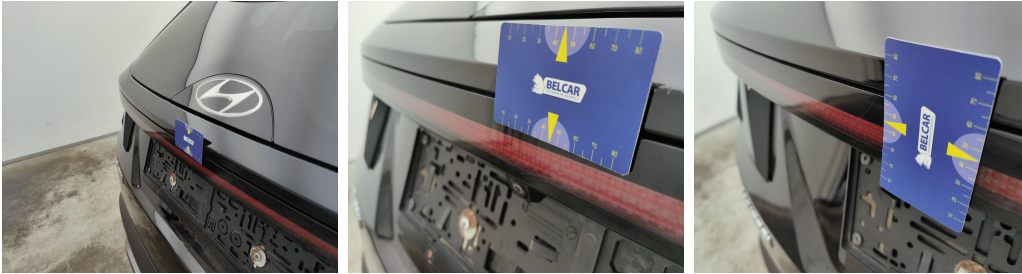
| Damages | Type | Acceptable |
|---|---|---|
| 158 | Rear Bonnet / 3rd Stoplight / Replace | N |

Rear Bonnet / 3rd Stoplight / Replace-scratch

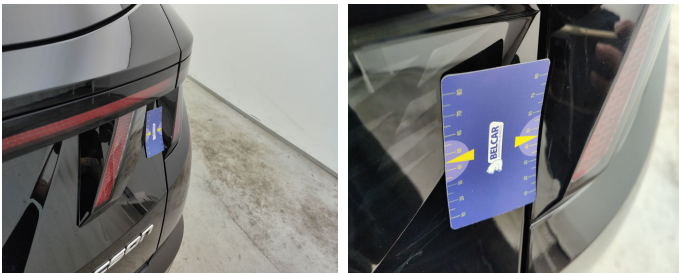
| Damages | Type | Acceptable |
|---|---|---|
| 174 | Light / Rear Right / Replace | Y |

Light / Rear Right / Replace-scratch

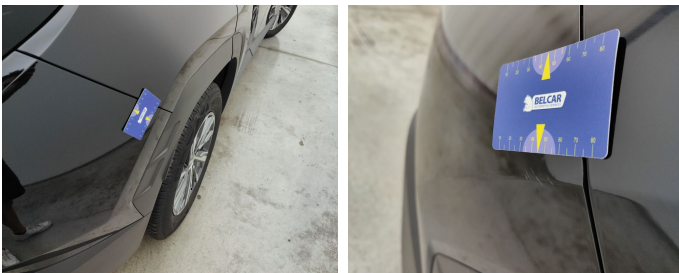
| Damages | Type | Acceptable |
|---|---|---|
| 136 | Bumper Rear // Polish | Y |

Bumper Rear // Polish-scratch

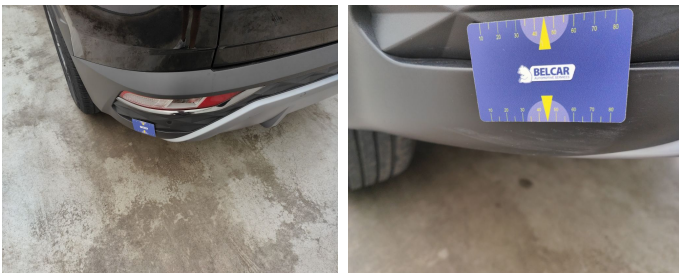
| Damages | Type | Acceptable |
|---|---|---|
| 282 | Bumper Rear / Trim Center / Replace | N |

Bumper Rear / Trim Center / Replace-scratch

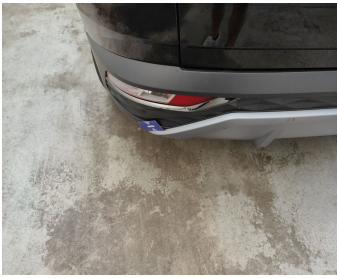
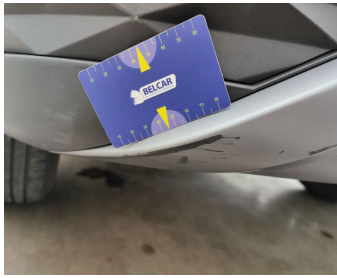
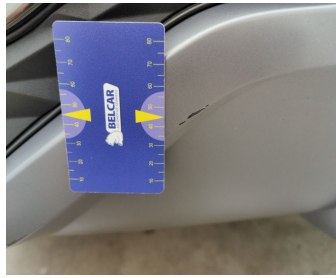
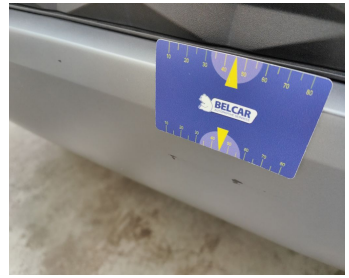
| Damages | Type | Acceptable |
|---|---|---|
| 139 | Bumper Rear / Spoiler / Replace | N |

Bumper Rear / Spoiler / Replace-scratch

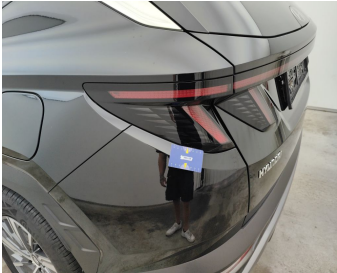
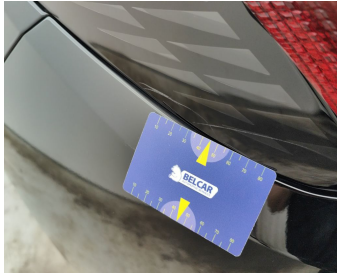
| Damages | Type | Acceptable |
|---|---|---|
| 124 | Light / Rear left / Replace | N |

Light / Rear left / Replace-scratch

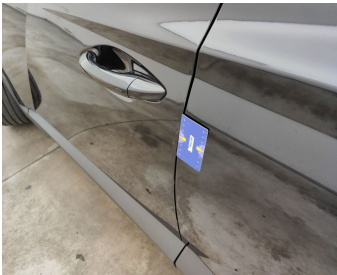
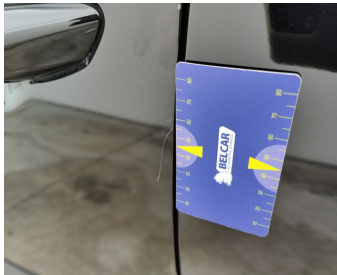
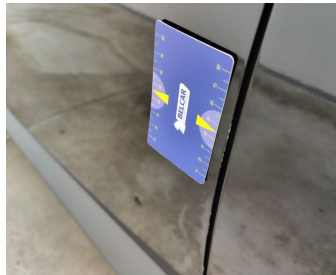
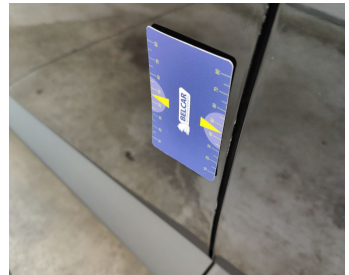
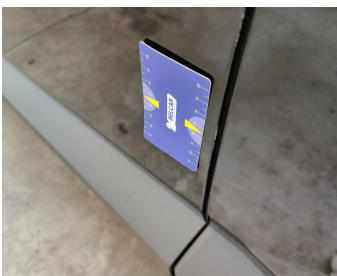
| Damages | Type | Acceptable |
|---|---|---|
| 83 | Door Front Left // Painting | Y |

Door Front Left // Painting-scratch

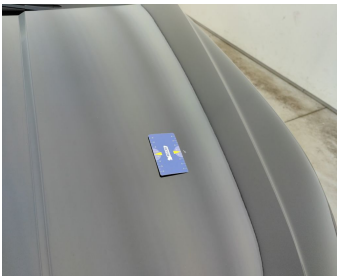
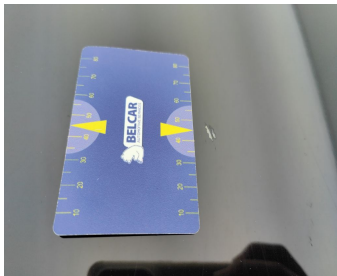
| Damages | Type | Acceptable |
|---|---|---|
| 32 | Front Bonnet // Painting | Y |

Front Bonnet // Painting-scratch

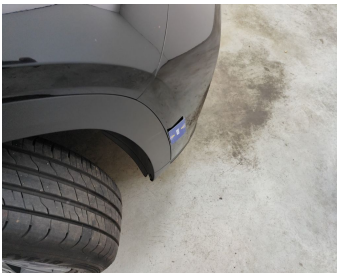
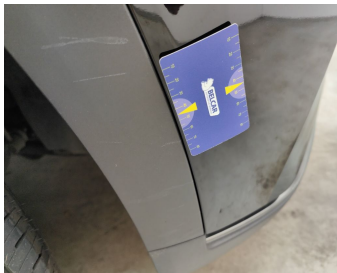
| Damages | Type | Acceptable |
|---|---|---|
| 237 | Wing Front right / Trim / Replace | N |

Wing Front right / Trim / Replace-scratch

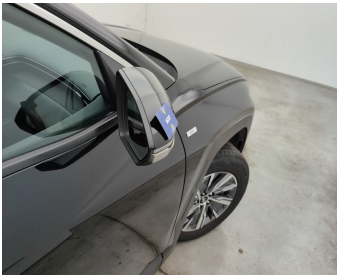
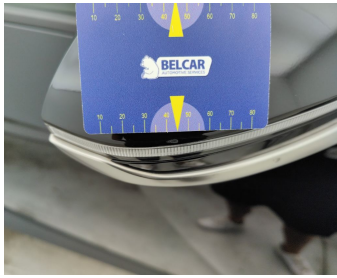
| Damages | Type | Acceptable |
|---|---|---|
| 222 | Side View Mirror Right // Painting | Y |

Side View Mirror Right // Painting-scratch

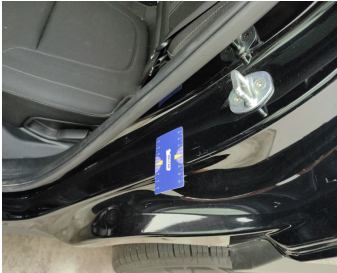
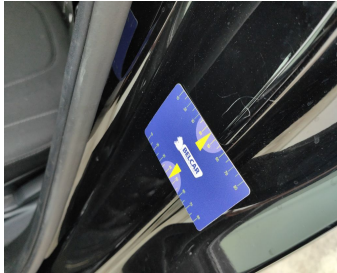
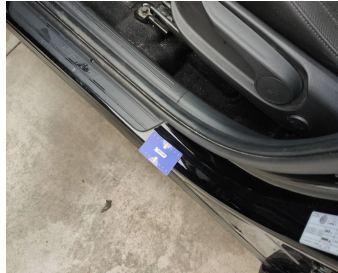
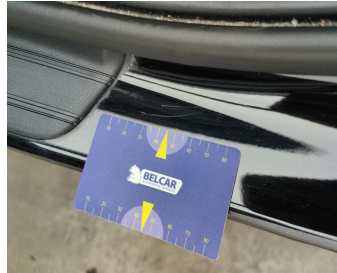
| Damages | Type | Acceptable |
|---|---|---|
| 91 | Rocker Panel Left // Smart Repair Medium | Y |

Rocker Panel Left // Smart Repair Medium-scratch

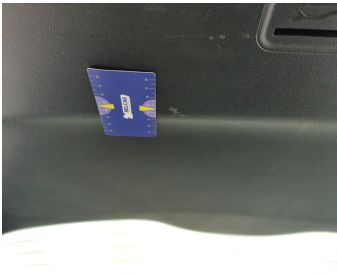
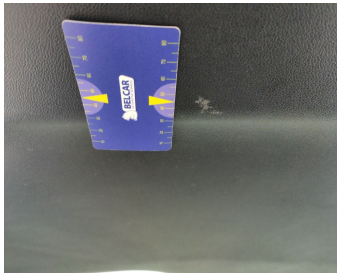
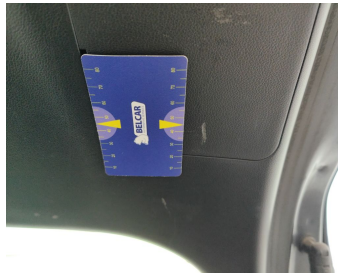
| Damages | Type | Acceptable |
|---|---|---|
| 594 | Trunk Lid Interior Coating / Complete Panel / Replace | Y |

Trunk Lid Interior Coating / Complete Panel / Replace-scratch

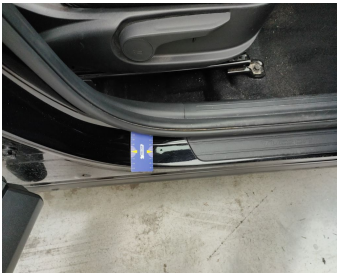
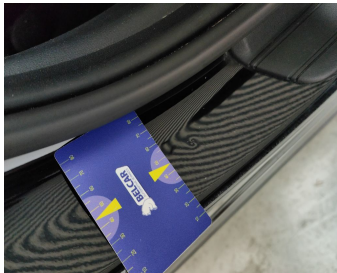
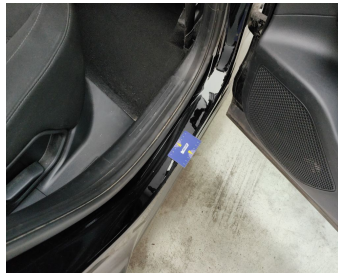
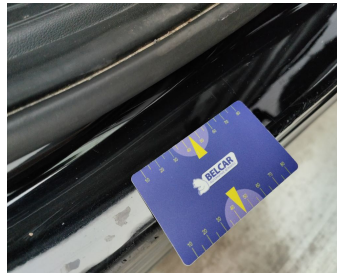
| Damages | Type | Acceptable |
|---|---|---|
| 201 | Rocker Panel Right // Smart Repair Medium | Y |

Rocker Panel Right // Smart Repair Medium-scratch

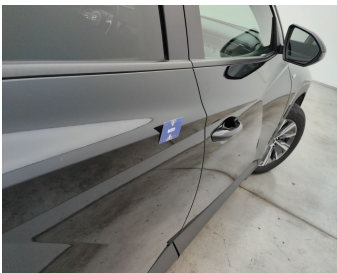
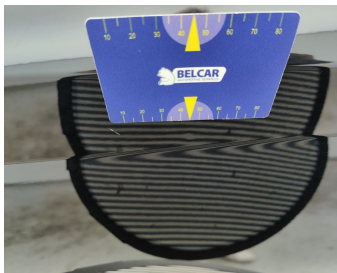
| Damages | Type | Acceptable |
|---|---|---|
| 194 | Door Rear Right // Repair & Painting | Y |

Door Rear Right // Repair & Painting-scratch + dent

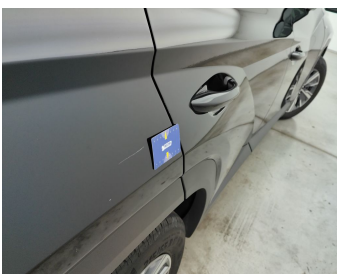
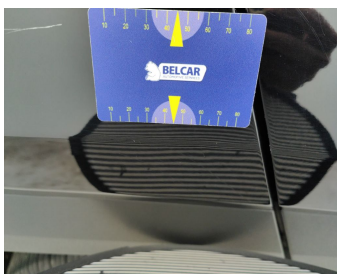
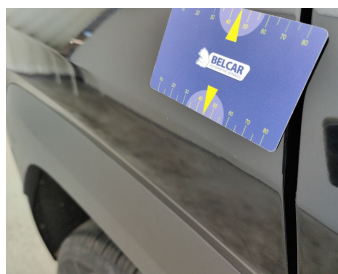
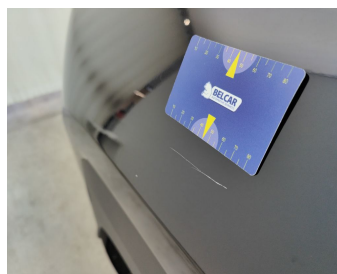
| Damages | Type | Acceptable |
|---|---|---|
| 184 | Wing Rear Right // Repair & Painting | Y |

Wing Rear Right // Repair & Painting-scratch + dent

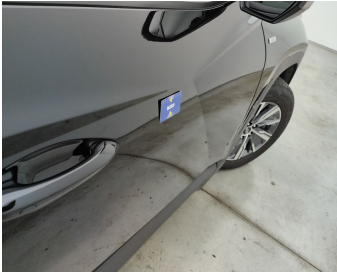
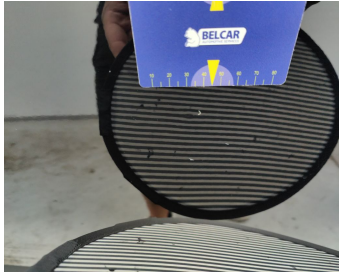
| Damages | Type | Acceptable |
|---|---|---|
| 214 | Door Front Right // Repair & Painting | Y |

Door Front Right // Repair & Painting-scratch + dent

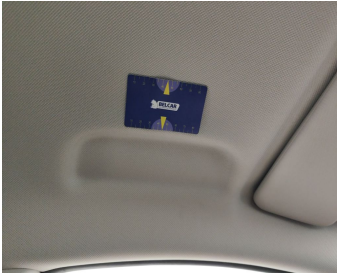
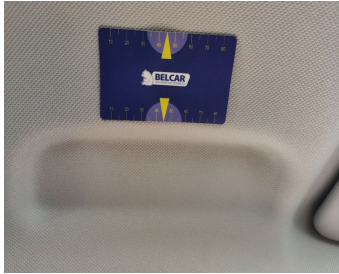
| Damages | Type | Acceptable |
|---|---|---|
| 541 | Interior // Repair 2 | Y |

Interior // Repair 2-missing

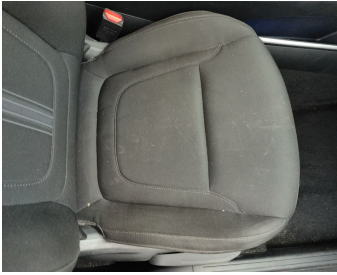
| Damages | Type | Acceptable |
|---|---|---|
| 860 | Interior Cleaning // Small | N |

Interior Cleaning // Small-stain

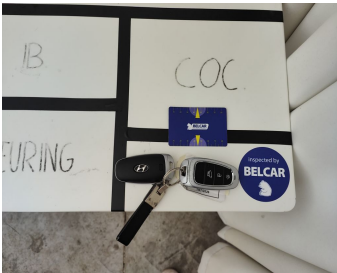
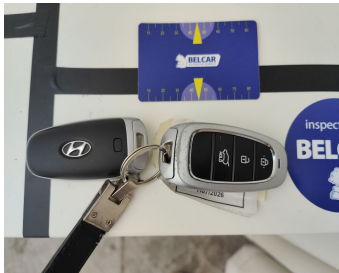
| Damages | Type | Acceptable |
|---|---|---|
| 883 | Key Price Range 2 // | Y |

Key Price Range 2 //-worn

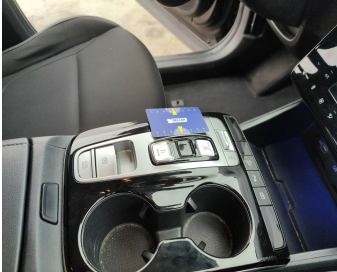
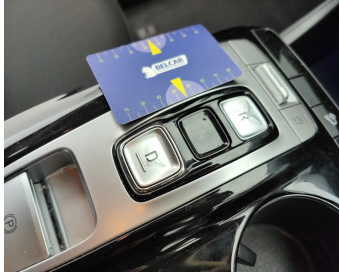
| Damages | Type | Acceptable |
|---|---|---|
| 561 | Dashboard // Repair | Y |

Dashboard // Repair-worn

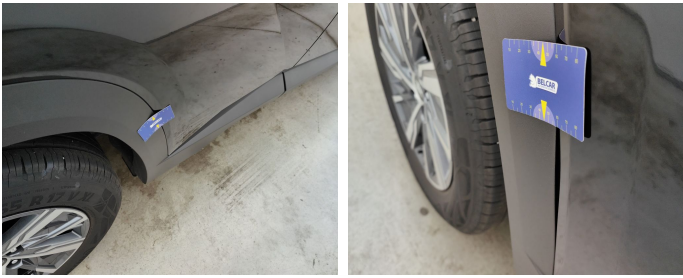
| Damages | Type | Acceptable |
|---|---|---|
| 187 | Wing Rear Right / Trim / Replace | Y |

Wing Rear Right / Trim / Replace-bad position
