# INSPECTION REPORT

**End of contract**

| License plate | 2DQU410 |
| Make | Peugeot 2008 1.2 96kW Active P |

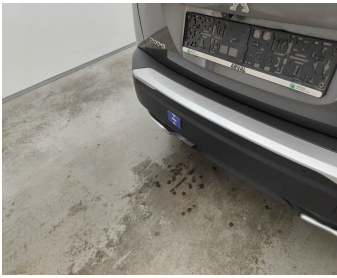
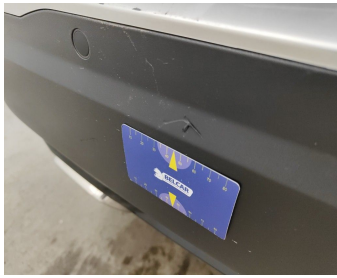
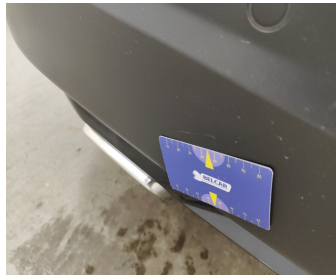
| Damages | Type | Acceptable |
|---|---|---|
| 138 | Bumper Rear / Lower Cover Not Painted / Replace | Y |

Bumper Rear / Lower Cover Not Painted / Replace-scratch

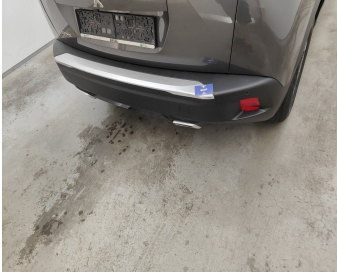
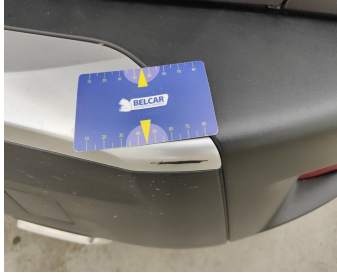
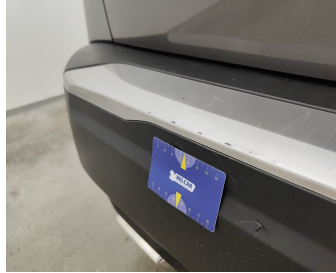
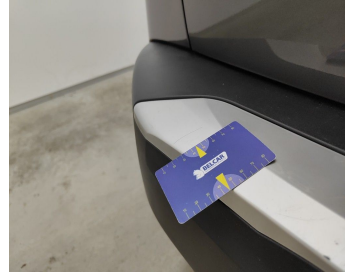
| Damages | Type | Acceptable |
|---|---|---|
| 282 | Bumper Rear / Trim Center / Replace | N |

Bumper Rear / Trim Center / Replace-scratch

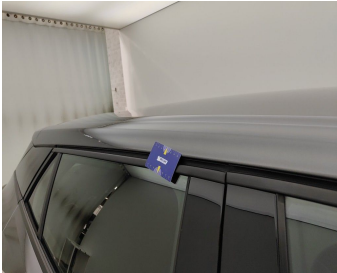
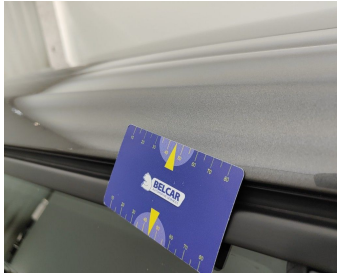
| Damages | Type | Acceptable |
|---|---|---|
| 165 | Roof // Polish | Y |

Roof // Polish-scratch

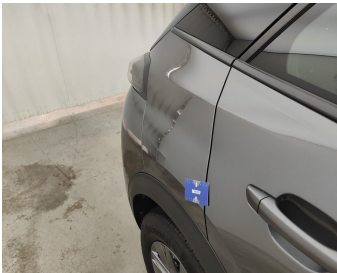
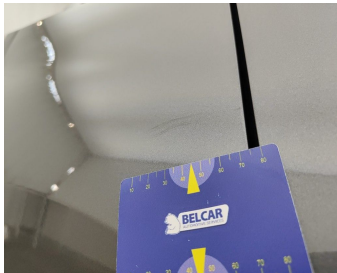
| Damages | Type | Acceptable |
|---|---|---|
| 186 | Wing Rear Right // Polish | Y |

Wing Rear Right // Polish-scratch

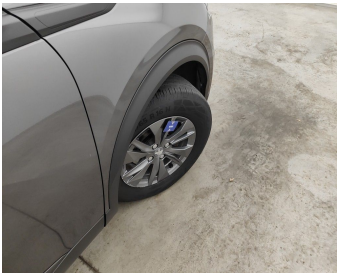
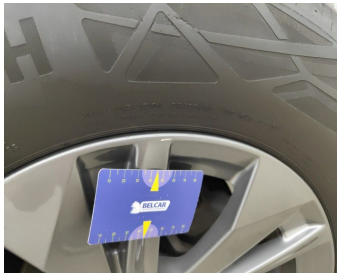
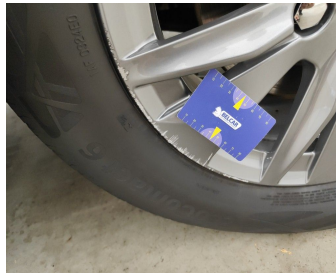
| Damages | Type | Acceptable |
|---|---|---|
| 341 | Wheel Alloy Front Right // Repair | N |

Wheel Alloy Front Right // Repair-scratch

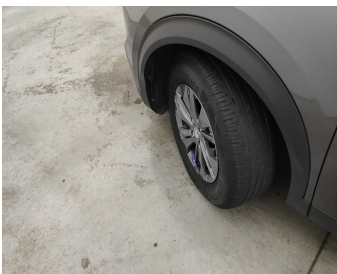
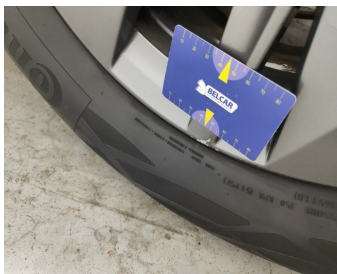
| Damages | Type | Acceptable |
|---|---|---|
| 311 | Wheel Alloy Front Left // Repair | Y |

Wheel Alloy Front Left // Repair-scratch

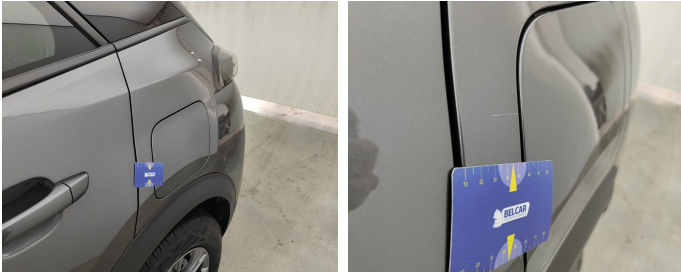
| Damages | Type | Acceptable |
|---|---|---|
| 113 | Wing Rear Left // Painting | Y |

Wing Rear Left // Painting-scratch

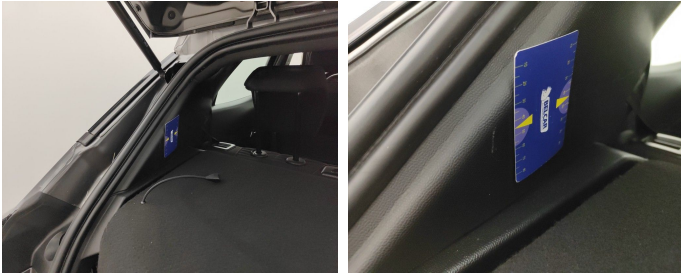
| Damages | Type | Acceptable |
|---|---|---|
| 532 | Trunk Compartment / Side Cover Left / Replace | Y |

Trunk Compartment / Side Cover Left / Replace-scratch

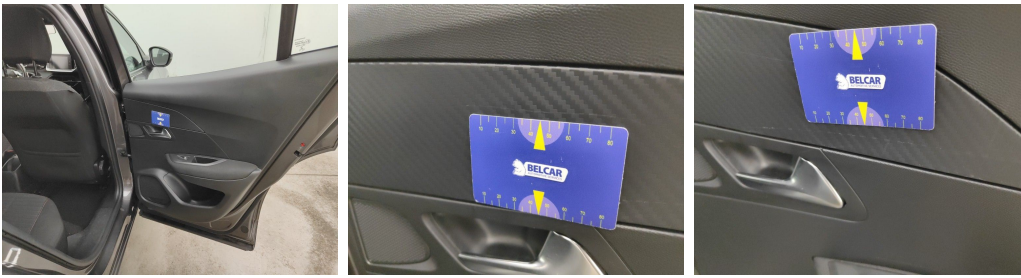
| Damages | Type | Acceptable |
|---|---|---|
| 641 | Rear Right Door Interior Coating // Repair | N |

Rear Right Door Interior Coating // Repair-scratch

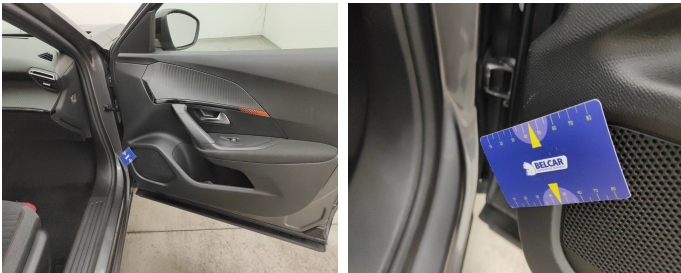
| Damages | Type | Acceptable |
|---|---|---|
| 621 | Front Right Door Interior Coating // Repair | N |

Front Right Door Interior Coating // Repair-scratch

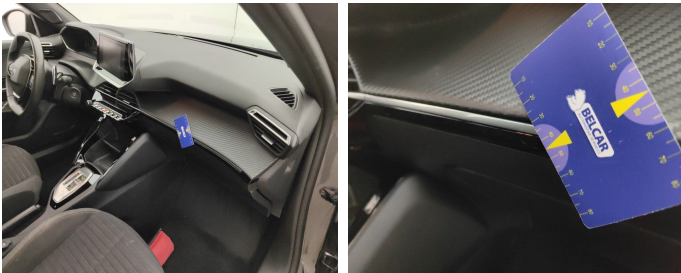
| Damages | Type | Acceptable |
|---|---|---|
| 561 | Dashboard // Repair | N |

Dashboard // Repair-scratch

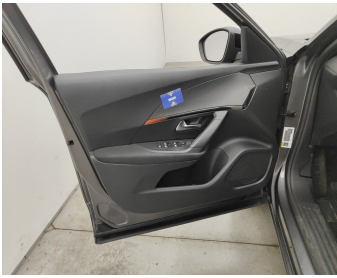
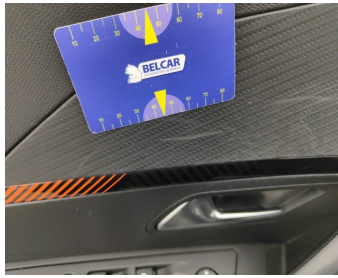
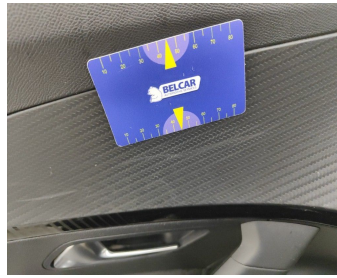
| Damages | Type | Acceptable |
|---|---|---|
| 611 | Front Left Door Interior Coating // Repair | N |

Front Left Door Interior Coating // Repair-scratch

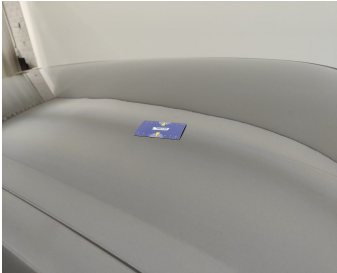
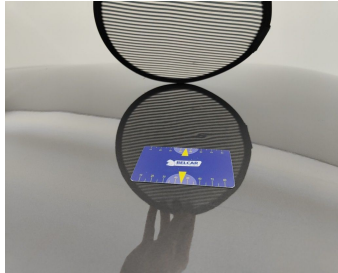
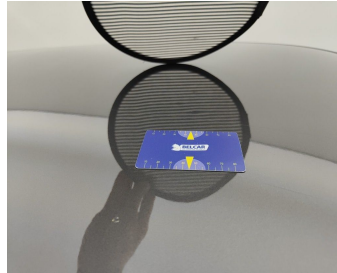
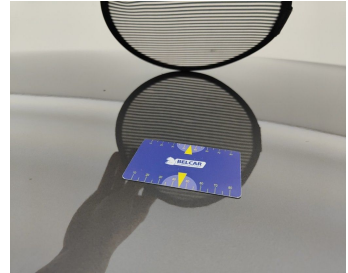
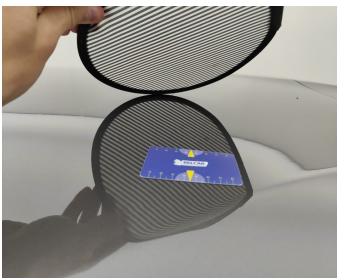
| Damages | Type | Acceptable |
|---|---|---|
| 161 | Roof // Smart Repair Medium | N |

Roof // Smart Repair Medium-dent

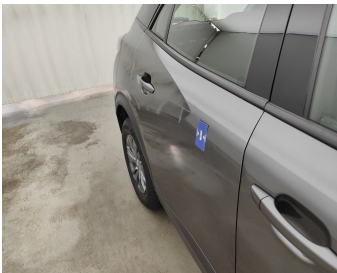
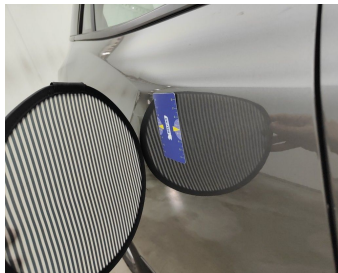
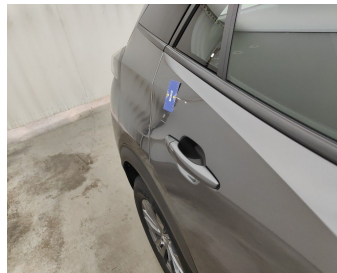
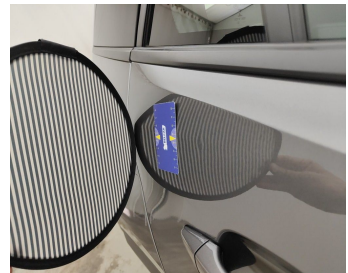
| Damages | Type | Acceptable |
|---|---|---|
| 190 | Door Rear Right // Smart Repair Small | Y |

Door Rear Right // Smart Repair Small-dent

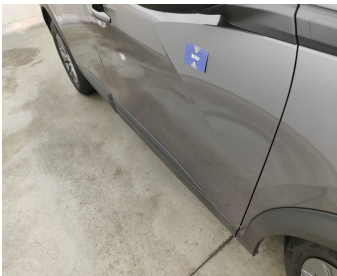
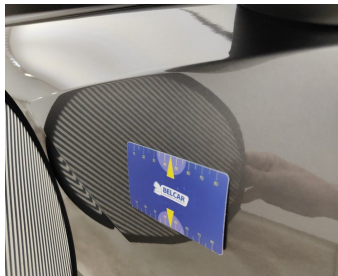
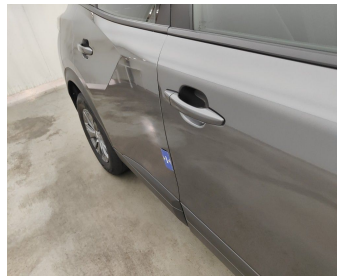
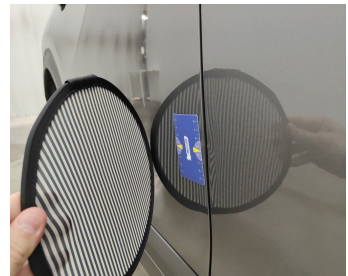
| Damages | Type | Acceptable |
|---|---|---|
| 214 | Door Front Right // Repair & Painting | N |

Door Front Right // Repair & Painting-scratch + dent

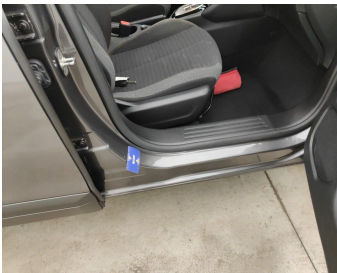
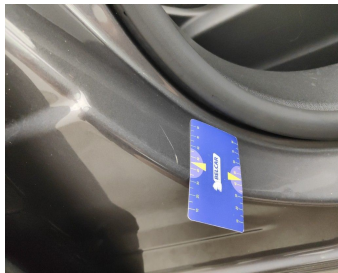
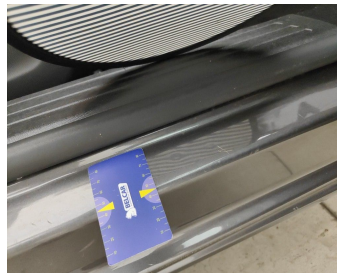
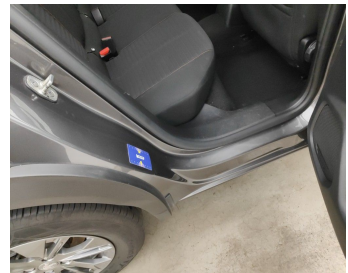
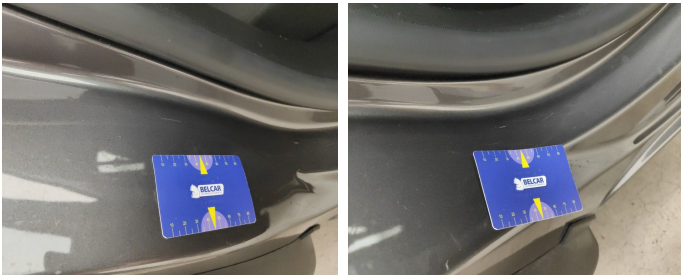
| Damages | Type | Acceptable |
|---|---|---|
| 201 | Rocker Panel Right // Smart Repair Medium | N |

Rocker Panel Right // Smart Repair Medium-scratch + dent

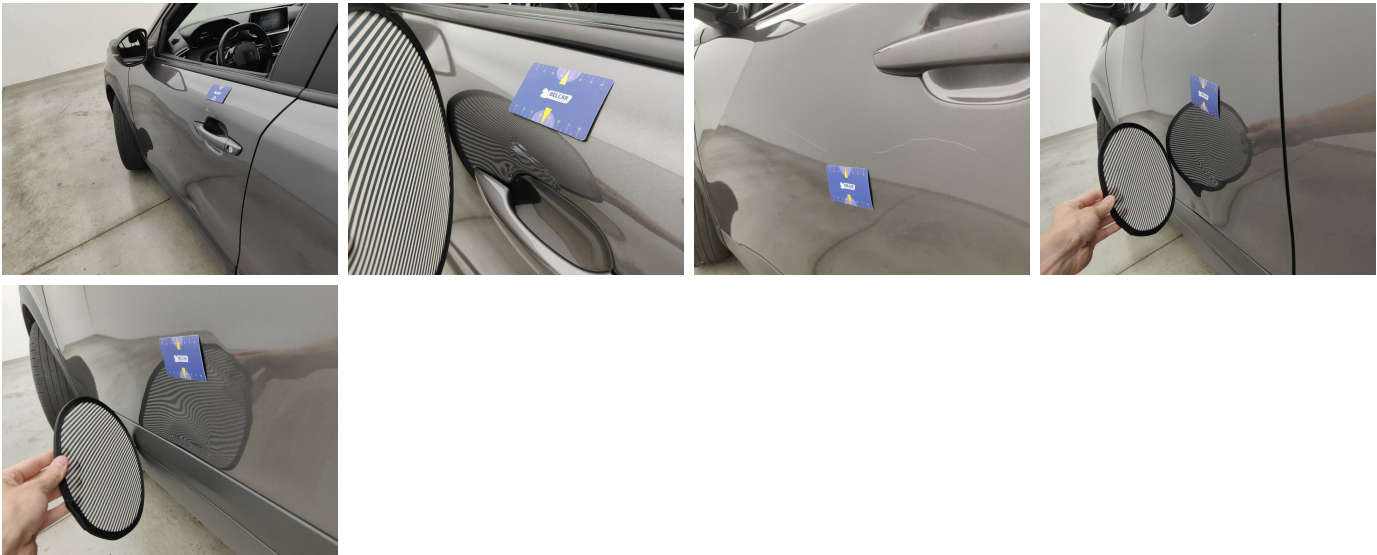
| Damages | Type | Acceptable |
|---|---|---|
| 84 | Door Front Left // Repair & Painting | N |

Door Front Left // Repair & Painting-scratch + dent

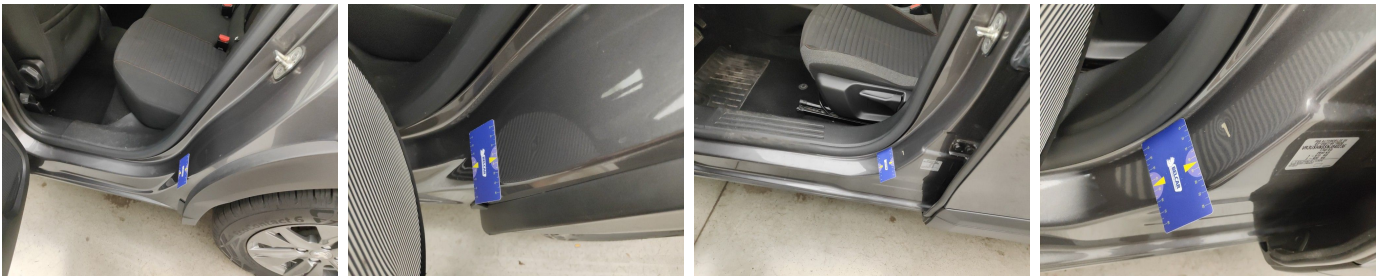
| Damages | Type | Acceptable |
|---|---|---|
| 91 | Rocker Panel Left // Smart Repair Medium | Y |

Rocker Panel Left // Smart Repair Medium-scratch + dent

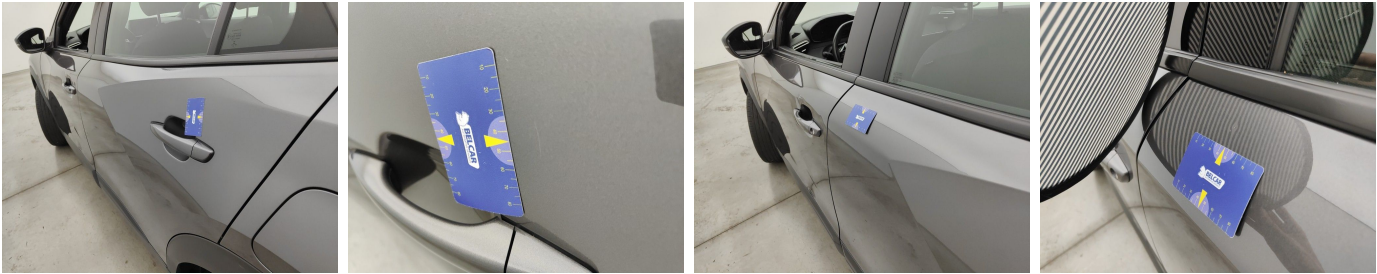
| Damages | Type | Acceptable |
|---|---|---|
| 104 | Door Rear Left // Repair & Painting | N |

Door Rear Left // Repair & Painting-scratch + dent

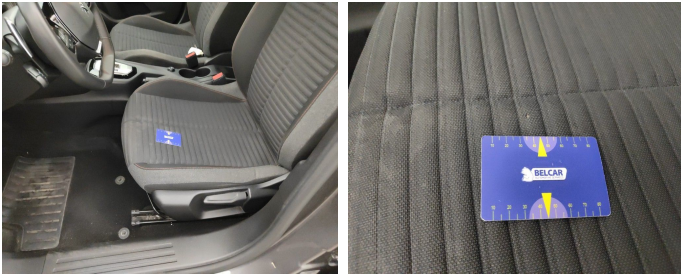
| Damages | Type | Acceptable |
|---|---|---|
| 412 | Seat Front Left / Bottom Coating / Replace | N |

Seat Front Left / Bottom Coating / Replace-Incinerated

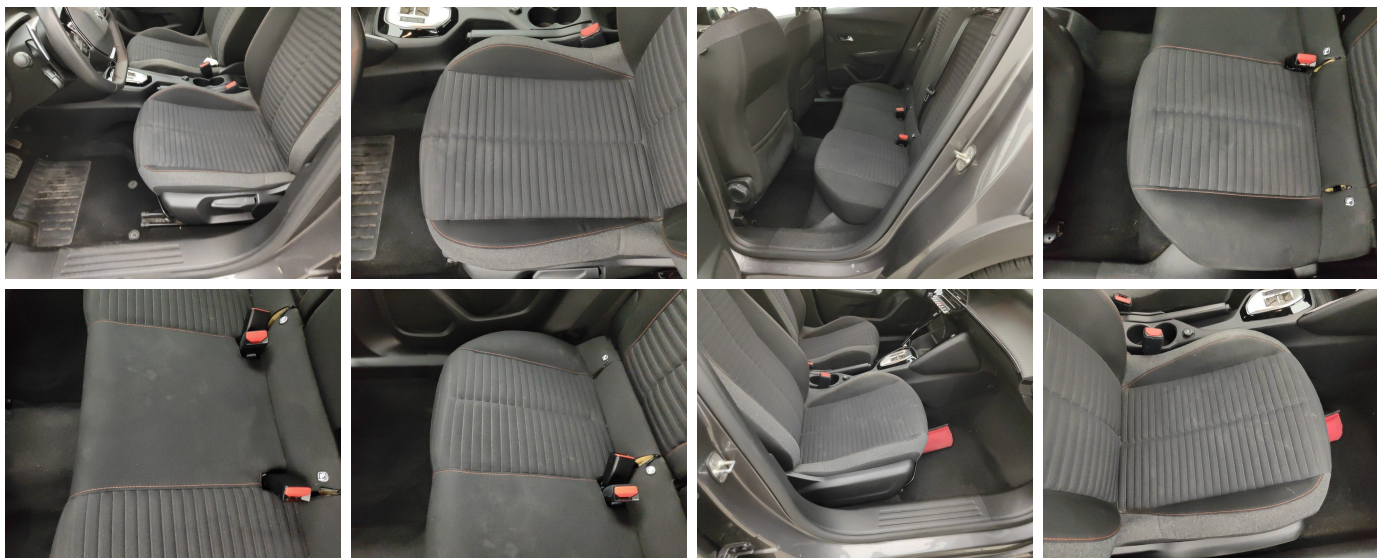
| Damages | Type | Acceptable |
|---|---|---|
| 860 | Interior Cleaning // Small | N |

Interior Cleaning // Small-stain

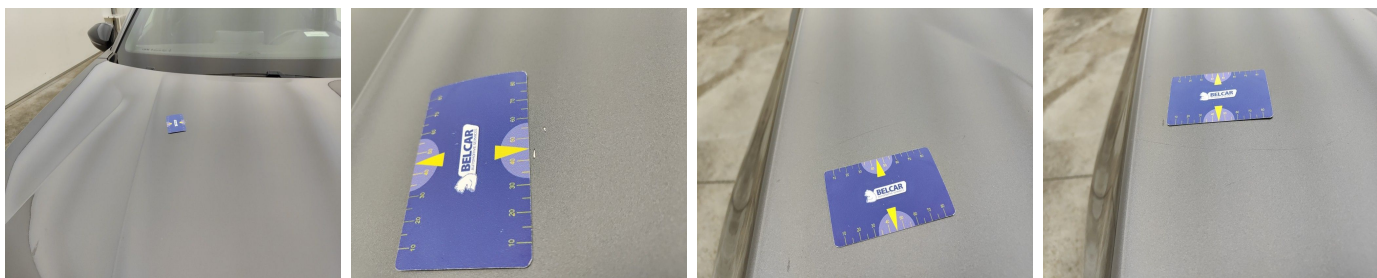
| Damages | Type | Acceptable |
|---|---|---|
| 32 | Front Bonnet // Painting | N |

Front Bonnet // Painting-stone chipping

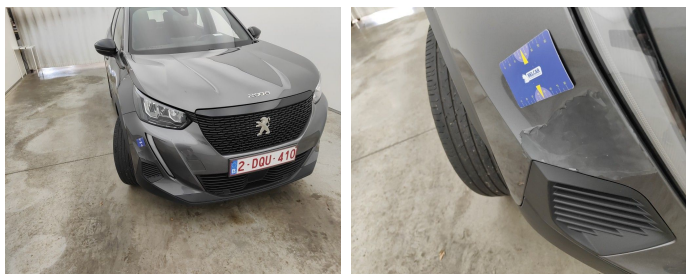
| Damages | Type | Acceptable |
|---|---|---|
| 13 | Bumper Front // Painting | N |

Bumper Front // Painting-Chipped paint
