# INSPECTION REPORT

**End of contract**

| License plate | 2AUT510 |
| Make | Skoda Karoq 2.0TDi 85kW Ambiti |

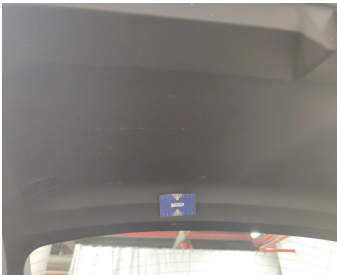
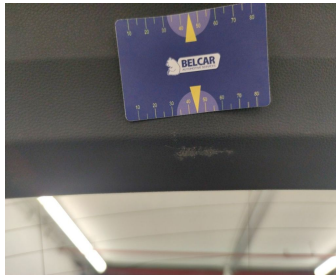
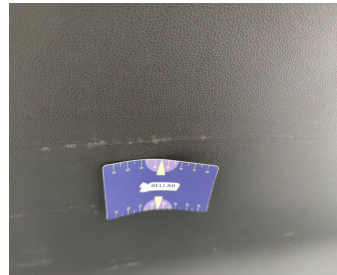
| Damages | Type | Acceptable |
|---|---|---|
| 594 | Trunk Lid Interior Coating / Complete Panel / Replace | Y |

Trunk Lid Interior Coating / Complete Panel / Replace-scratch

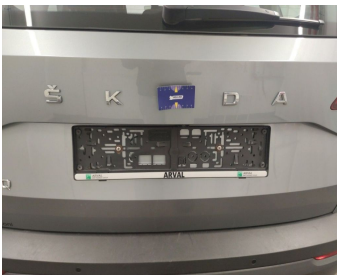
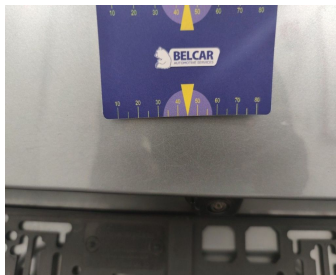
| Damages | Type | Acceptable |
|---|---|---|
| 156 | Rear Bonnet // Polish | Y |

Rear Bonnet // Polish-scratch

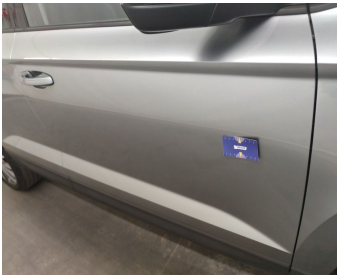
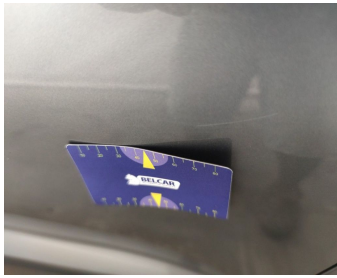
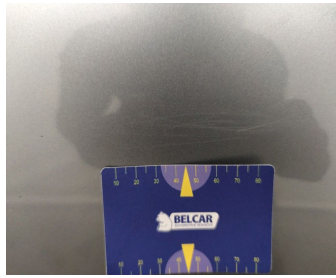
| Damages | Type | Acceptable |
|---|---|---|
| 216 | Door Front Right // Polish | Y |

Door Front Right // Polish-scratch

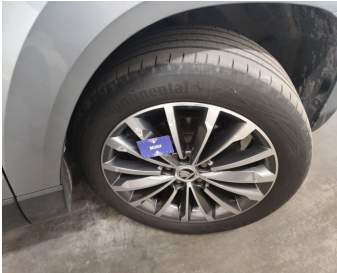
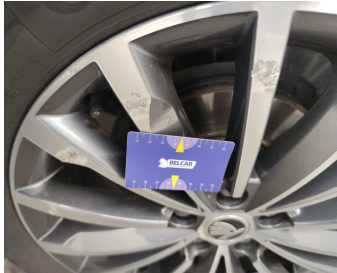
| Damages | Type | Acceptable |
|---|---|---|
| 340 | Wheel Two Tone Front Right // Repair | N |

Wheel Two Tone Front Right // Repair-scratch

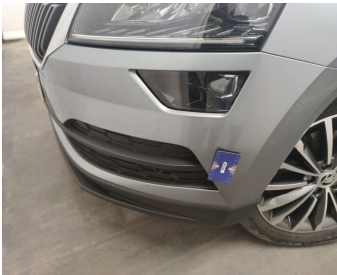
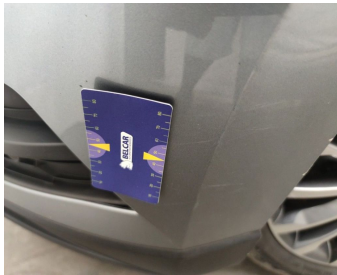
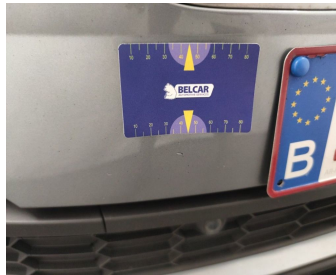
| Damages | Type | Acceptable |
|---|---|---|
| 13 | Bumper Front // Painting | N |

Bumper Front // Painting-scratch

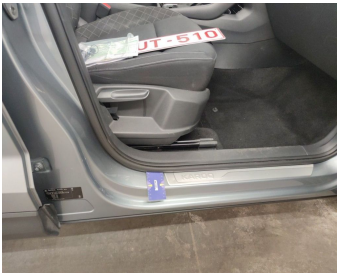
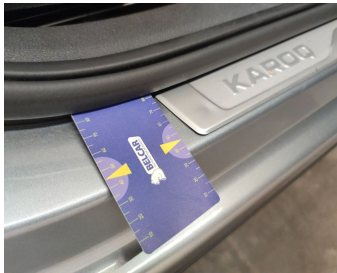
| Damages | Type | Acceptable |
|---|---|---|
| 208 | Rocker Panel Right / Cover Not Painted / Replace | Y |

Rocker Panel Right / Cover Not Painted / Replace-dent

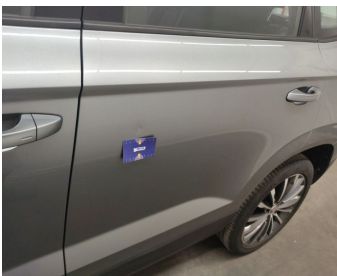
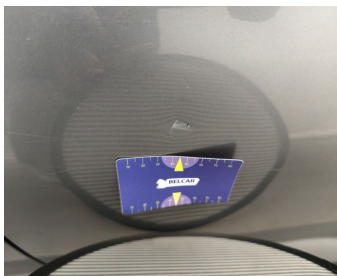
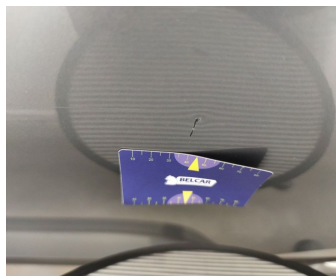
| Damages | Type | Acceptable |
|---|---|---|
| 104 | Door Rear Left // Repair & Painting | N |

Door Rear Left // Repair & Painting-scratch + dent

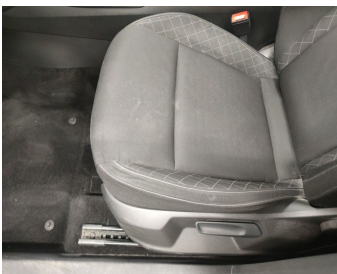
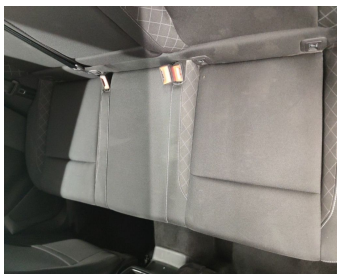
| Damages | Type | Acceptable |
|---|---|---|
| 860 | Interior Cleaning // Small | N |

Interior Cleaning // Small-stain

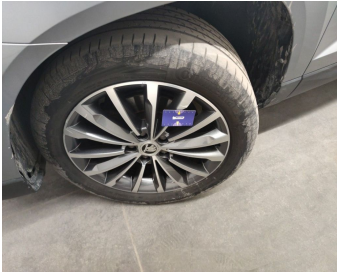
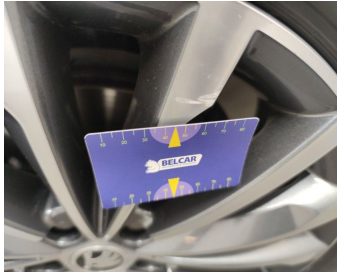
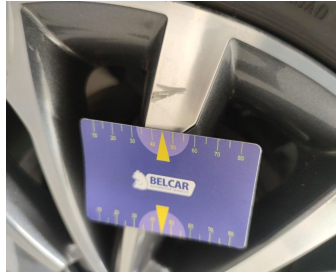
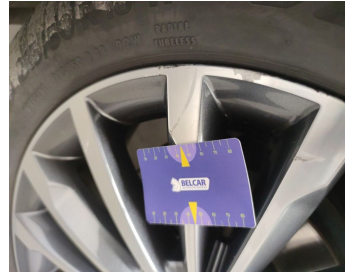
| Damages | Type | Acceptable |
|---|---|---|
| 310 | Wheel Two Tone Front Left // Repair | N |

Wheel Two Tone Front Left // Repair-scratch

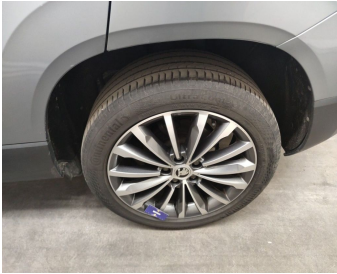
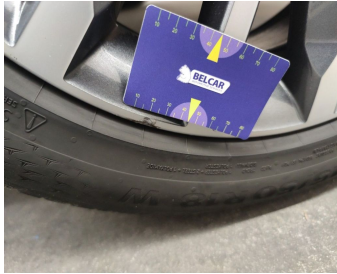
| Damages | Type | Acceptable |
|---|---|---|
| 320 | Wheel Two Tone Rear Left // Repair | Y |

Wheel Two Tone Rear Left // Repair-scratch

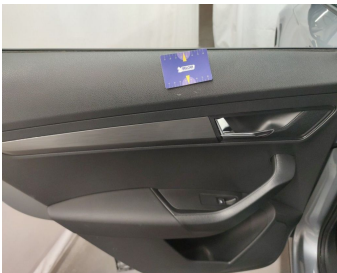
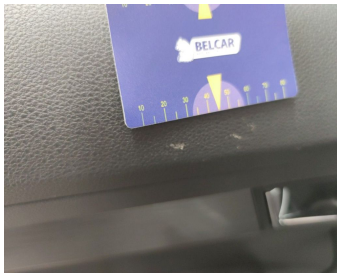
| Damages | Type | Acceptable |
|---|---|---|
| 634 | Rear Left Door Interior Coating // Replace Completely | Y |

Rear Left Door Interior Coating // Replace Completely-scratch

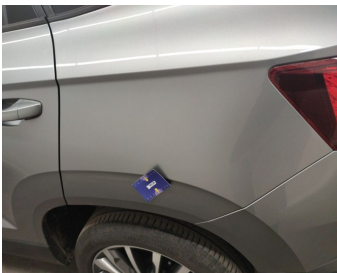
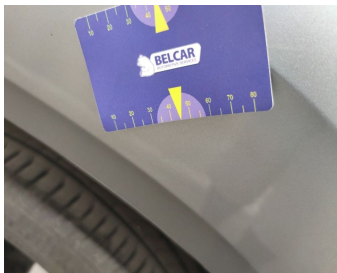
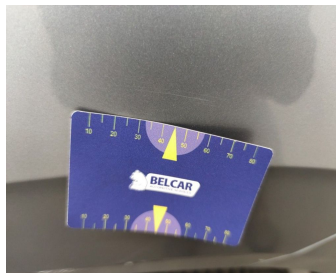
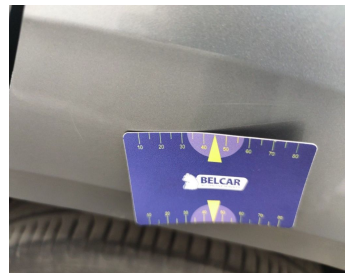
| Damages | Type | Acceptable |
|---|---|---|
| 116 | Wing Rear Left // Polish | Y |

Wing Rear Left // Polish-scratch

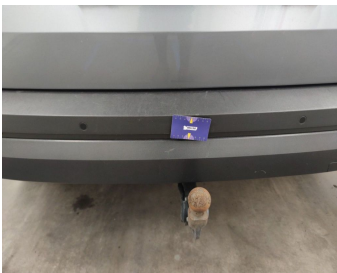
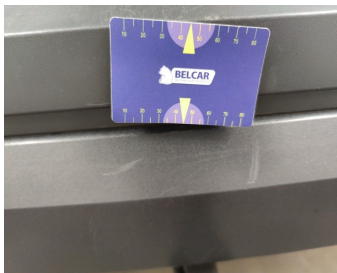
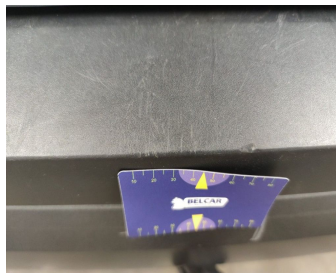
| Damages | Type | Acceptable |
|---|---|---|
| 139 | Bumper Rear / Spoiler / Replace | N |

Bumper Rear / Spoiler / Replace-scratch

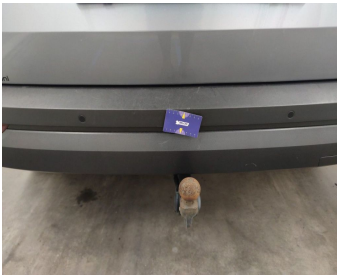
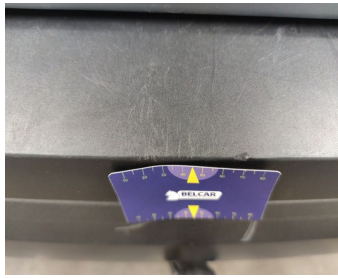
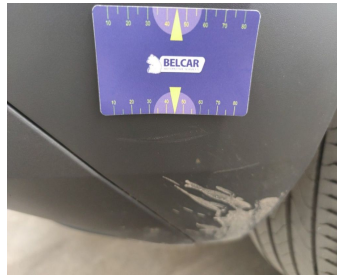
| Damages | Type | Acceptable |
|---|---|---|
| 138 | Bumper Rear / Lower Cover Not Painted / Replace | N |

Bumper Rear / Lower Cover Not Painted / Replace-scratch
