# INSPECTION REPORT

End of contract

| File | 317425 |
| Make | Peugeot 5008 1.5BHDi 96kW GT L |

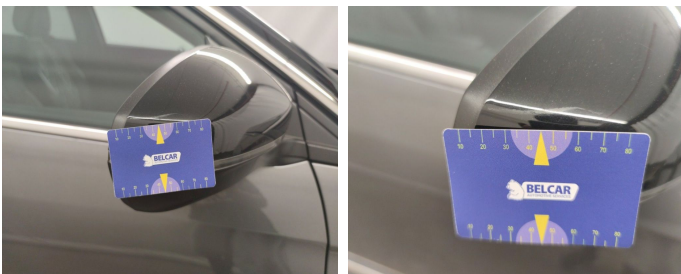
| Damages | Type | Acceptable |
|---|---|---|
| 225 | Side View Mirror Right // Polish | Y |

Side View Mirror Right // Polish-scratch

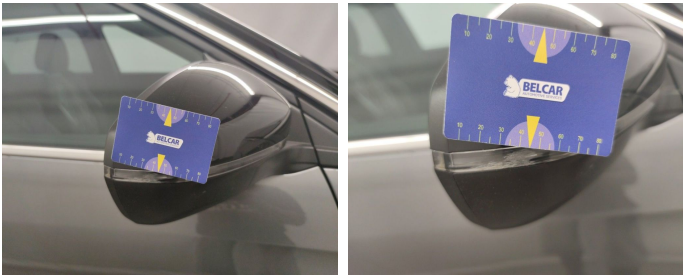
| Damages | Type | Acceptable |
|---|---|---|
| 228 | Side View Mirror Right / Direction Indicator / Replace | N |

Side View Mirror Right / Direction Indicator / Replace-scratch

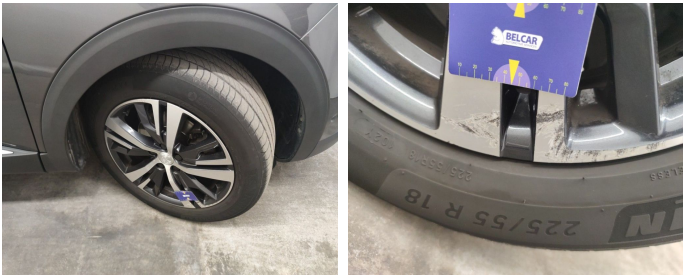
| Damages | Type | Acceptable |
|---|---|---|
| 340 | Wheel Two Tone Front Right // Repair | N |

Wheel Two Tone Front Right // Repair-scratch

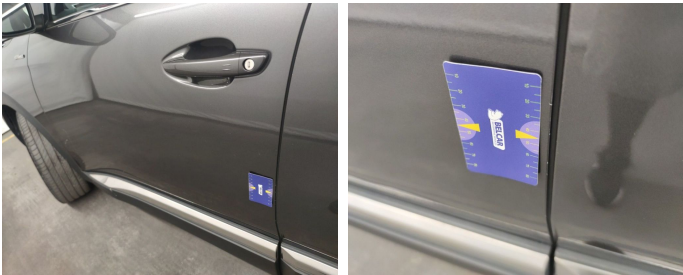
| Damages | Type | Acceptable |
|---|---|---|
| 81 | Door Front Left // Smart Repair Medium | Y |

Door Front Left // Smart Repair Medium-scratch

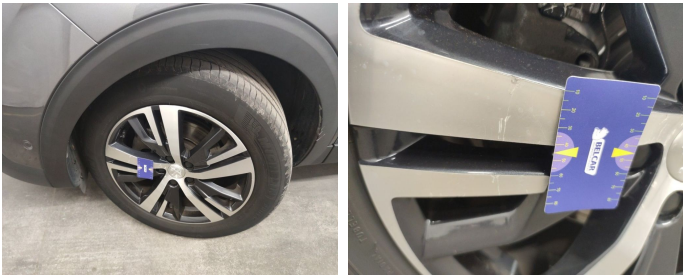
| Damages | Type | Acceptable |
|---|---|---|
| 310 | Wheel Two Tone Front Left // Repair | Y |

Wheel Two Tone Front Left // Repair-scratch

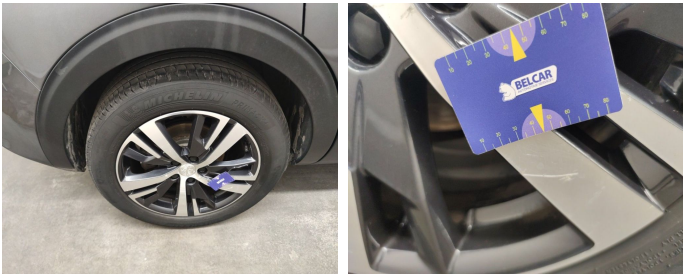
| Damages | Type | Acceptable |
|---|---|---|
| 330 | Wheel Two Tone Rear Right // Repair | Y |

Wheel Two Tone Rear Right // Repair-scratch

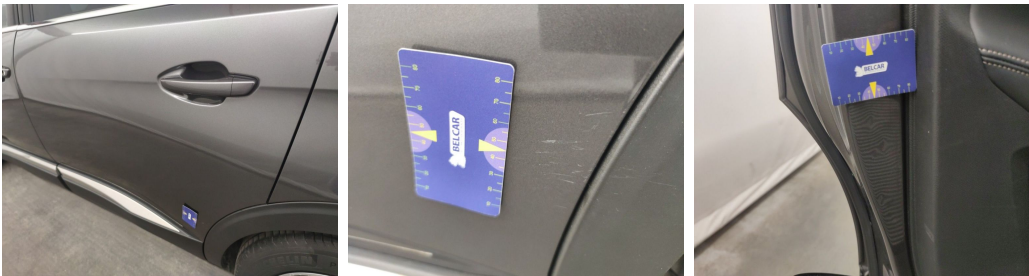
| Damages | Type | Acceptable |
|---|---|---|
| 101 | Door Rear Left // Smart Repair Medium | N |

Door Rear Left // Smart Repair Medium-dent

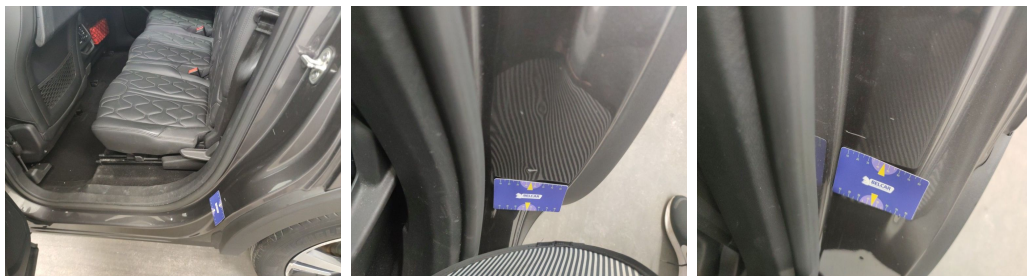
| Damages | Type | Acceptable |
|---|---|---|
| 91 | Rocker Panel Left // Smart Repair Medium | N |

Rocker Panel Left // Smart Repair Medium-scratch + dent

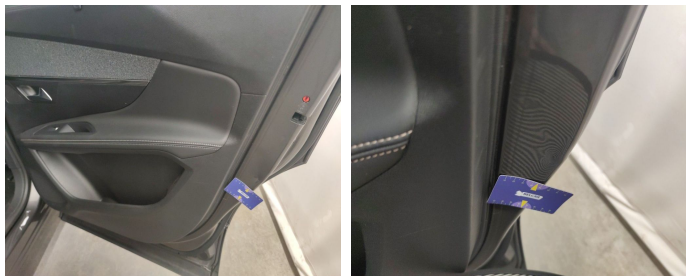
| Damages | Type | Acceptable |
|---|---|---|
| 191 | Door Rear Right // Smart Repair Medium | N |

Door Rear Right // Smart Repair Medium-scratch + dent

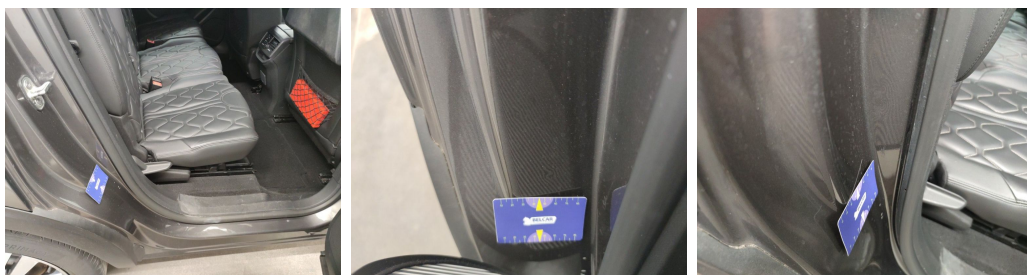
| Damages | Type | Acceptable |
|---|---|---|
| 201 | Rocker Panel Right // Smart Repair Medium | N |

Rocker Panel Right // Smart Repair Medium-scratch + dent

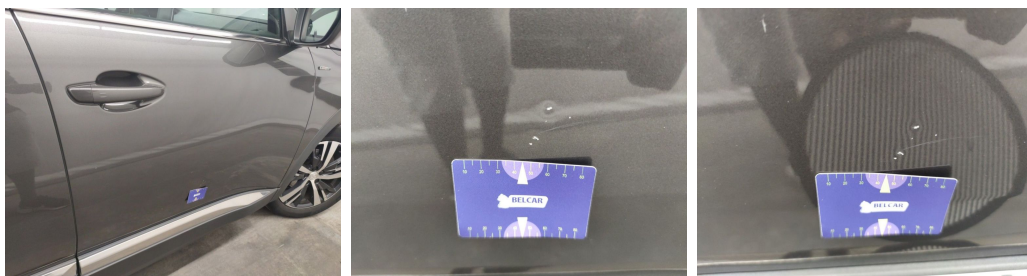
| Damages | Type | Acceptable |
|---|---|---|
| 214 | Door Front Right // Repair & Painting | N |

Door Front Right // Repair & Painting-scratch + dent

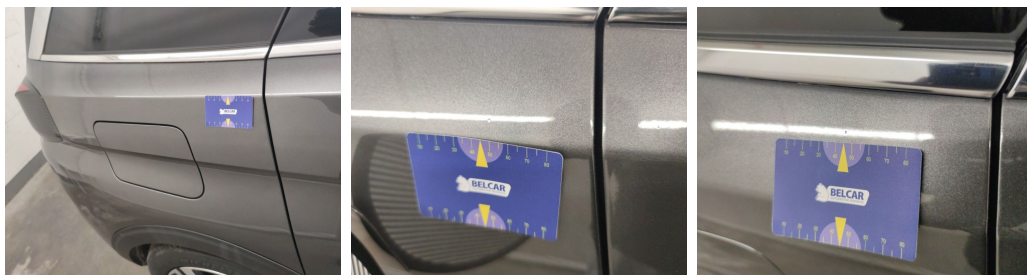
| Damages | Type | Acceptable |
|---|---|---|
| 183 | Wing Rear Right // Painting | N |

Wing Rear Right // Painting-bad repair

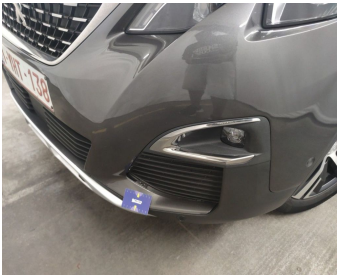
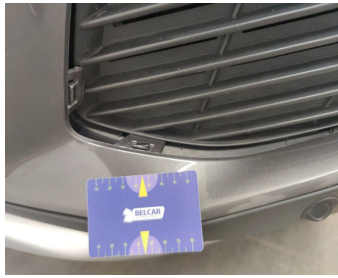
| Damages | Type | Acceptable |
|---|---|---|
| 273 | Bumper Front / Grid Left / Replace | Y |

Bumper Front / Grid Left / Replace-bad position

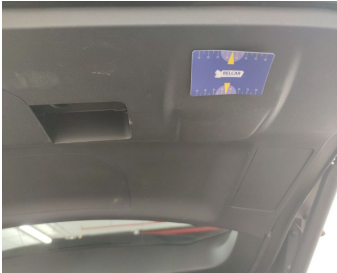
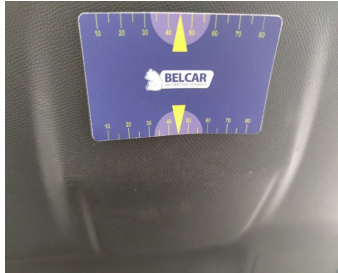
| Damages | Type | Acceptable |
|---|---|---|
| 594 | Trunk Lid Interior Coating / Complete Panel / Replace | Y |

Trunk Lid Interior Coating / Complete Panel / Replace-scratch

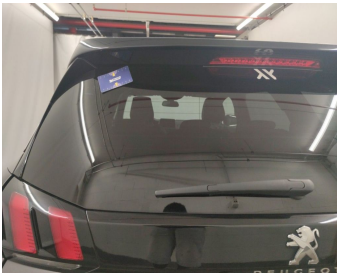
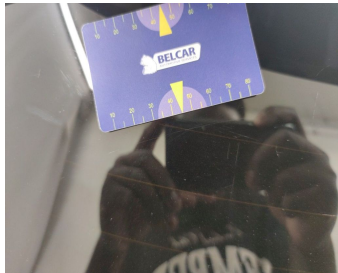
| Damages | Type | Acceptable |
|---|---|---|
| 159 | Rear Bonnet / Rear Window / Replace | Y |

Rear Bonnet / Rear Window / Replace-scratch

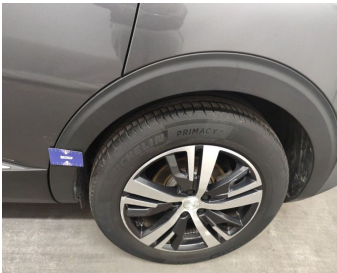
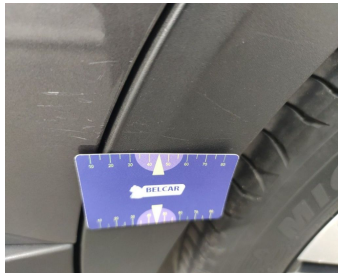
| Damages | Type | Acceptable |
|---|---|---|
| 117 | Wing Rear Left / Trim / Replace | Y |

Wing Rear Left / Trim / Replace-scratch

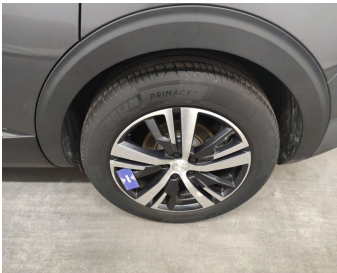
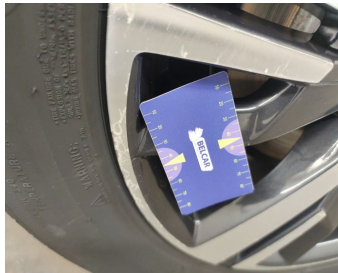
| Damages | Type | Acceptable |
|---|---|---|
| 320 | Wheel Two Tone Rear Left // Repair | N |

Wheel Two Tone Rear Left // Repair-scratch

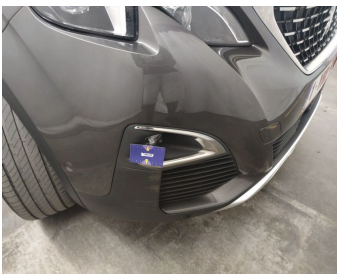
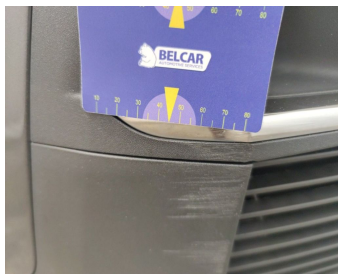
| Damages | Type | Acceptable |
|---|---|---|
| 275 | Bumper Front / Grid Right / Replace | N |

Bumper Front / Grid Right / Replace-scratch

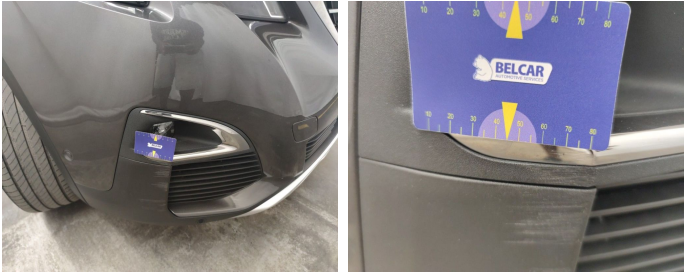
| Damages | Type | Acceptable |
|---|---|---|
| 272 | Bumper Front / Trim Right / Replace | N |

Bumper Front / Trim Right / Replace-scratch

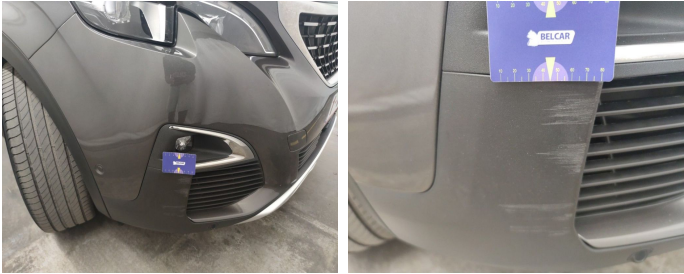
| Damages | Type | Acceptable |
|---|---|---|
| 19 | Bumper Front / Lower Cover Not Painted / Replace | N |

Bumper Front / Lower Cover Not Painted / Replace-scratch
