# INSPECTION REPORT

**End of contract**

| License plate | 2FHX912 |
| Make | Peugeot 3008 1.5BHDi 96kW Acti |

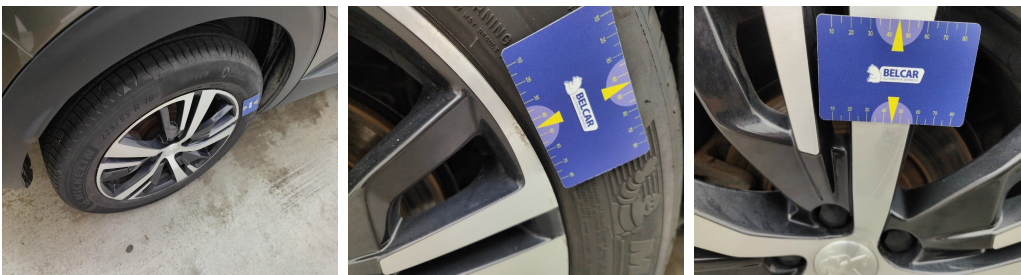
| Damages | Type | Acceptable |
|---|---|---|
| 330 | Wheel Two Tone Rear Right // Repair | N |

Wheel Two Tone Rear Right // Repair-scratch

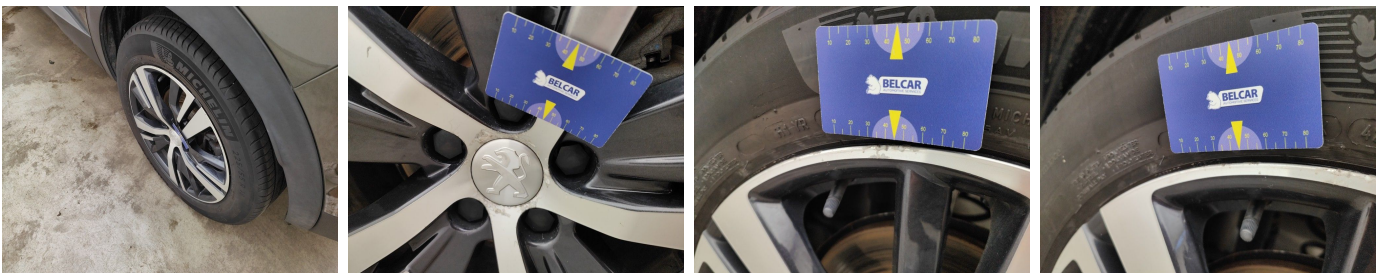
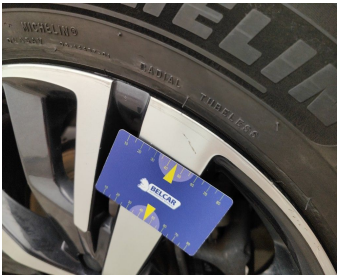
| Damages | Type | Acceptable |
|---|---|---|
| 320 | Wheel Two Tone Rear Left // Repair | N |

Wheel Two Tone Rear Left // Repair-scratch

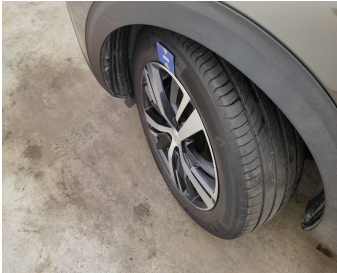
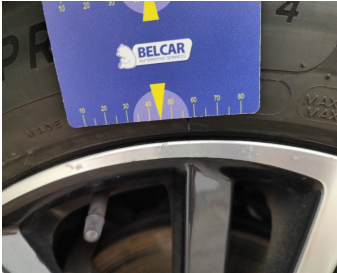
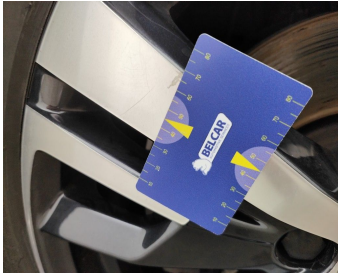
| Damages | Type | Acceptable |
|---|---|---|
| 310 | Wheel Two Tone Front Left // Repair | Y |

Wheel Two Tone Front Left // Repair-scratch

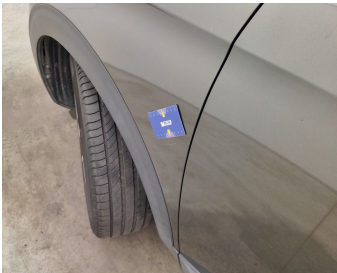
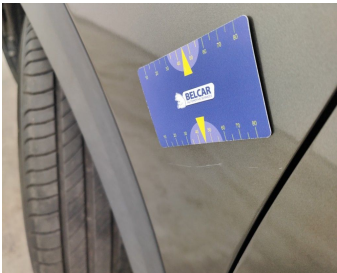
| Damages | Type | Acceptable |
|---|---|---|
| 63 | Wing Front Left // Painting | Y |

Wing Front Left // Painting-scratch

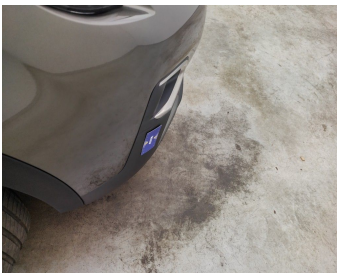
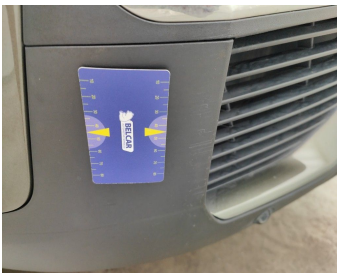
| Damages | Type | Acceptable |
|---|---|---|
| 272 | Bumper Front / Trim Right / Replace | N |

Bumper Front / Trim Right / Replace-scratch

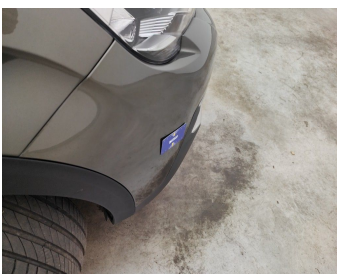
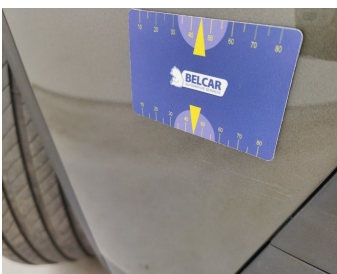
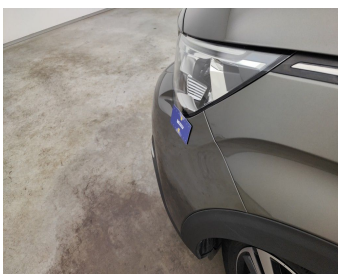
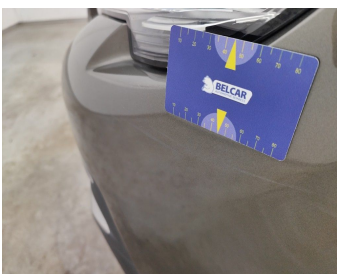
| Damages | Type | Acceptable |
|---|---|---|
| 13 | Bumper Front // Painting | Y |

Bumper Front // Painting-scratch

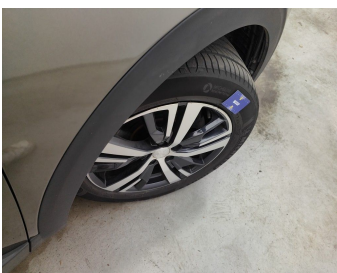
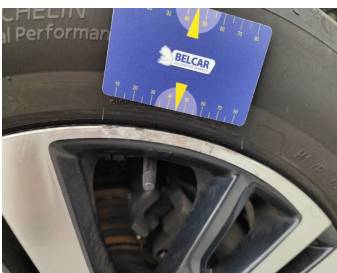
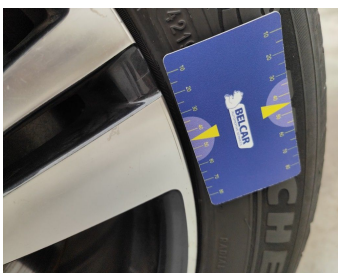
| Damages | Type | Acceptable |
|---|---|---|
| 340 | Wheel Two Tone Front Right // Repair | N |

Wheel Two Tone Front Right // Repair-scratch

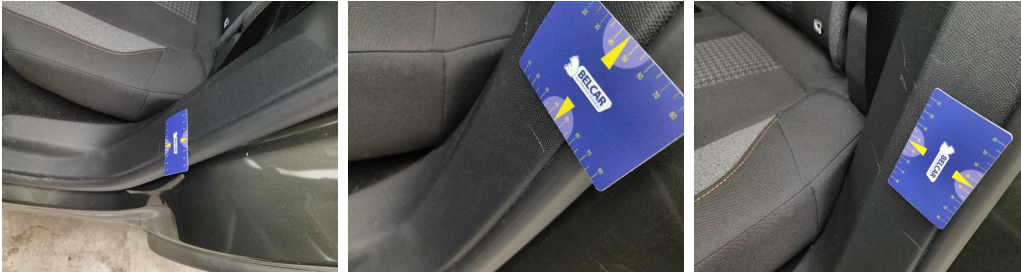
| Damages | Type | Acceptable |
|---|---|---|
| 431 | Seat Rear Left // Repair | Y |

Seat Rear Left // Repair-scratch

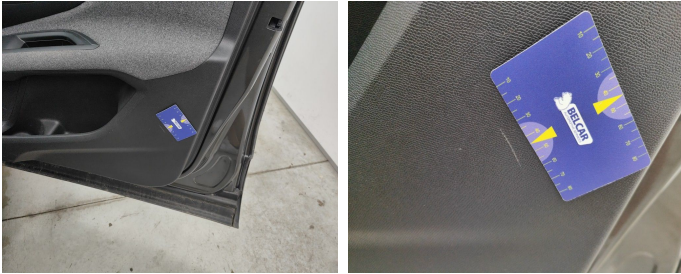
| Damages | Type | Acceptable |
|---|---|---|
| 624 | Front Right Door Interior Coating // Replace Completely | Y |

Front Right Door Interior Coating // Replace Completely-scratch

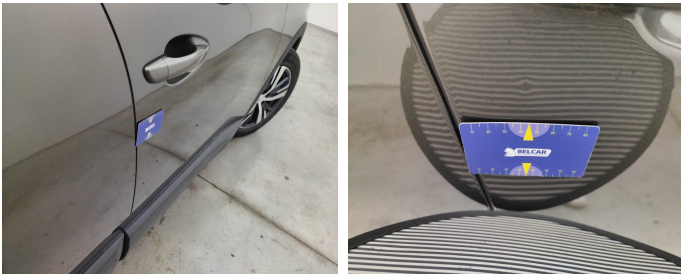
| Damages | Type | Acceptable |
|---|---|---|
| 210 | Door Front Right // Smart Repair Small | Y |

Door Front Right // Smart Repair Small-dent

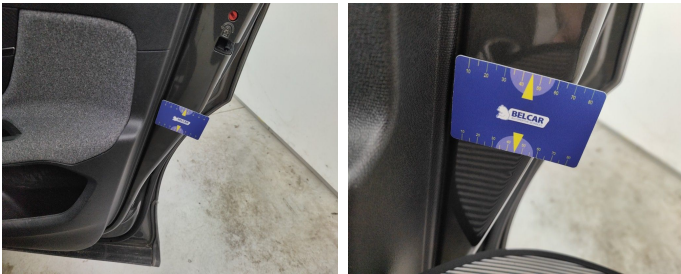
| Damages | Type | Acceptable |
|---|---|---|
| 194 | Door Rear Right // Repair & Painting | Y |

Door Rear Right // Repair & Painting-dent

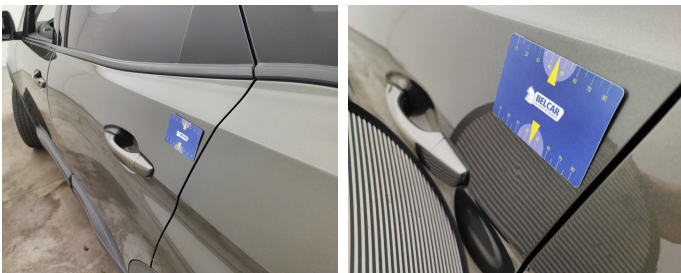
| Damages | Type | Acceptable |
|---|---|---|
| 100 | Door Rear Left // Smart Repair Small | Y |

Door Rear Left // Smart Repair Small-dent

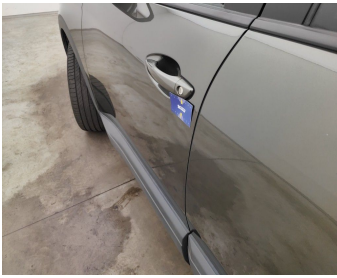
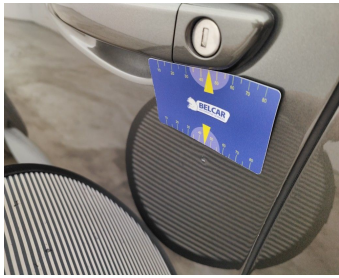
| Damages | Type | Acceptable |
|---|---|---|
| 84 | Door Front Left // Repair & Painting | Y |

Door Front Left // Repair & Painting-scratch + dent

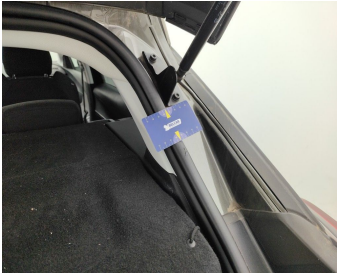
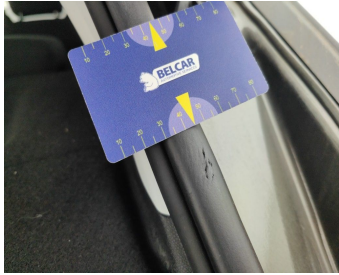
| Damages | Type | Acceptable |
|---|---|---|
| 540 | Interior // Repair 1 | N |

Interior // Repair 1-tear

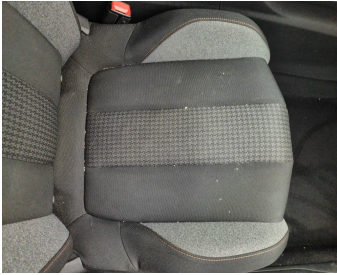
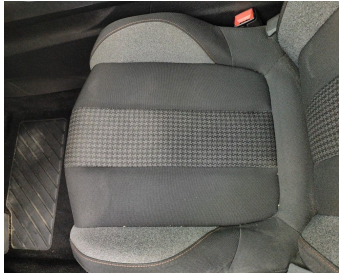
| Damages | Type | Acceptable |
|---|---|---|
| 860 | Interior Cleaning // Small | N |

Interior Cleaning // Small-stain
