# INSPECTION REPORT

**End of contract**

| License plate | 1YXR802 |
| Make | Opel Comb.1.5D 75kW 2.3T L2H1 |

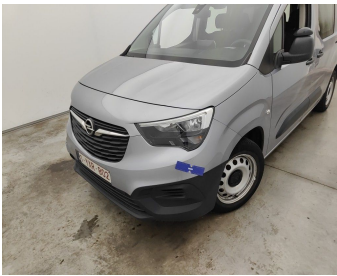
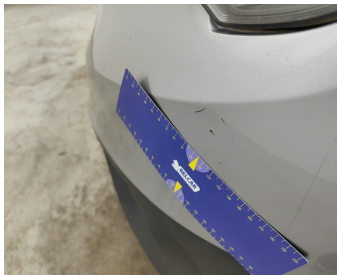
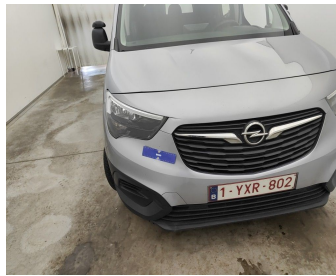
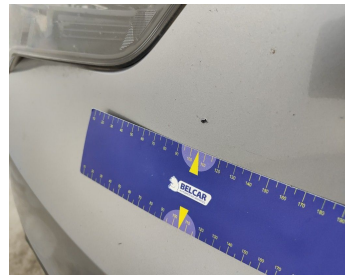
| Damages | Type | Acceptable |
|---|---|---|
| 13 | Bumper Front // Painting | Y |

Bumper Front // Painting-scratch

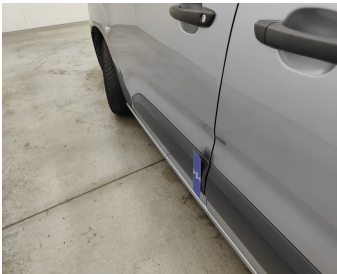
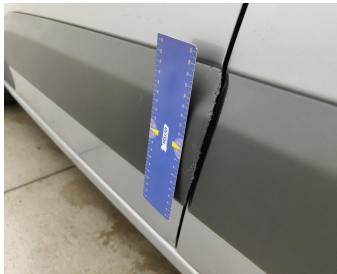
| Damages | Type | Acceptable |
|---|---|---|
| 87 | Door Front Left / Trim / Replace | Y |

Door Front Left / Trim / Replace-scratch

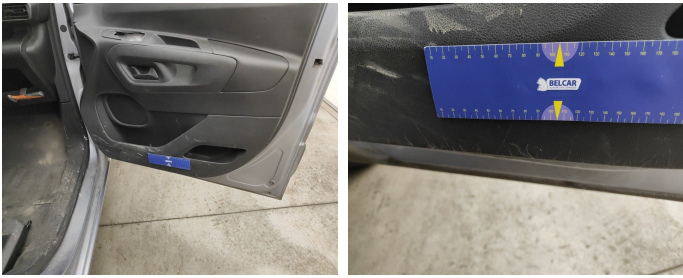
| Damages | Type | Acceptable |
|---|---|---|
| 624 | Front Right Door Interior Coating // Replace Completely | Y |

Front Right Door Interior Coating // Replace Completely-scratch

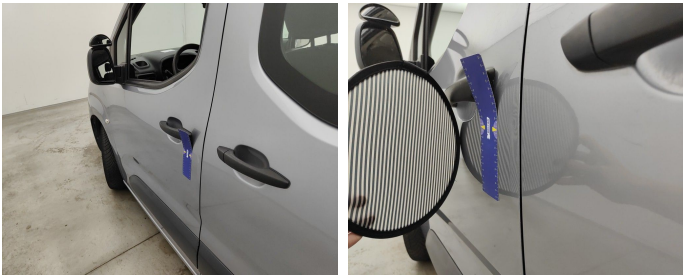
| Damages | Type | Acceptable |
|---|---|---|
| 84 | Door Front Left // Repair & Painting | N |

Door Front Left // Repair & Painting-dent

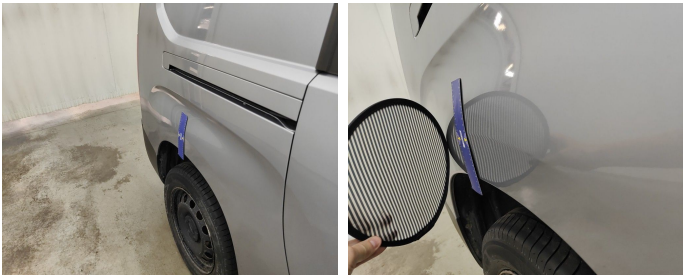
| Damages | Type | Acceptable |
|---|---|---|
| 184 | Wing Rear Right // Repair & Painting | Y |

Wing Rear Right // Repair & Painting-dent

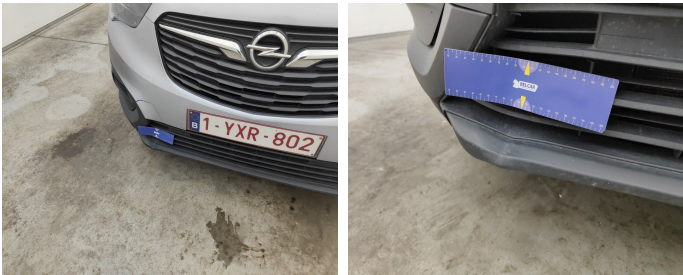
| Damages | Type | Acceptable |
|---|---|---|
| 19 | Bumper Front / Lower Cover Not Painted / Replace | N |

Bumper Front / Lower Cover Not Painted / Replace-dent

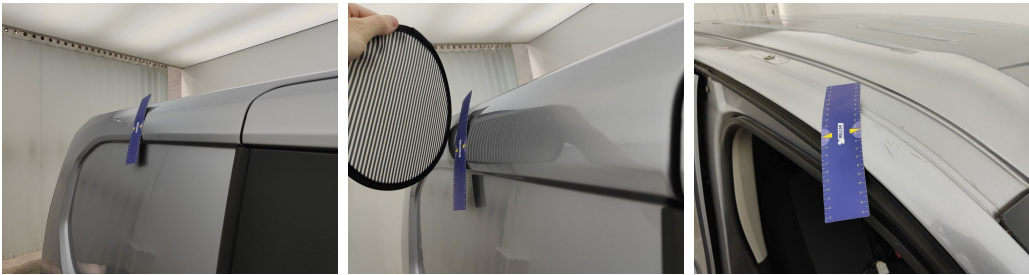
| Damages | Type | Acceptable |
|---|---|---|
| 163 | Roof // Repair & Painting | Y |

Roof // Repair & Painting-dent

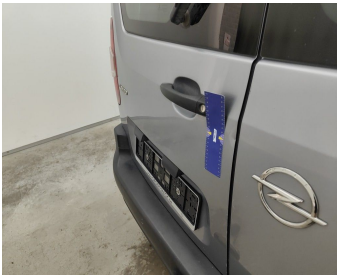
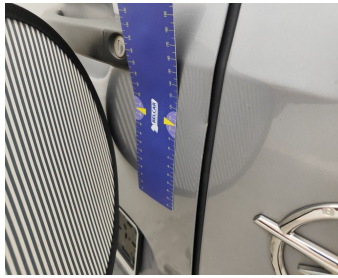
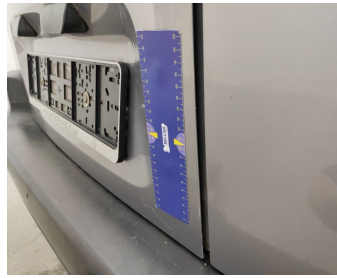
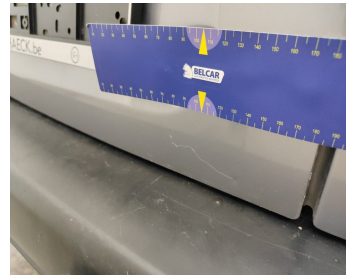
| Damages | Type | Acceptable |
|---|---|---|
| 294 | Rear Loading Door Left // Repair & Painting | N |

Rear Loading Door Left // Repair & Painting-scratch + dent

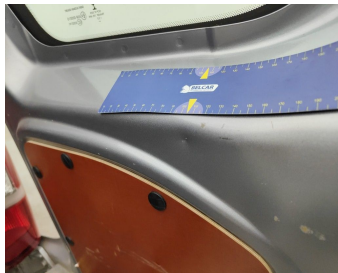
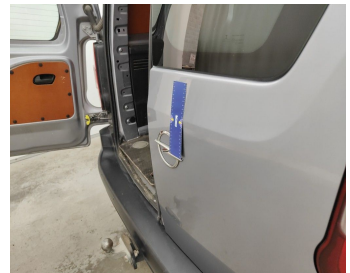
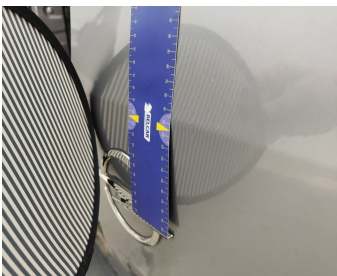
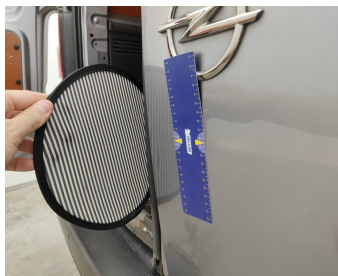
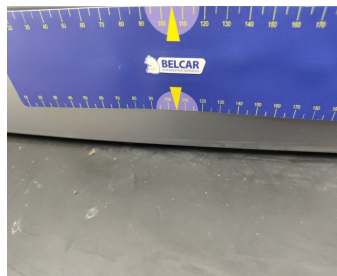
| Damages | Type | Acceptable |
|---|---|---|
| 304 | Rear Loading Door Right // Repair & Painting | N |

Rear Loading Door Right // Repair & Painting-scratch + dent

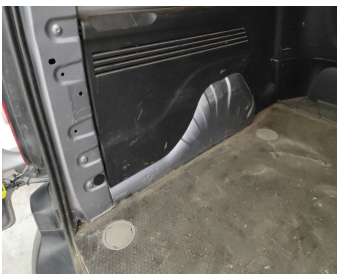
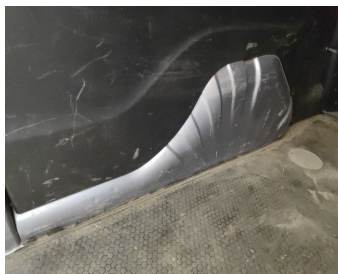
| Damages | Type | Acceptable |
|---|---|---|
| 532 | Trunk Compartment / Side Cover Left / Replace | Y |

Trunk Compartment / Side Cover Left / Replace-scratch + dent

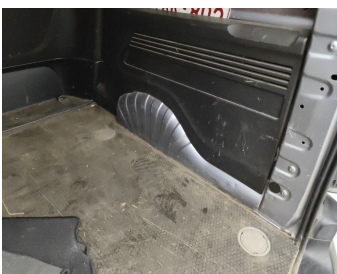
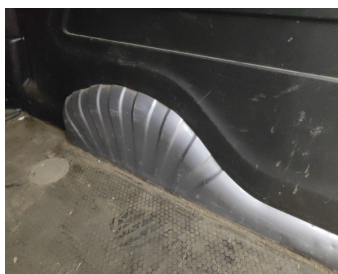
| Damages | Type | Acceptable |
|---|---|---|
| 533 | Trunk Compartment / Side Cover Right / Replace | Y |

Trunk Compartment / Side Cover Right / Replace-scratch  
+ dent

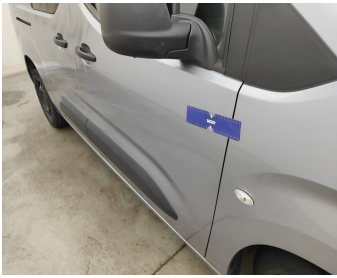
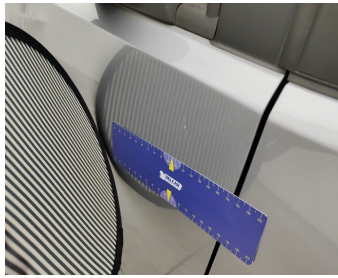
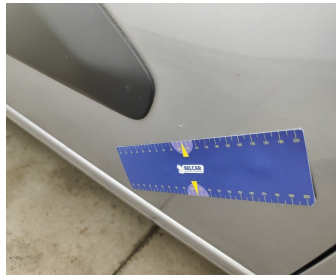
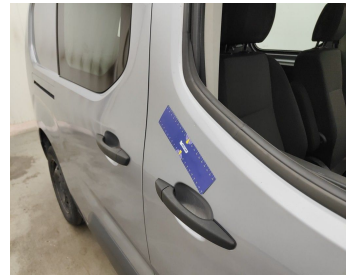
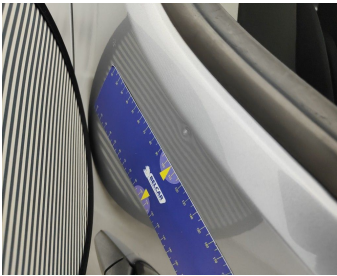
| Damages | Type | Acceptable |
|---|---|---|
| 214 | Door Front Right // Repair & Painting | N |

Door Front Right // Repair & Painting-scratch + dent

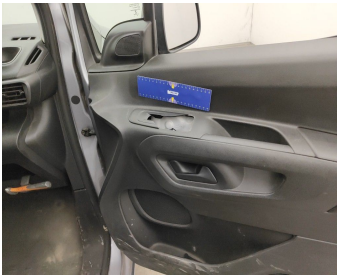
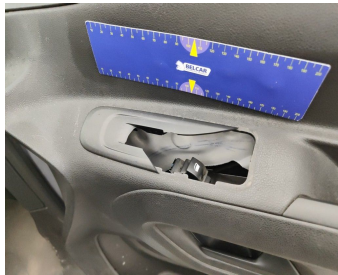
| Damages | Type | Acceptable |
|---|---|---|
| 629 | Front Right Door Interior Coating / Control Module / Replace | N |

Front Right Door Interior Coating / Control Module /  
Replace-cracked

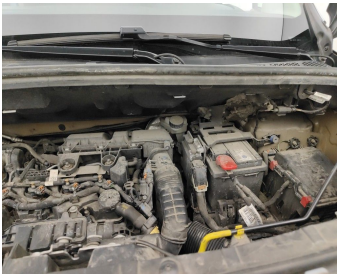
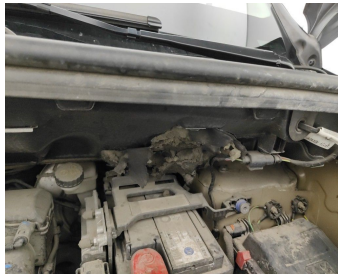
| Damages | Type | Acceptable |
|---|---|---|
| 38 | Front Bonnet / Insulation / Replace | N |

Front Bonnet / Insulation / Replace-tear

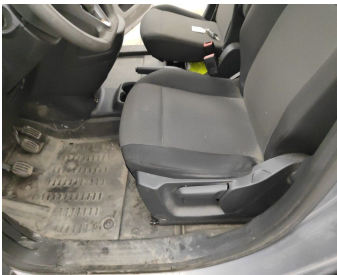
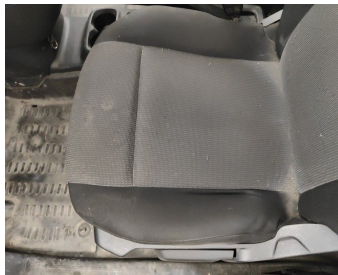
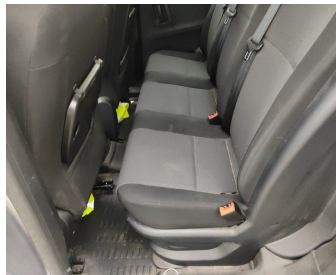
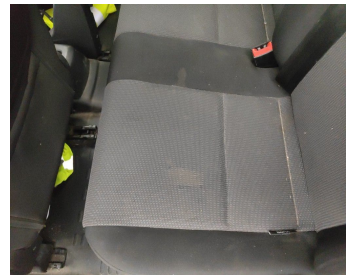
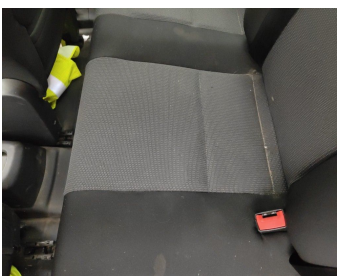
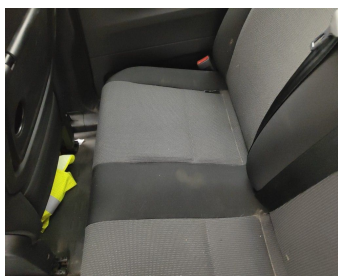
| Damages | Type | Acceptable |
|---|---|---|
| 860 | Interior Cleaning // Small | N |

Interior Cleaning // Small-stain

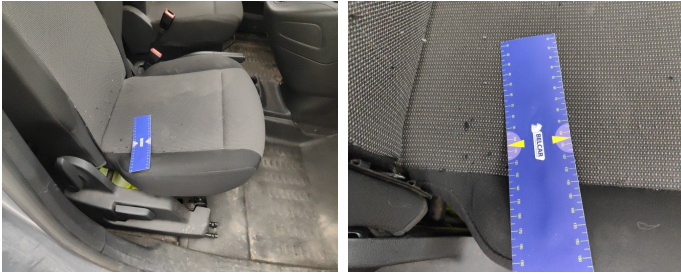
| Damages | Type | Acceptable |
|---|---|---|
| 422 | Seat Front Right / Bottom Coating / Replace | Y |

Seat Front Right / Bottom Coating / Replace-worn

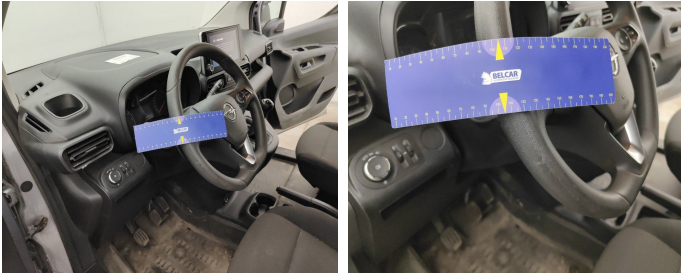
| Damages | Type | Acceptable |
|---|---|---|
| 569 | Dashboard / Steering Wheel / Replace | Y |

Dashboard / Steering Wheel / Replace-worn

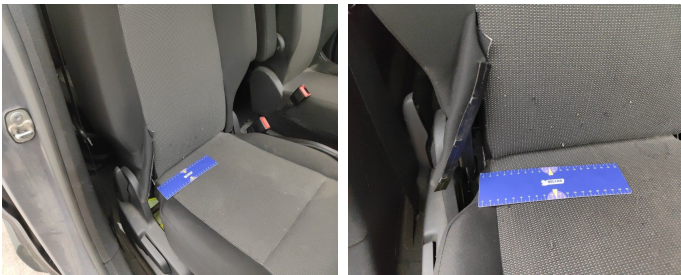
| Damages | Type | Acceptable |
|---|---|---|
| 423 | Seat Front Right / Rear Coating / Replace | N |

Seat Front Right / Rear Coating / Replace-bad position

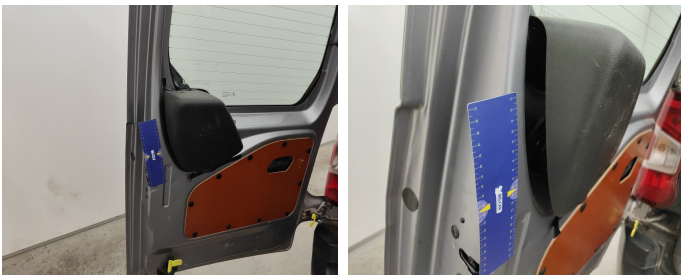
| Damages | Type | Acceptable |
|---|---|---|
| 592 | Trunk Lid Interior Coating / MDF Rear Left / Replace | N |

Trunk Lid Interior Coating / MDF Rear Left / Replace-bad position

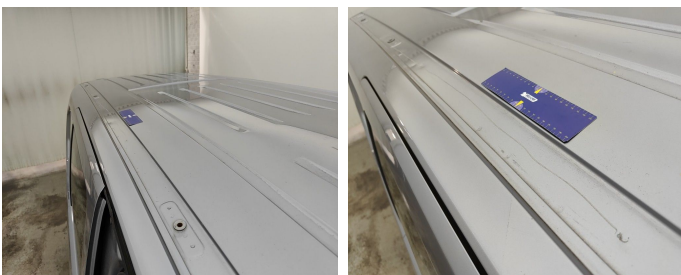
| Damages | Type | Acceptable |
|---|---|---|
| 162 | Roof // Painting | N |

Roof // Painting-scratch

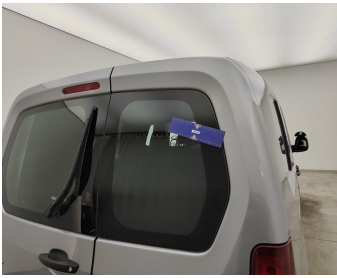
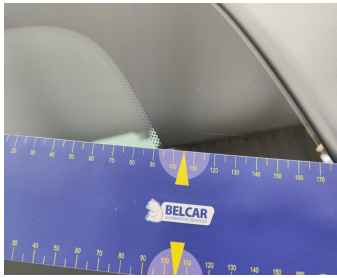
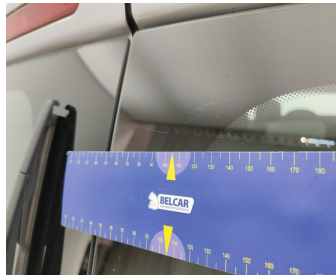
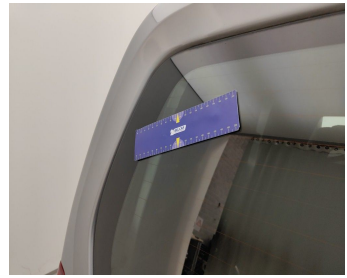
| Damages | Type | Acceptable |
|---|---|---|
| 159 | Rear Bonnet / Rear Window / Replace | Y |

Rear Bonnet / Rear Window / Replace-scratch

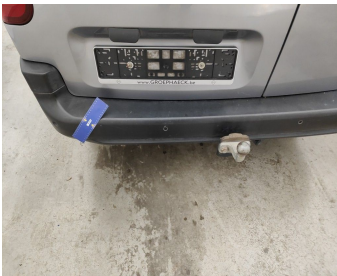
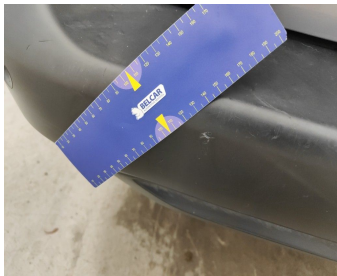
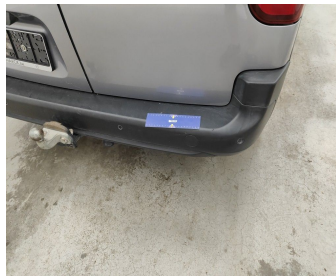
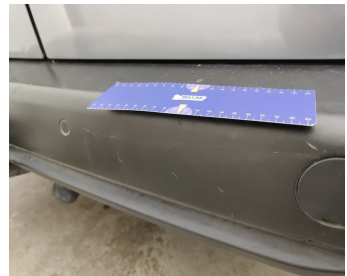
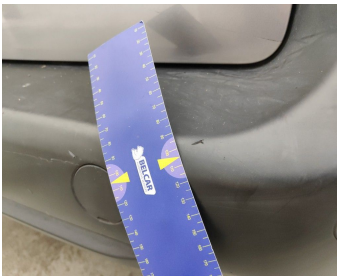
| Damages | Type | Acceptable |
|---|---|---|
| 138 | Bumper Rear / Lower Cover Not Painted / Replace | Y |

Bumper Rear / Lower Cover Not Painted / Replace-scratch

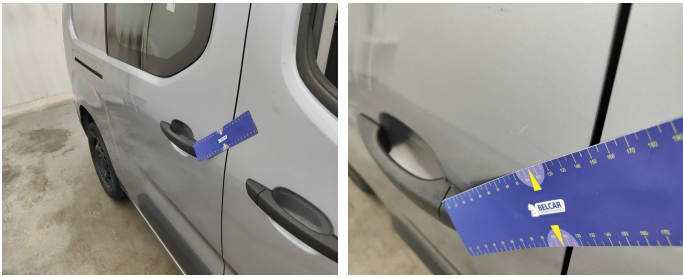
| Damages | Type | Acceptable |
|---|---|---|
| 193 | Door Rear Right // Painting | Y |

Door Rear Right // Painting-scratch

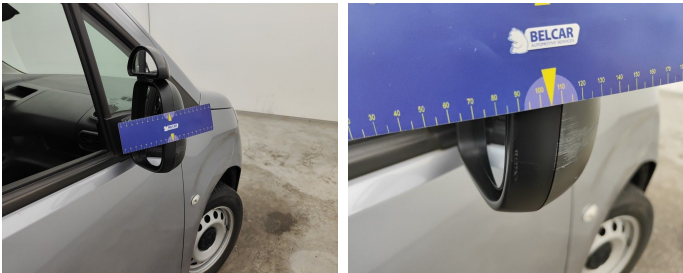
| Damages | Type | Acceptable |
|---|---|---|
| 223 | Side View Mirror Right // Replace Not Painted | Y |

Side View Mirror Right // Replace Not Painted-scratch

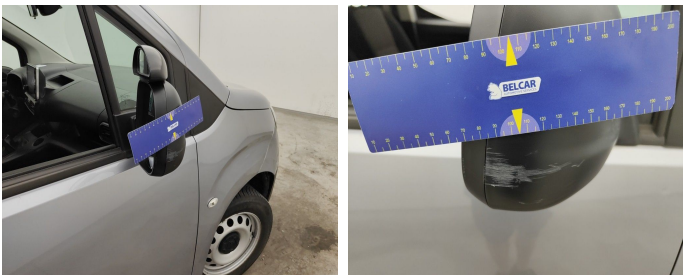
| Damages | Type | Acceptable |
|---|---|---|
| 227 | Side View Mirror Right / Shell / Replace Not Painted | Y |

Side View Mirror Right / Shell / Replace Not Painted-scratch
