# INSPECTION REPORT

**End of contract**

| License plate | VG9875 |
| Make | Nissan *E-NV200 Fg Optima SSD |

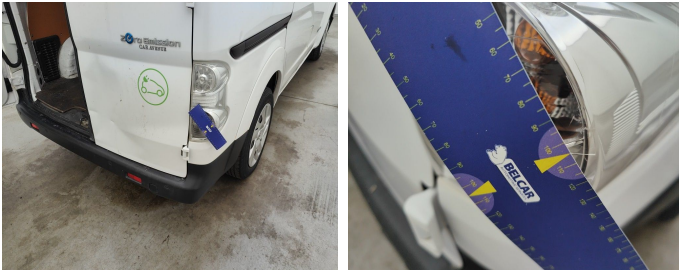
Light / Rear Right / Replace-scratch

| Damages | Type | Acceptable |
|---|---|---|
| 174 | Light / Rear Right / Replace | N |

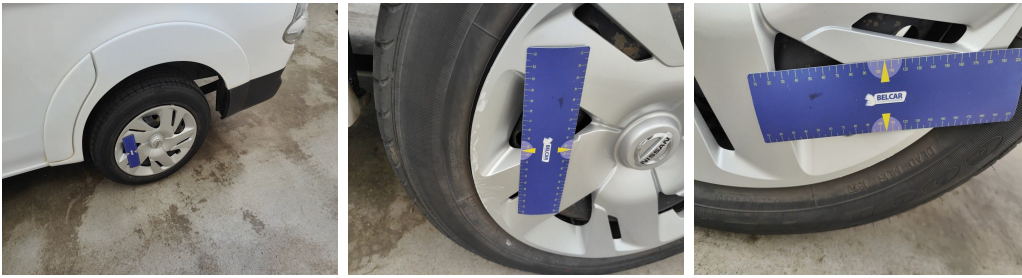
Wheel Rear Left / Wheel Cover / Replace-scratch

| Damages | Type | Acceptable |
|---|---|---|
| 324 | Wheel Rear Left / Wheel Cover / Replace | Y |

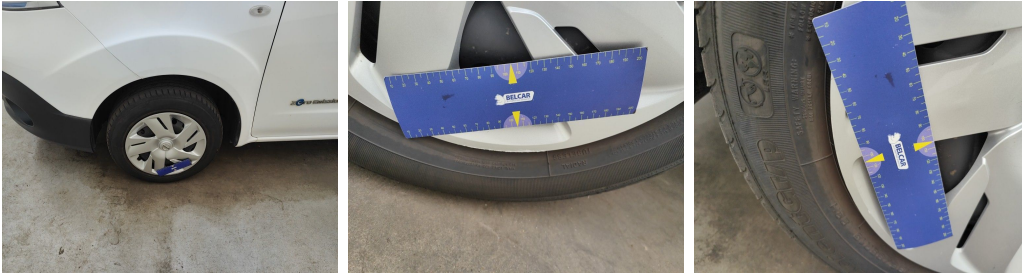
Wheel Front Left / Wheel Cover / Replace-scratch

| Damages | Type | Acceptable |
|---|---|---|
| 314 | Wheel Front Left / Wheel Cover / Replace | Y |

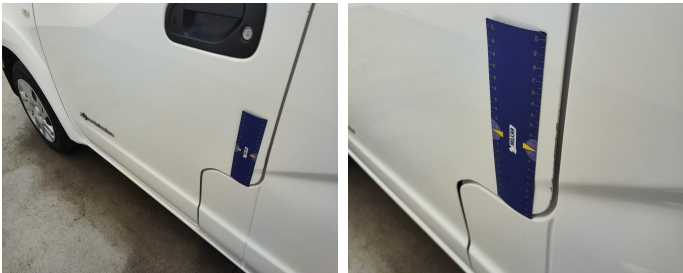
Door Front Left // Smart Repair Small-scratch

| Damages | Type | Acceptable |
|---|---|---|
| 80 | Door Front Left // Smart Repair Small | Y |

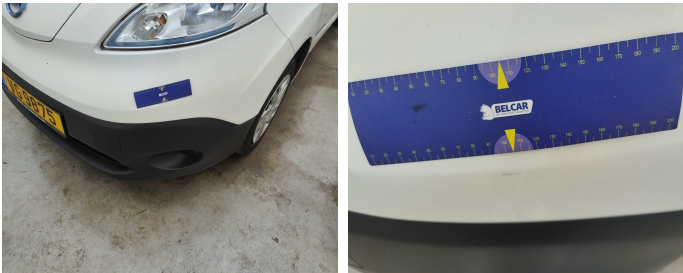
Bumper Front // Painting-scratch

| Damages | Type | Acceptable |
|---|---|---|
| 13 | Bumper Front // Painting | Y |

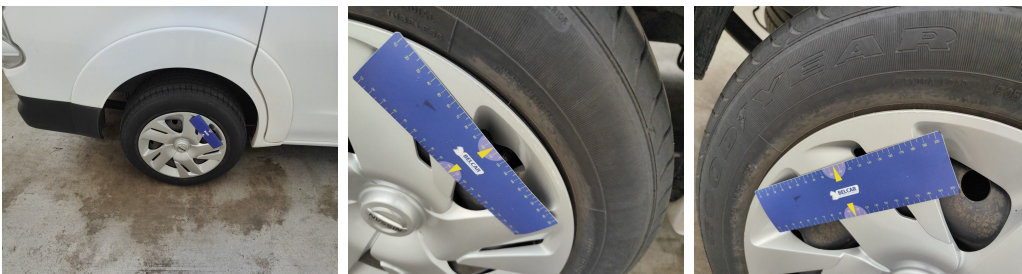
Wheel Rear Right / Wheel Cover / Replace-scratch

| Damages | Type | Acceptable |
|---|---|---|
| 334 | Wheel Rear Right / Wheel Cover / Replace | Y |

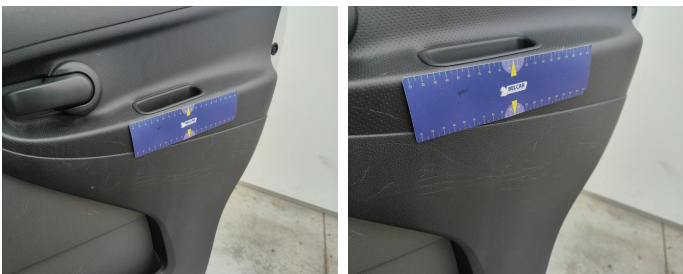
Front Right Door Interior Coating // Replace Completely-scratch

| Damages | Type | Acceptable |
|---|---|---|
| 624 | Front Right Door Interior Coating // Replace Completely | Y |

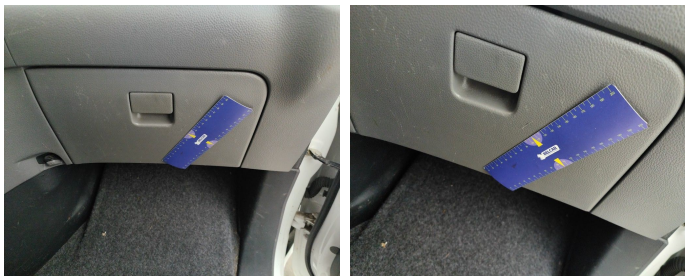
Dashboard / Storage Tray / Replace-scratch

| Damages | Type | Acceptable |
|---|---|---|
| 565 | Dashboard / Storage Tray / Replace | Y |

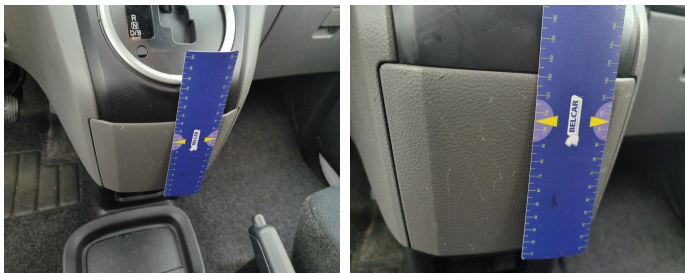
Central Console // Replace Completely-scratch

| Damages | Type | Acceptable |
|---|---|---|
| 554 | Central Console // Replace Completely | Y |

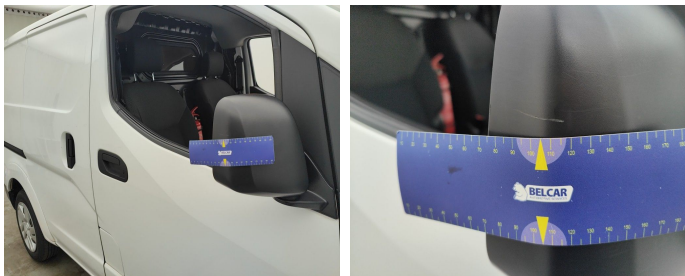
Side View Mirror Right / Shell / Replace Not Painted-scratch

| Damages | Type | Acceptable |
|---|---|---|
| 227 | Side View Mirror Right / Shell / Replace Not Painted | Y |

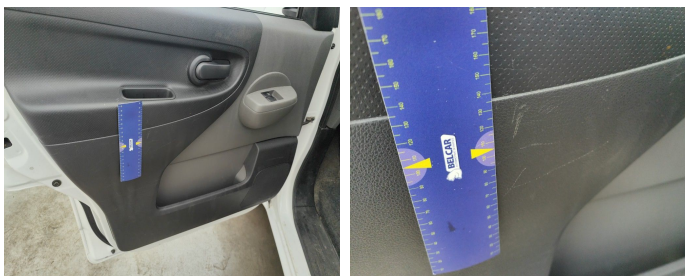
Front Left Door Interior Coating // Replace Completely-scratch

| Damages | Type | Acceptable |
|---|---|---|
| 614 | Front Left Door Interior Coating // Replace Completely | Y |

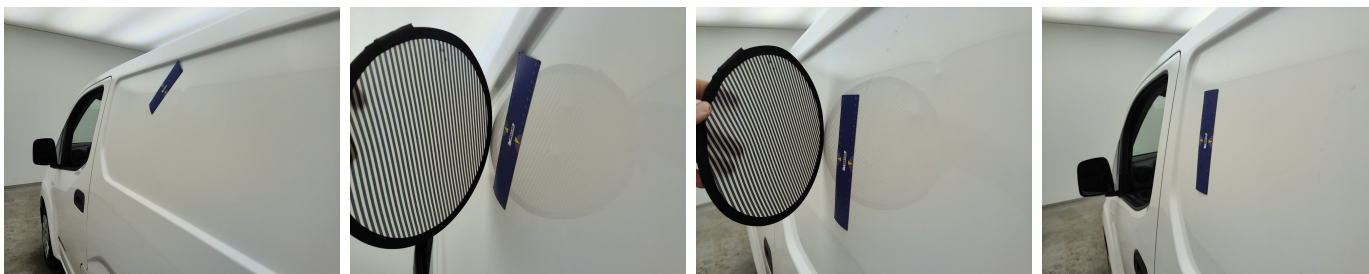
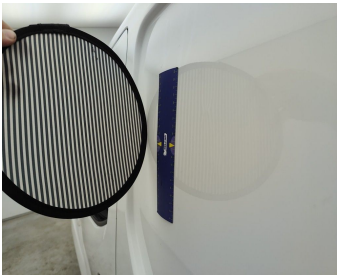
Wing Rear Left // Repair & Painting-dent

| Damages | Type | Acceptable |
|---|---|---|
| 114 | Wing Rear Left // Repair & Painting | N |

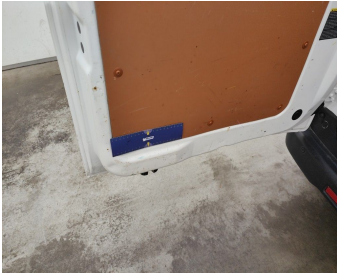
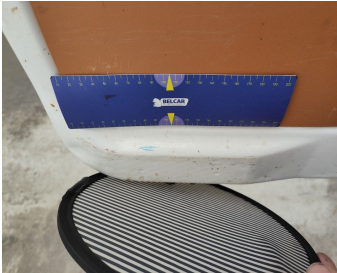
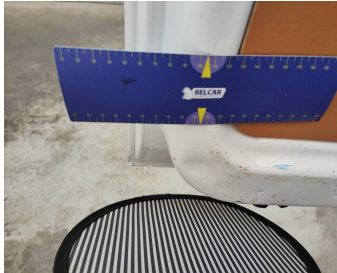
Rear Loading Door Left // Repair & Painting-scratch + dent

| Damages | Type | Acceptable |
|---|---|---|
| 294 | Rear Loading Door Left // Repair & Painting | Y |

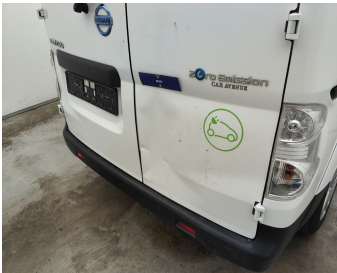
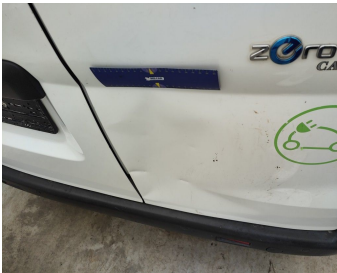
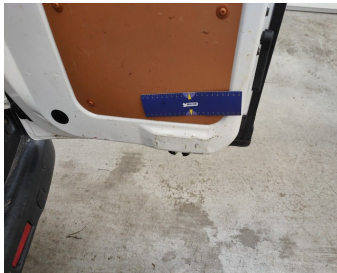
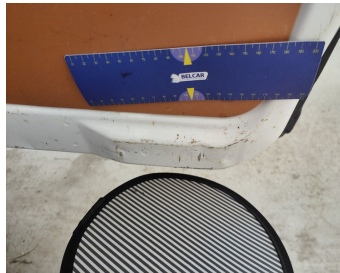
Rear Loading Door Right // Repair & Painting-scratch + dent

| Damages | Type | Acceptable |
|---|---|---|
| 304 | Rear Loading Door Right // Repair & Painting | N |

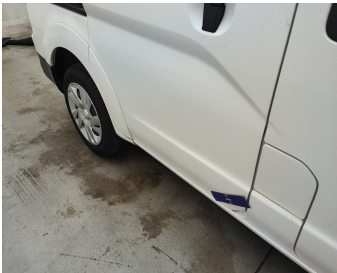
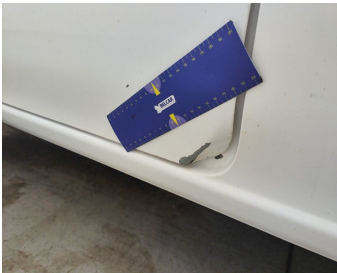
Door Rear Right // Repair & Painting-scratch + dent

| Damages | Type | Acceptable |
|---|---|---|
| 194 | Door Rear Right // Repair & Painting | N |

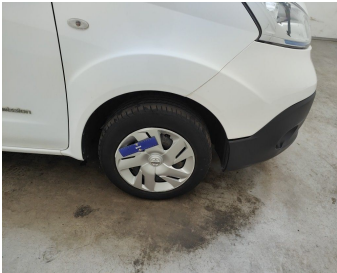
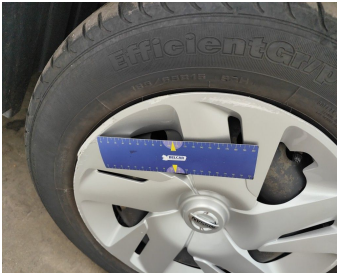
Wheel Front Right / Wheel Cover / Replace-cracked

| Damages | Type | Acceptable |
|---|---|---|
| 344 | Wheel Front Right / Wheel Cover / Replace | N |

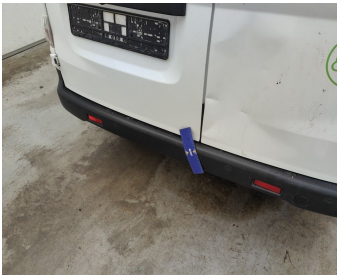
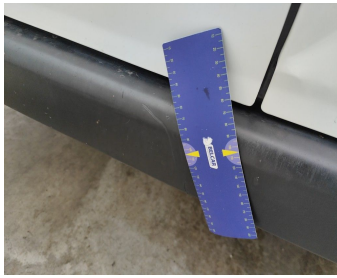
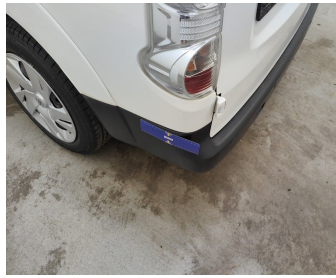
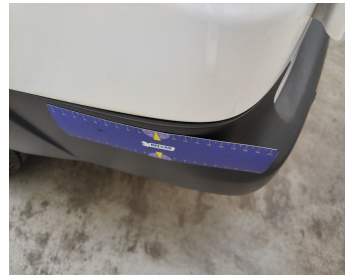
Bumper Rear / Lower Cover Not Painted / Replace-bad position

| Damages | Type | Acceptable |
|---|---|---|
| 138 | Bumper Rear / Lower Cover Not Painted / Replace | N |

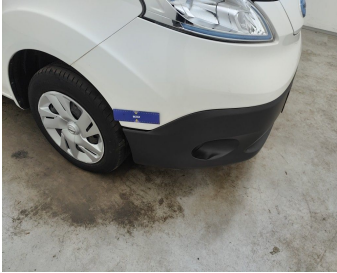
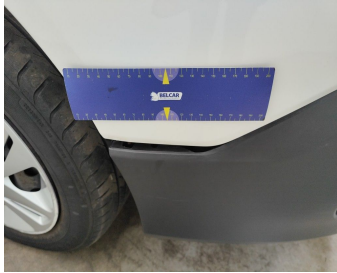
Bumper Front / Lower Cover Not Painted / Replace-bad position

| Damages | Type | Acceptable |
|---|---|---|
| 19 | Bumper Front / Lower Cover Not Painted / Replace | N |

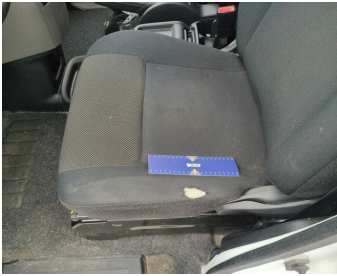
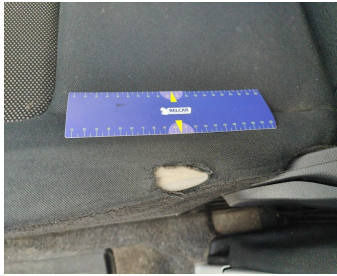
Seat Front Left / Bottom Coating / Replace-hole

| Damages | Type | Acceptable |
|---|---|---|
| 412 | Seat Front Left / Bottom Coating / Replace | Y |
