# INSPECTION REPORT

**End of contract**

| License plate | 2DBL917 |
| Make | Skoda Scala 1.0TSI 81kW Clever |

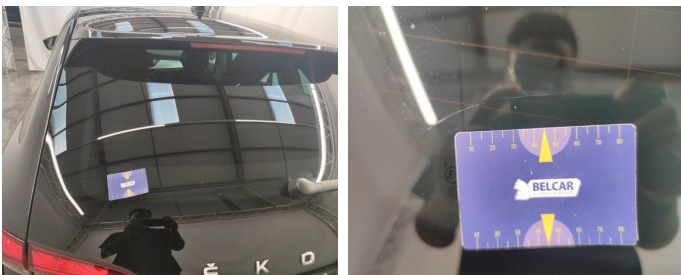
Rear Bonnet / Rear Window / Replace-scratch

| Damages | Type | Acceptable |
|---|---|---|
| 159 | Rear Bonnet / Rear Window / Replace | N |

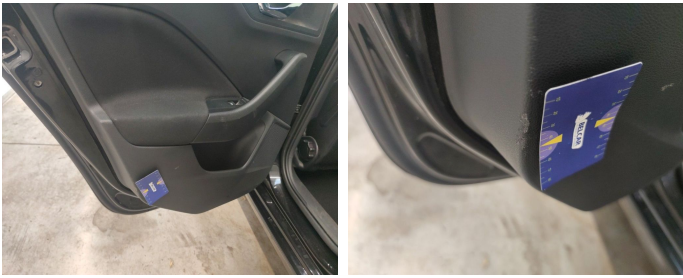
Rear Left Door Interior Coating // Repair-scratch

| Damages | Type | Acceptable |
|---|---|---|
| 631 | Rear Left Door Interior Coating // Repair | Y |

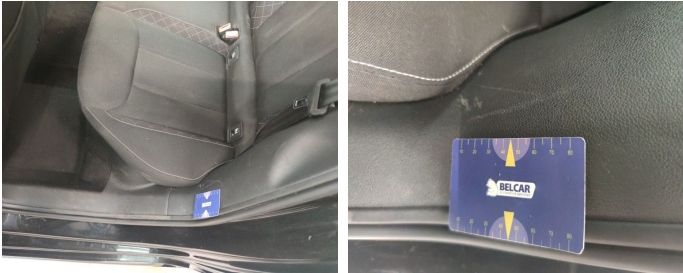
Interior / Side Cover rear Seat / Replace-scratch

| Damages | Type | Acceptable |
|---|---|---|
| 774 | Interior / Side Cover rear Seat / Replace | Y |

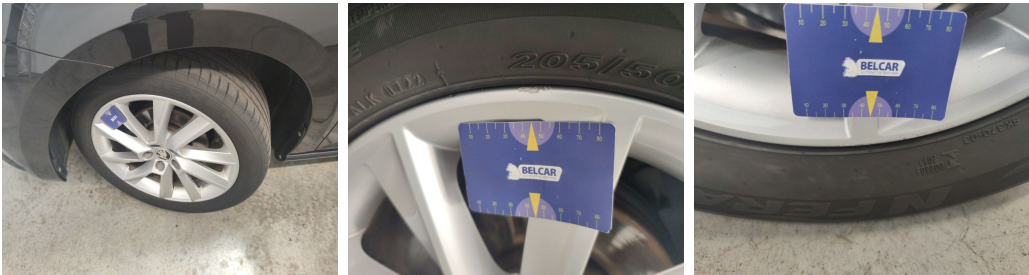
Wheel Alloy Front Left // Repair-scratch

| Damages | Type | Acceptable |
|---|---|---|
| 311 | Wheel Alloy Front Left // Repair | N |

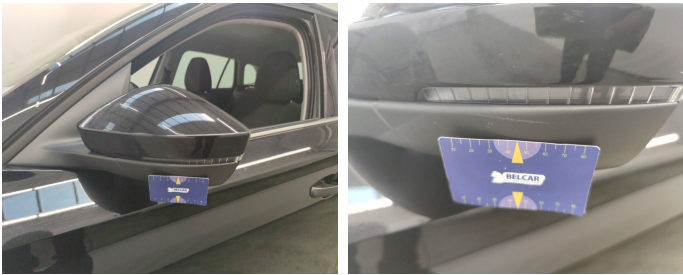
Side View Mirror Left // Plastic Repair-scratch

| Damages | Type | Acceptable |
|---|---|---|
| 71 | Side View Mirror Left // Plastic Repair | N |

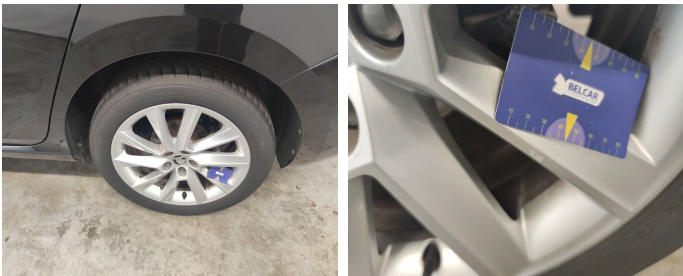
Wheel Alloy Rear Left // Repair-scratch

| Damages | Type | Acceptable |
|---|---|---|
| 321 | Wheel Alloy Rear Left // Repair | Y |

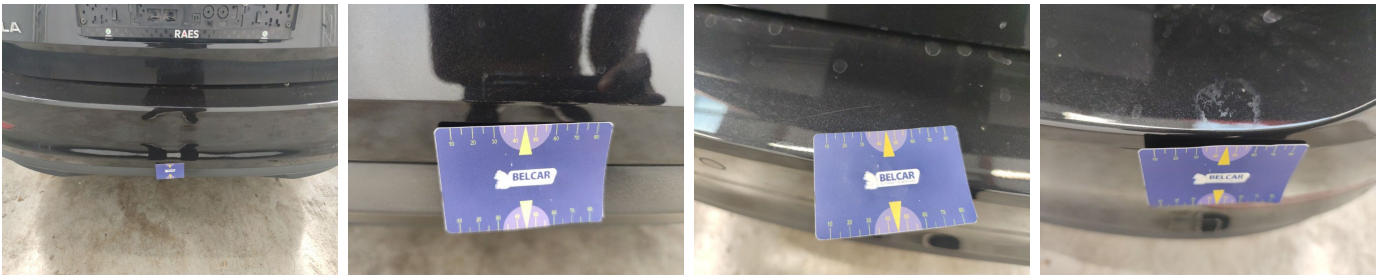
Bumper Rear // Polish-scratch

| Damages | Type | Acceptable |
|---|---|---|
| 136 | Bumper Rear // Polish | Y |

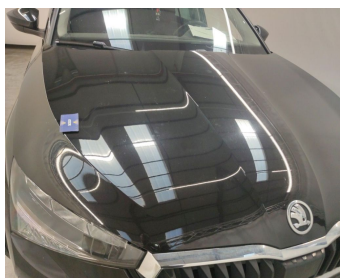
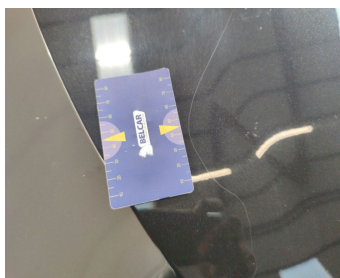
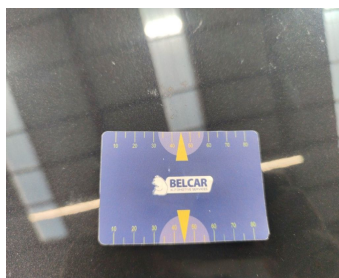
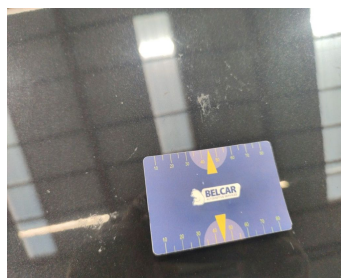
Front Bonnet // Painting-scratch

| Damages | Type | Acceptable |
|---|---|---|
| 32 | Front Bonnet // Painting | N |

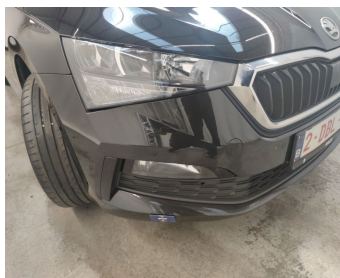
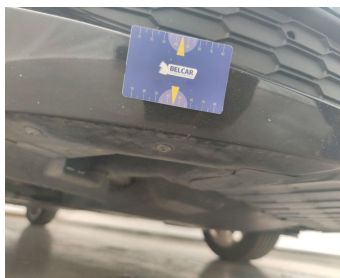
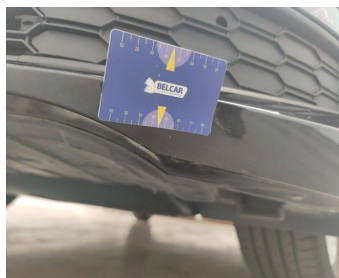
Bumper Front // Painting-scratch

| Damages | Type | Acceptable |
|---|---|---|
| 13 | Bumper Front // Painting | Y |

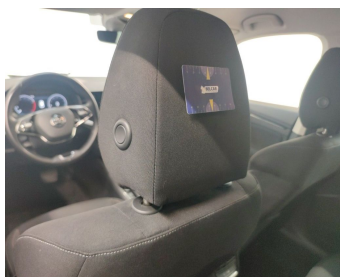
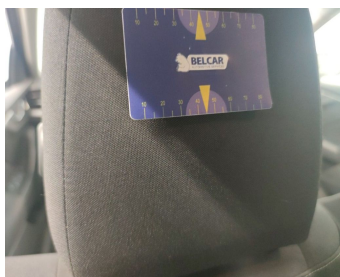
Seat Front Left / Headrest / Replace-scratch

| Damages | Type | Acceptable |
|---|---|---|
| 417 | Seat Front Left / Headrest / Replace | Y |

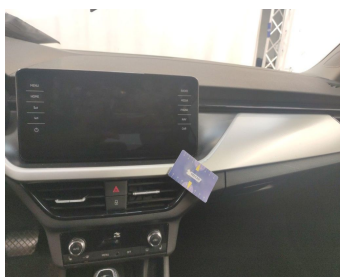
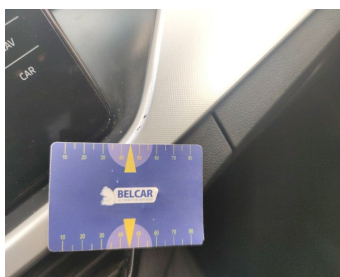
Dashboard // Repair-scratch

| Damages | Type | Acceptable |
|---|---|---|
| 561 | Dashboard // Repair | N |

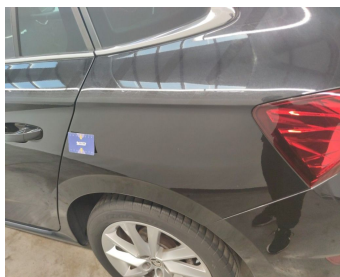
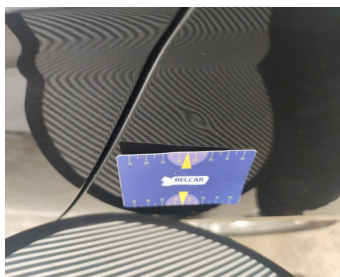
Wing Rear Left // Smart Repair Small-dent

| Damages | Type | Acceptable |
|---|---|---|
| 110 | Wing Rear Left // Smart Repair Small | Y |

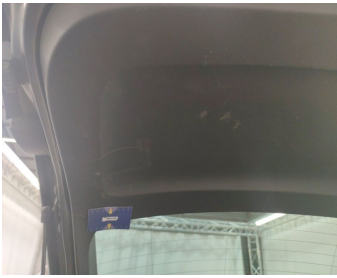
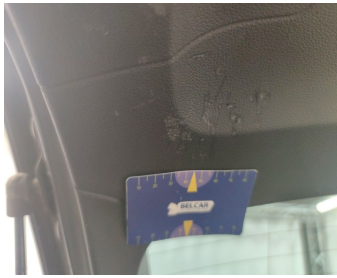
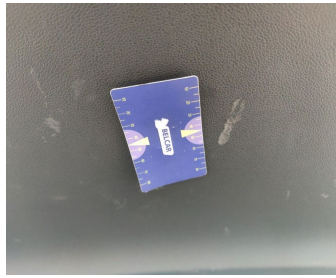
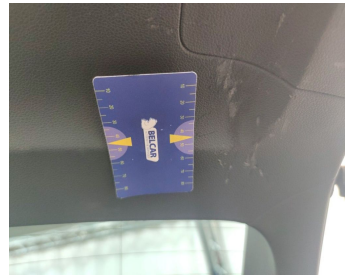
Trunk Lid Interior Coating / Complete Panel / Replace-scratch + dent

| Damages | Type | Acceptable |
|---|---|---|
| 594 | Trunk Lid Interior Coating / Complete Panel / Replace | Y |

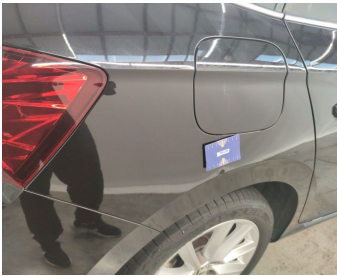
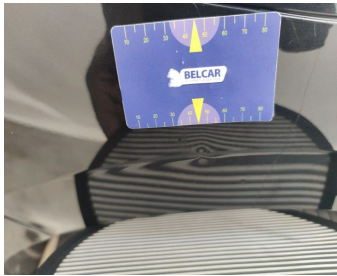
Wing Rear Right // Smart Repair Large-scratch + dent

| Damages | Type | Acceptable |
|---|---|---|
| 182 | Wing Rear Right // Smart Repair Large | N |

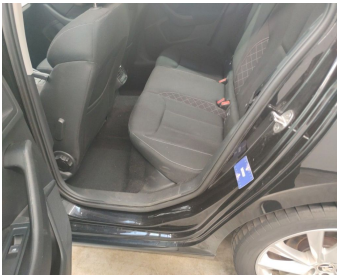
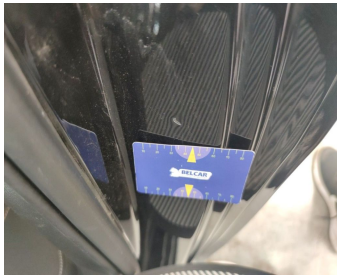
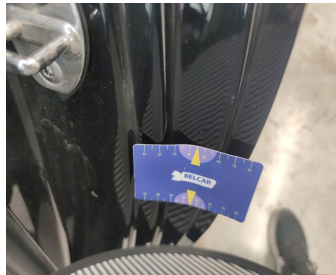
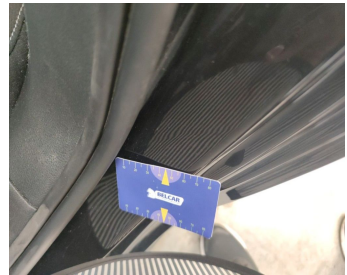
Rocker Panel Left // Smart Repair Medium-scratch + dent

| Damages | Type | Acceptable |
|---|---|---|
| 91 | Rocker Panel Left // Smart Repair Medium | N |

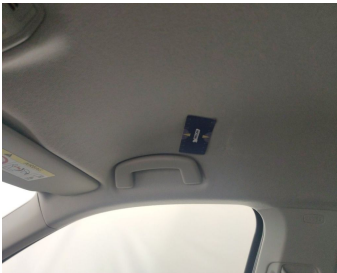
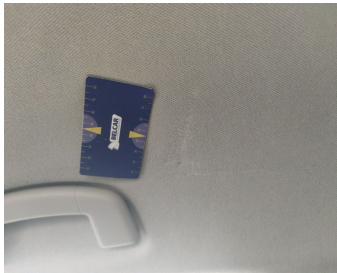
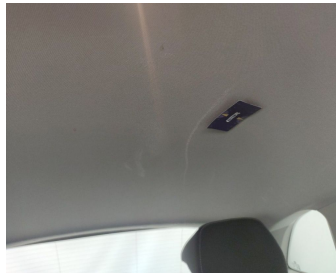
Interior / Headliner/ Replace-scratch + dent

| Damages | Type | Acceptable |
|---|---|---|
| 549 | Interior / Headliner/ Replace | N |

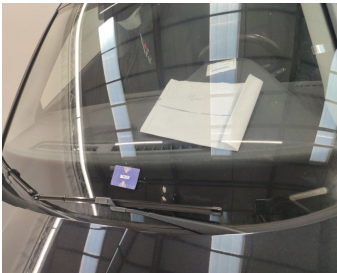
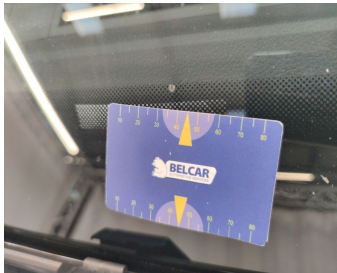
Windshield // Repair-cracked

| Damages | Type | Acceptable |
|---|---|---|
| 40 | Windshield // Repair | Y |

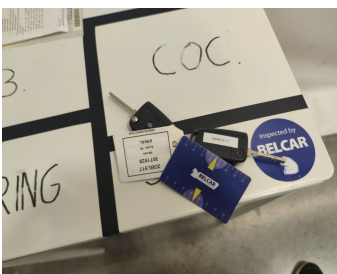
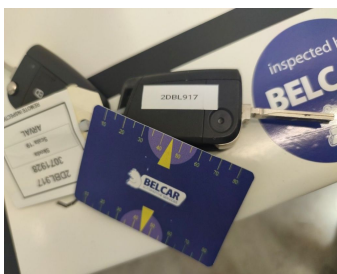
Emergency Key //-missing

| Damages | Type | Acceptable |
|---|---|---|
| 880 | Emergency Key // | N |
