# INSPECTION REPORT

**End of contract**

| License plate | 2CTM530 |
| Make | Hyundai Tuc.T-GDi Hyb.169kW Sh |

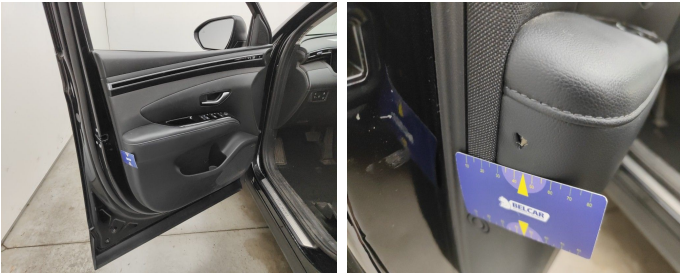
Front Left Door Interior Coating // Replace Completely-hole

| 614 | Front Left Door Interior Coating // Replace Completely | N |

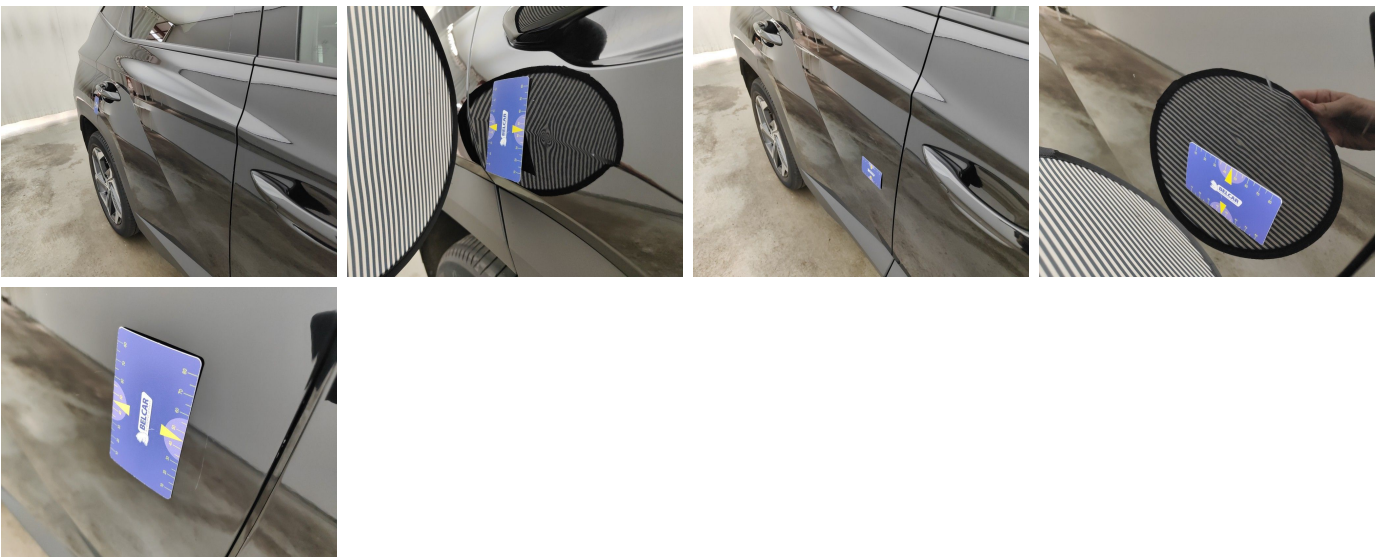
Door Rear Right // Repair & Painting-scratch + dent

| Damages | Type | Acceptable |
|---|---|---|
| 194 | Door Rear Right // Repair & Painting | N |

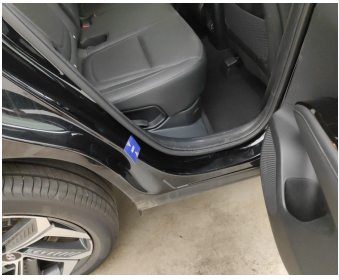
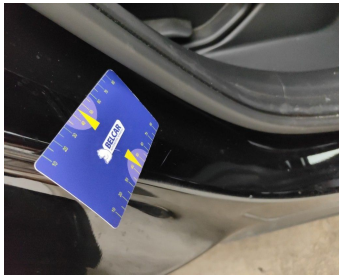
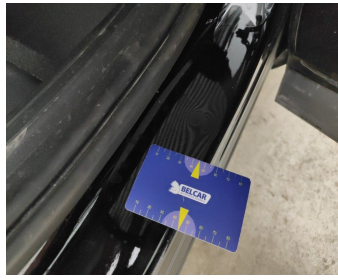
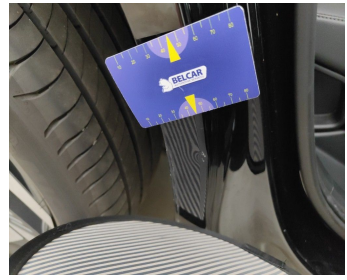
Rocker Panel Right // Smart Repair Medium-scratch + dent

| Damages | Type | Acceptable |
|---|---|---|
| 201 | Rocker Panel Right // Smart Repair Medium | N |

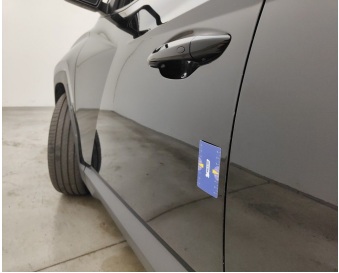
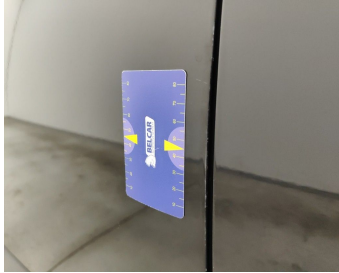
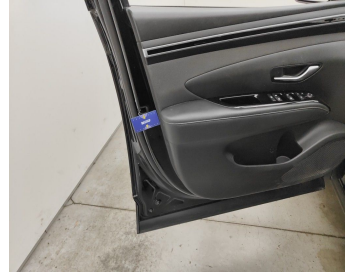
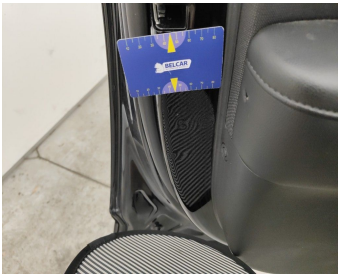
Door Front Left // Repair & Painting-scratch + dent

| Damages | Type | Acceptable |
|---|---|---|
| 84 | Door Front Left // Repair & Painting | Y |

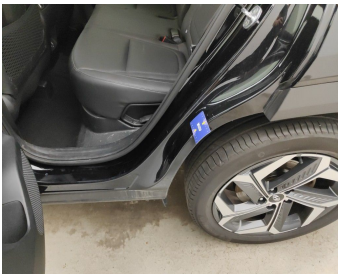
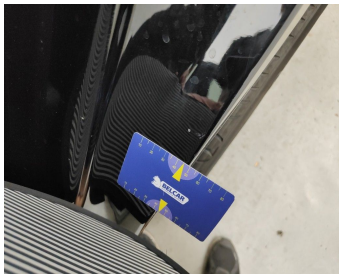
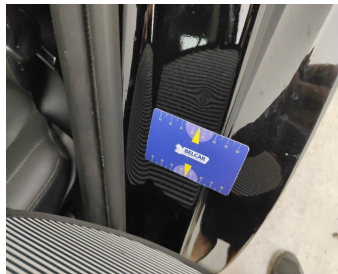
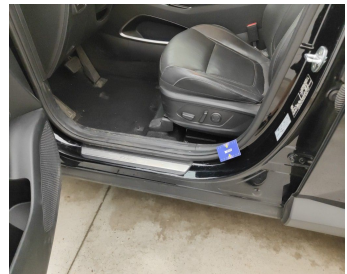
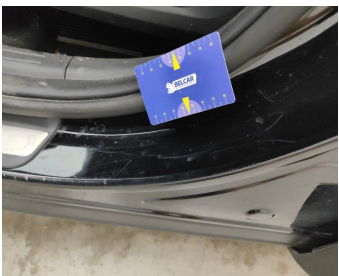
Rocker Panel Left // Smart Repair Medium-scratch + dent

| Damages | Type | Acceptable |
|---|---|---|
| 91 | Rocker Panel Left // Smart Repair Medium | Y |

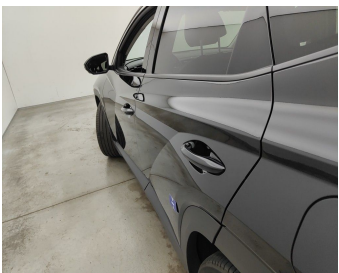
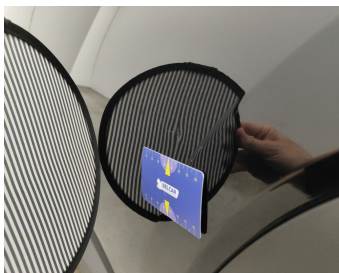
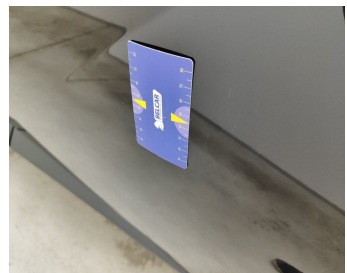
Door Rear Left // Repair & Painting-scratch + dent

| Damages | Type | Acceptable |
|---|---|---|
| 104 | Door Rear Left // Repair & Painting | Y |

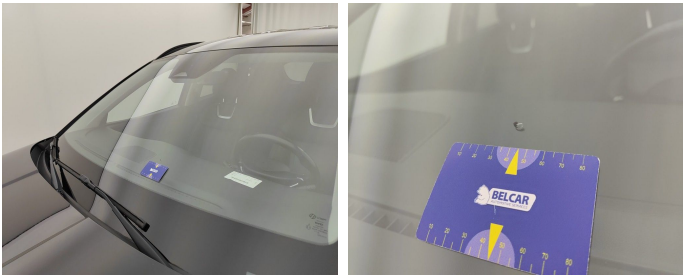
Windshield // Repair-glass damage

| Damages | Type | Acceptable |
|---|---|---|
| 40 | Windshield // Repair | Y |

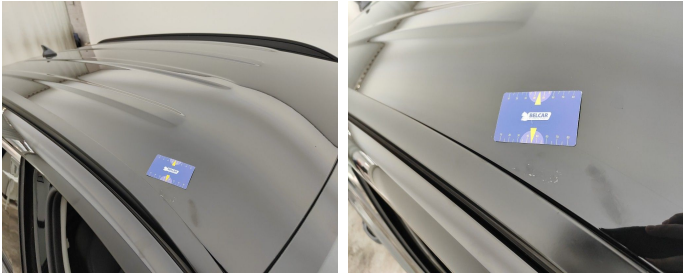
Roof // Painting-Chemical reaction

| Damages | Type | Acceptable |
|---|---|---|
| 162 | Roof // Painting | N |

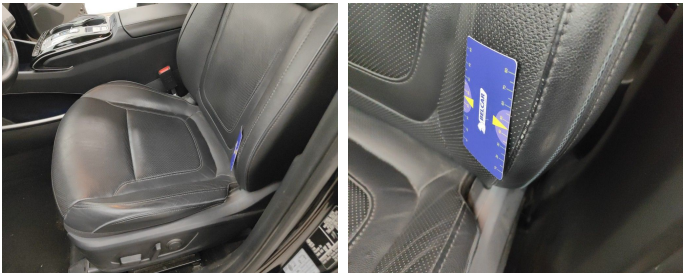
Seat Front Left / Rear Coating / Replace-worn

| 413 | Seat Front Left / Rear Coating / Replace | Y |

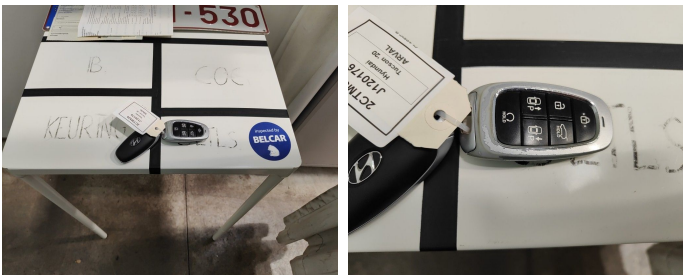
Key Price Range 2 //-worn

| 883 | Key Price Range 2 // | Y |

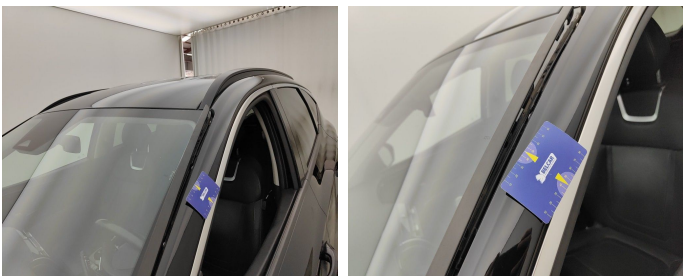
Windshield / Trim / Replace-bad position

| Damages | Type | Acceptable |
|---|---|---|
| 44 | Windshield / Trim / Replace | N |

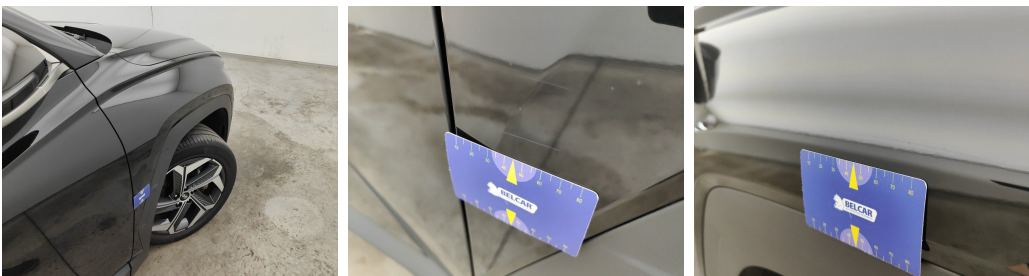
Wing Front right // Polish-scratch

| 236 | Wing Front right // Polish | Y |

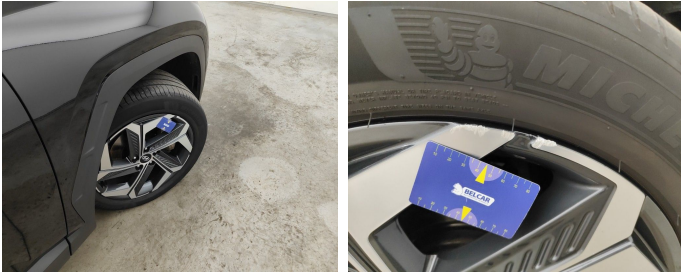
Wheel Two Tone Front Right // Repair-scratch

| 340 | Wheel Two Tone Front Right // Repair | Y |

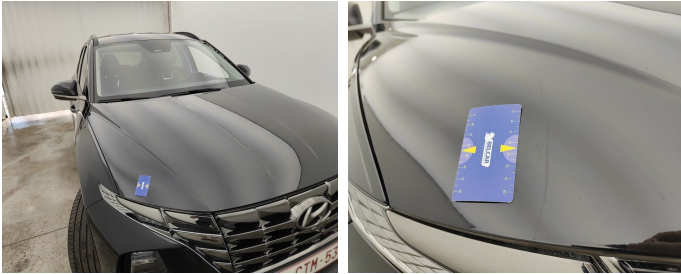
Front Bonnet // Polish-scratch

| Damages | Type | Acceptable |
|---|---|---|
| 35 | Front Bonnet // Polish | Y |

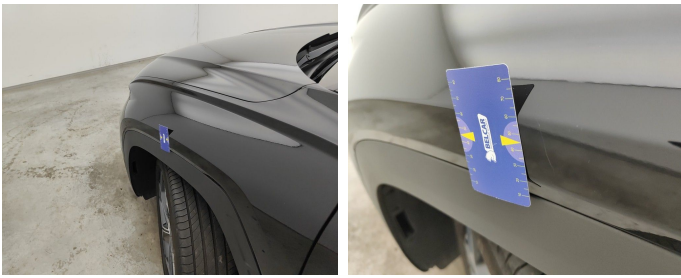
Wing Front Left // Polish-scratch

| Damages | Type | Acceptable |
|---|---|---|
| 66 | Wing Front Left // Polish | Y |

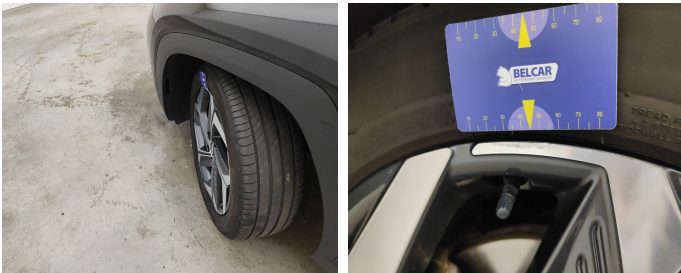
Wheel Two Tone Front Left // Repair-scratch

| 310 | Wheel Two Tone Front Left // Repair | Y |

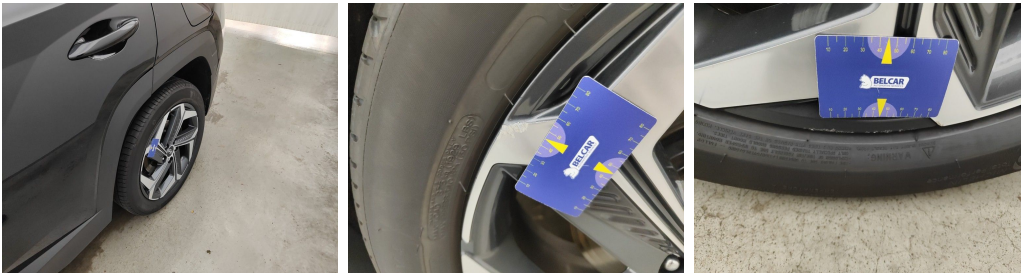
Wheel Two Tone Rear Left // Repair-scratch

| 320 | Wheel Two Tone Rear Left // Repair | N |

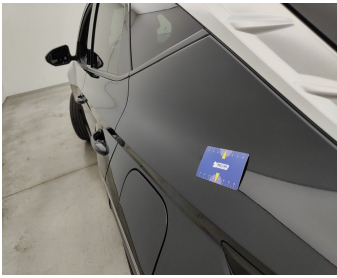
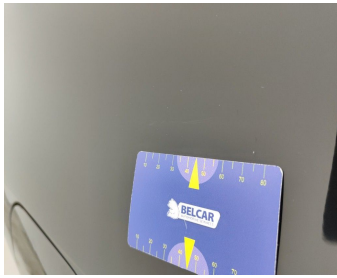
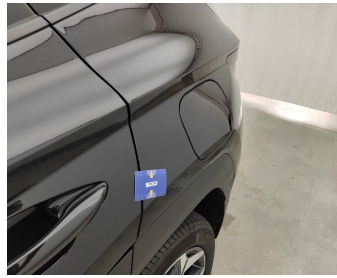
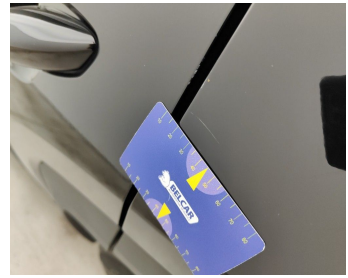
Wing Rear Left // Polish-scratch

| Damages | Type | Acceptable |
|---|---|---|
| 116 | Wing Rear Left // Polish | Y |

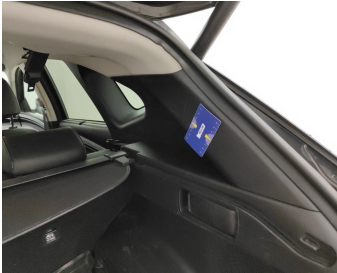
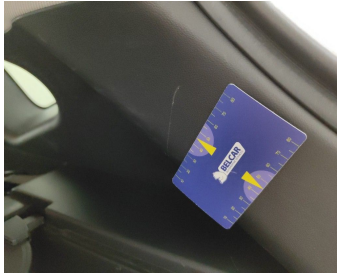
Trunk Compartment / Side Cover Right / Replace-scratch

| 533 | Trunk Compartment / Side Cover Right / Replace | Y |

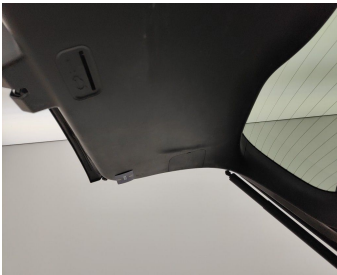
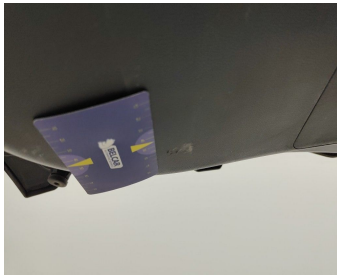
Trunk Lid Interior Coating / Complete Panel / Replace-scratch

| 594 | Trunk Lid Interior Coating / Complete Panel / Replace | Y |

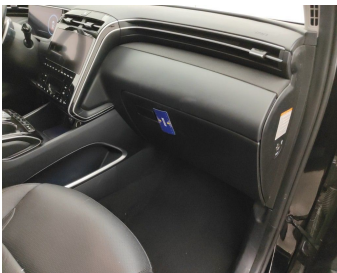
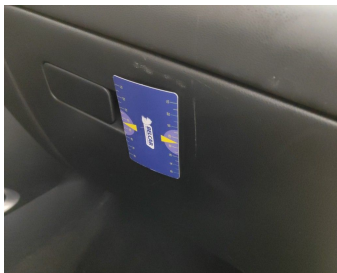
Dashboard / Storage Tray / Replace-scratch

| 565 | Dashboard / Storage Tray / Replace | Y |

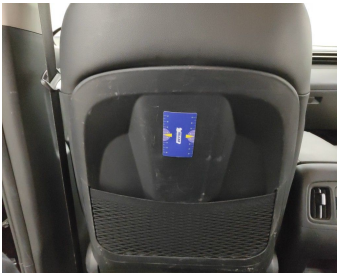
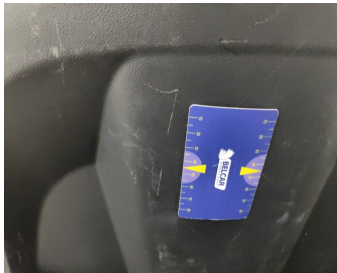
Seat Front Left // Repair-scratch

| 411 | Seat Front Left // Repair | Y |

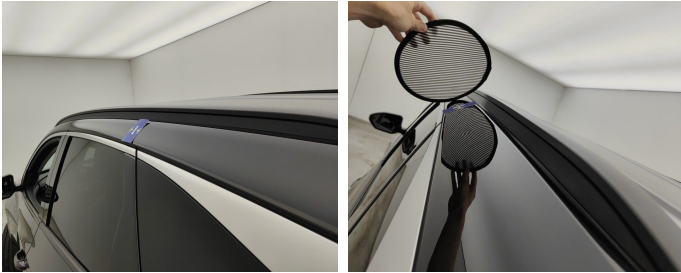
Roof // Smart Repair Medium-dent

| Damages | Type | Acceptable |
|---|---|---|
| 161 | Roof // Smart Repair Medium | N |

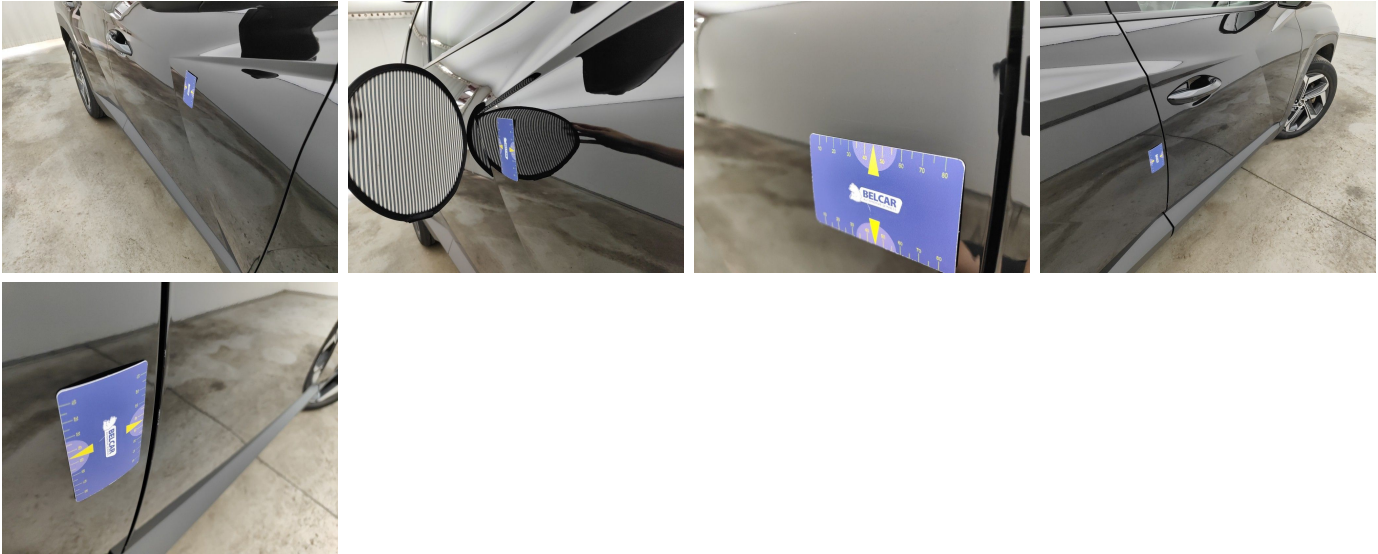
Door Front Right // Smart Repair Small-dent

| Damages | Type | Acceptable |
|---|---|---|
| 210 | Door Front Right // Smart Repair Small | Y |

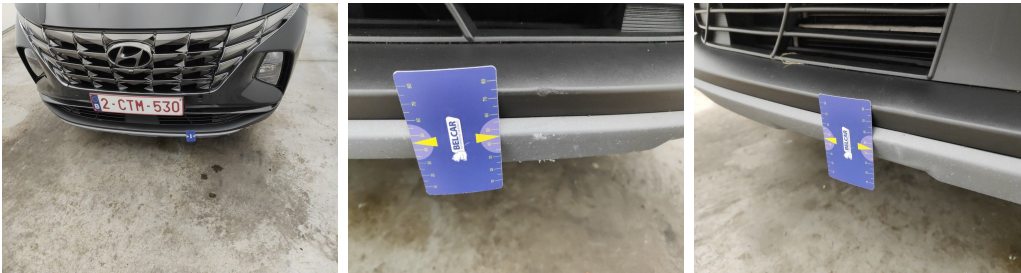
Bumper Front / Spoiler / Replace-scratch

| Damages | Type | Acceptable |
|---|---|---|
| 18 | Bumper Front / Spoiler / Replace | Y |

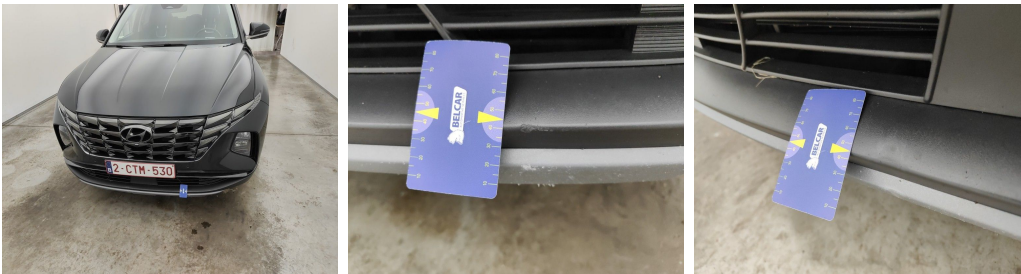
Bumper Front / Lower Cover Not Painted / Replace-scratch

| Damages | Type | Acceptable |
|---|---|---|
| 19 | Bumper Front / Lower Cover Not Painted / Replace | Y |

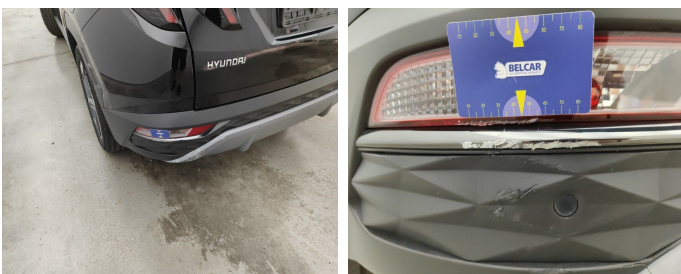
Bumper Rear / Trim Left / Replace-scratch

| Damages | Type | Acceptable |
|---|---|---|
| 281 | Bumper Rear / Trim Left / Replace | N |

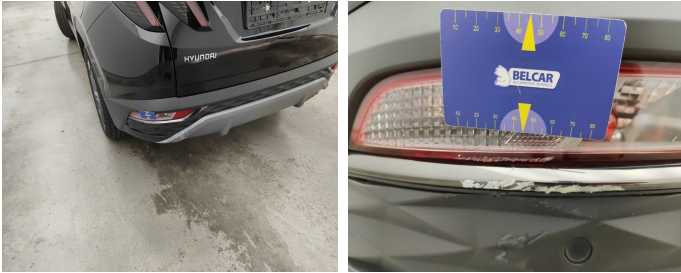
Back Side / Reflector L / Replace-scratch

| Damages | Type | Acceptable |
|---|---|---|
| 146 | Back Side / Reflector L / Replace | N |

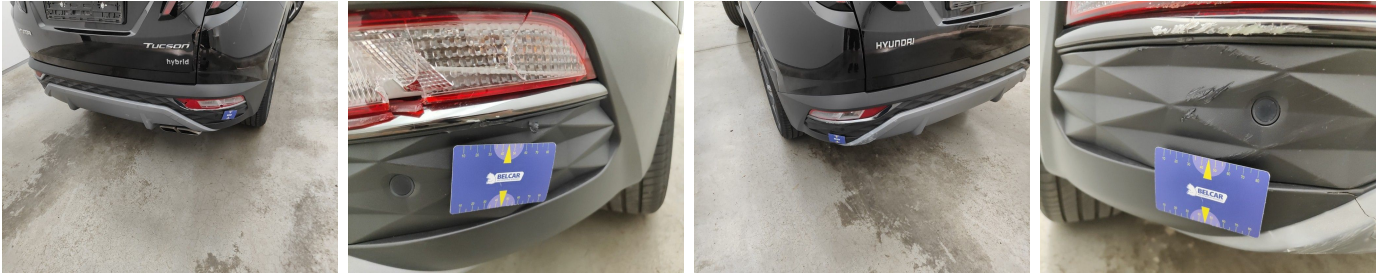
Bumper Rear / Trim Center / Replace-scratch

| Damages | Type | Acceptable |
|---|---|---|
| 282 | Bumper Rear / Trim Center / Replace | N |

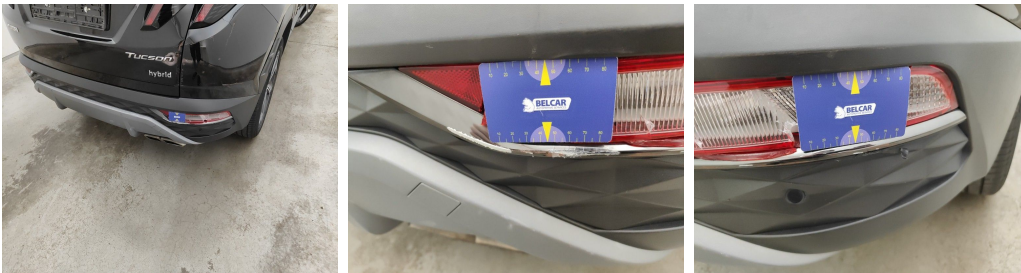
Bumper Rear / Trim Right / Replace-scratch

| Damages | Type | Acceptable |
|---|---|---|
| 283 | Bumper Rear / Trim Right / Replace | N |

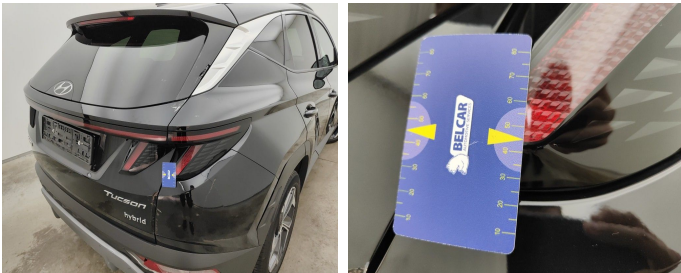
Light / Rear Right / Replace-scratch

| Damages | Type | Acceptable |
|---|---|---|
| 174 | Light / Rear Right / Replace | N |

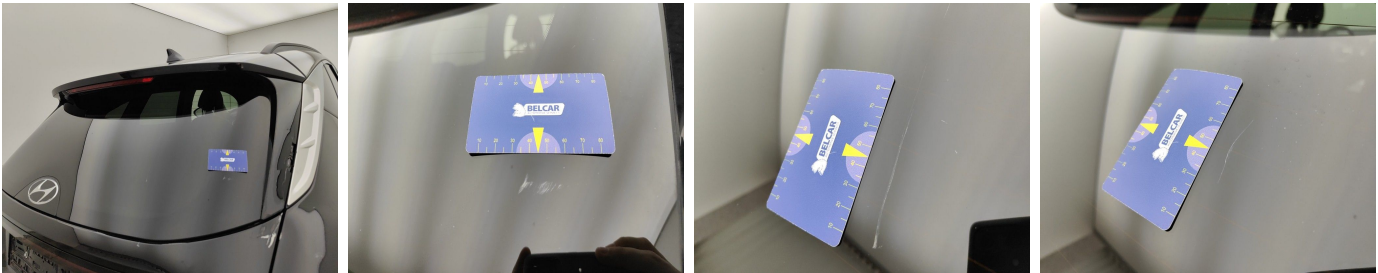
Rear Bonnet / Rear Window / Replace-scratch

| Damages | Type | Acceptable |
|---|---|---|
| 159 | Rear Bonnet / Rear Window / Replace | N |

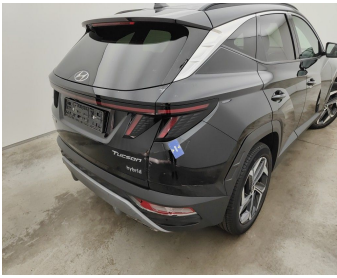
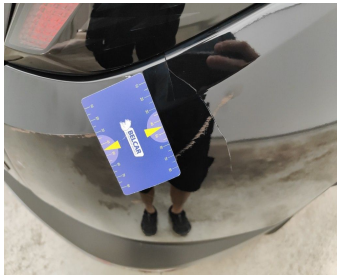
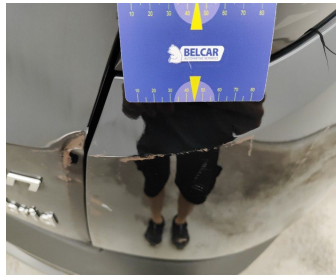
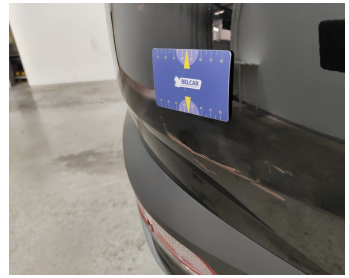
Bumper Rear // Replace & Painting-cracked

| Damages | Type | Acceptable |
|---|---|---|
| 135 | Bumper Rear // Replace & Painting | N |

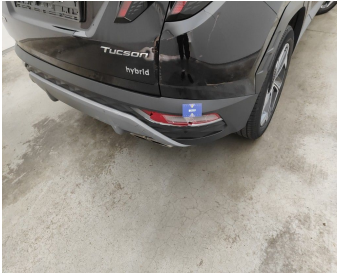
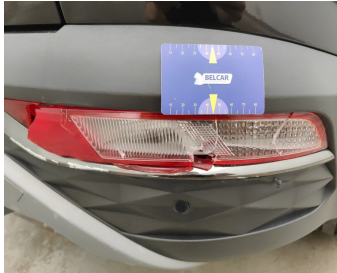
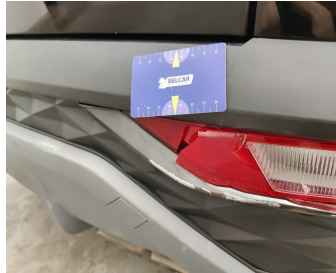
Back Side / Reflector R / Replace-cracked

| Damages | Type | Acceptable |
|---|---|---|
| 148 | Back Side / Reflector R / Replace | N |

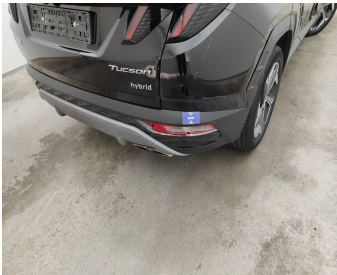
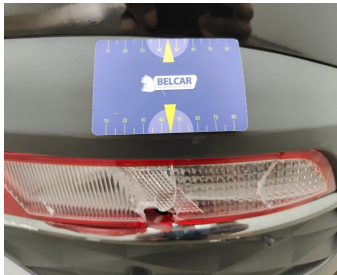
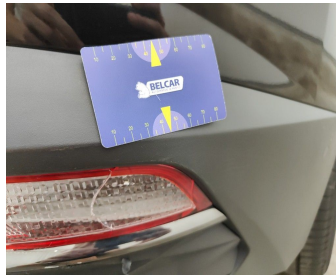
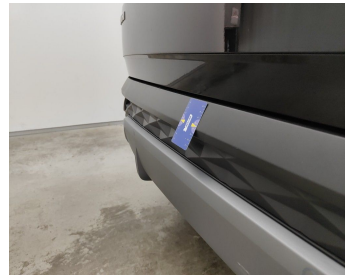
Bumper Rear / Lower Cover Not Painted / Replace-cracked

| Damages | Type | Acceptable |
|---|---|---|
| 138 | Bumper Rear / Lower Cover Not Painted / Replace | N |

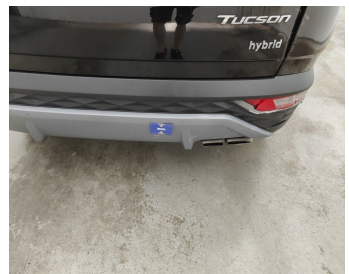
Bumper Rear / Spoiler / Replace-cracked

| Damages | Type | Acceptable |
|---|---|---|
| 139 | Bumper Rear / Spoiler / Replace | N |

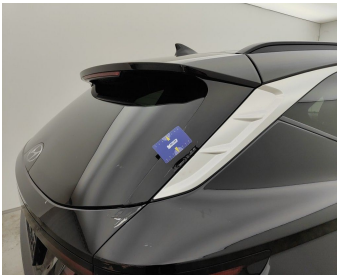
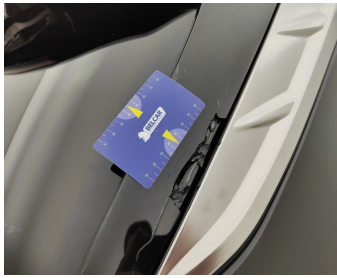
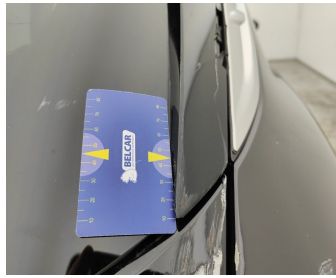
Rear Bonnet / Trim / Replace-cracked

| Damages | Type | Acceptable |
|---|---|---|
| 157 | Rear Bonnet / Trim / Replace | N |

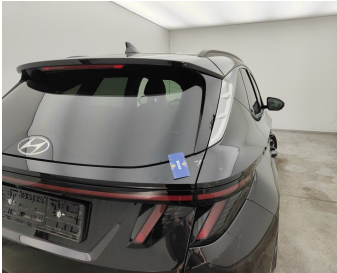
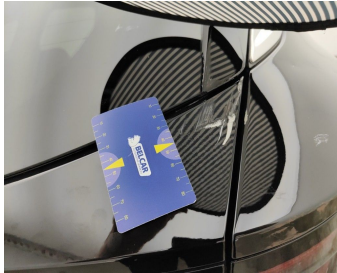
Rear Bonnet / Spoiler / Replace & Painting-scratch + dent

| Damages | Type | Acceptable |
|---|---|---|
| 169 | Rear Bonnet / Spoiler / Replace & Painting | N |

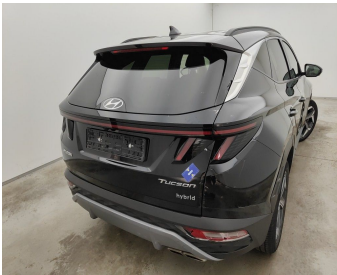
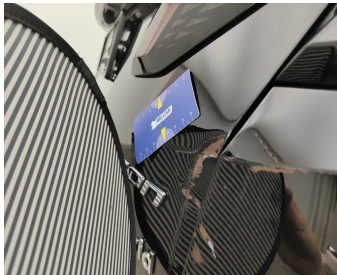
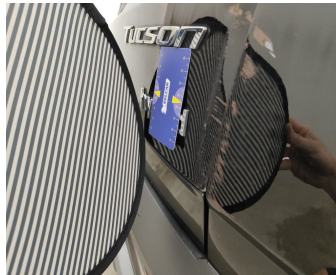
Rear Bonnet // Repair & Painting-scratch + dent

| Damages | Type | Acceptable |
|---|---|---|
| 154 | Rear Bonnet // Repair & Painting | N |

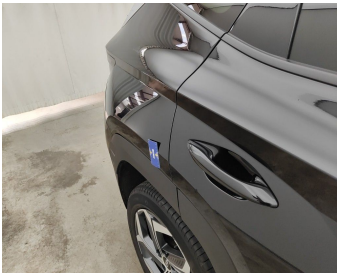
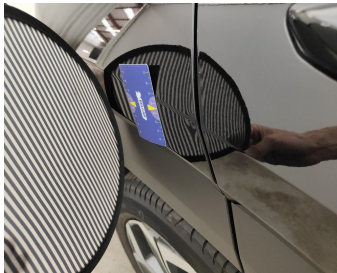
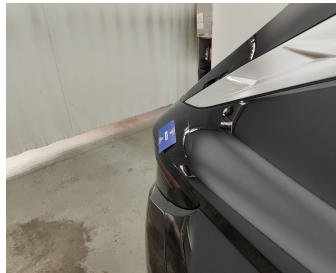
Wing Rear Right // Repair & Painting-scratch + dent

| Damages | Type | Acceptable |
|---|---|---|
| 184 | Wing Rear Right // Repair & Painting | N |

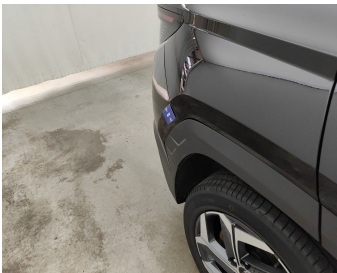
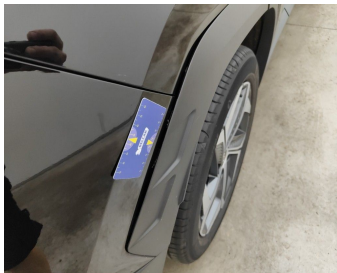
Wing Rear Right / Trim / Replace-bad position

| Damages | Type | Acceptable |
|---|---|---|
| 187 | Wing Rear Right / Trim / Replace | N |
