# INSPECTION REPORT

**End of contract**

| License plate | 2DPZ033 |
| Make | Peugeot 208 1.2PT 75 Active Pa |

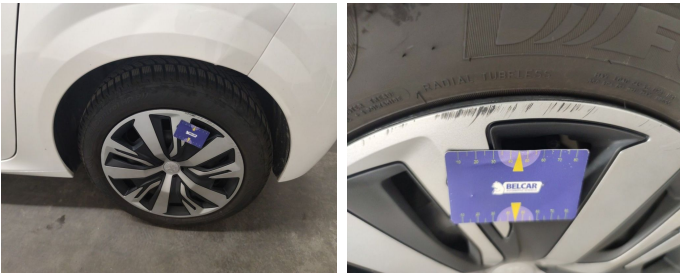
Wheel Rear Left / Wheel Cover / Replace-scratch

| Damages | Type | Acceptable |
|---|---|---|
| 324 | Wheel Rear Left / Wheel Cover / Replace | N |

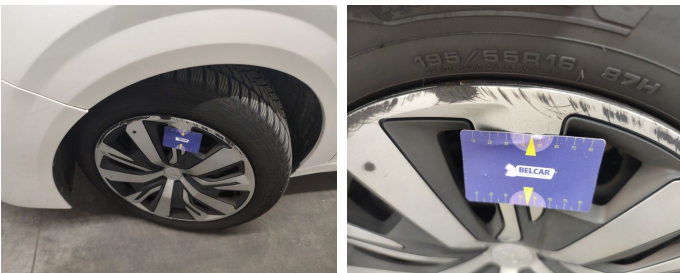
Wheel Front Left / Wheel Cover / Replace-scratch

| Damages | Type | Acceptable |
|---|---|---|
| 314 | Wheel Front Left / Wheel Cover / Replace | N |

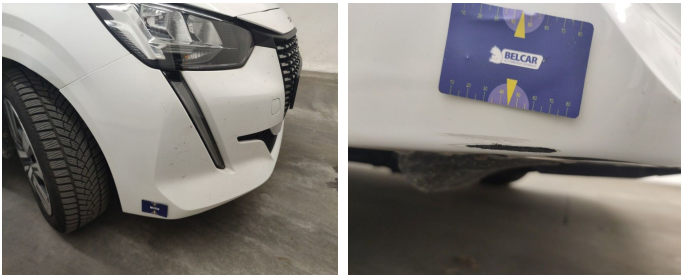
Bumper Front // Smart Repair Medium-scratch

| Damages | Type | Acceptable |
|---|---|---|
| 11 | Bumper Front // Smart Repair Medium | N |

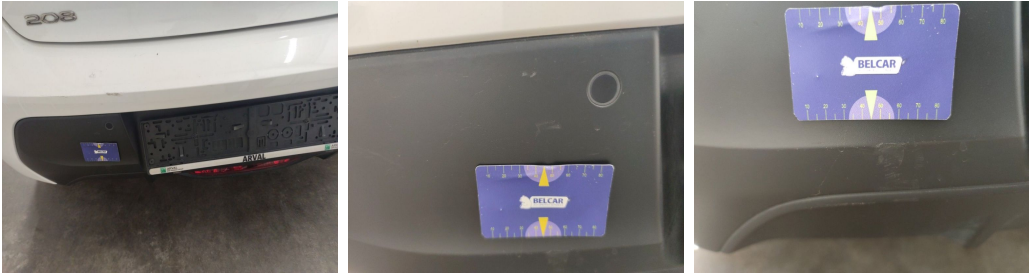
Bumper Rear / Lower Cover Not Painted / Replace-scratch

| Damages | Type | Acceptable |
|---|---|---|
| 138 | Bumper Rear / Lower Cover Not Painted / Replace | Y |

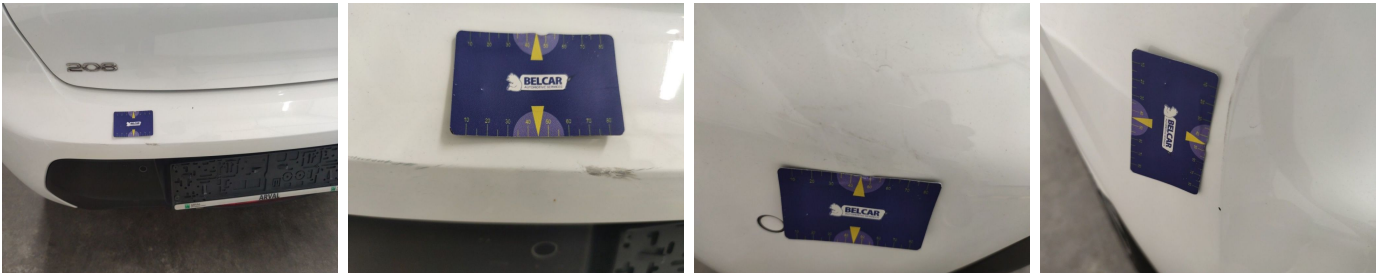
Bumper Rear // Painting-scratch

| Damages | Type | Acceptable |
|---|---|---|
| 133 | Bumper Rear // Painting | N |

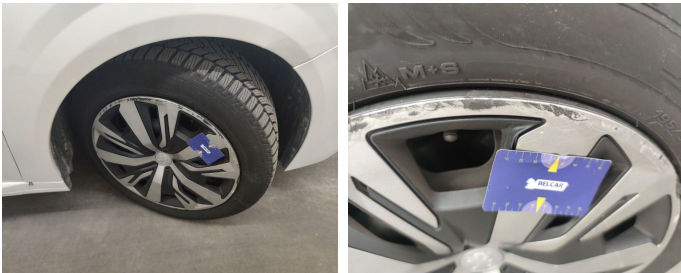
Wheel Front Right / Wheel Cover / Replace-scratch

| Damages | Type | Acceptable |
|---|---|---|
| 344 | Wheel Front Right / Wheel Cover / Replace | N |

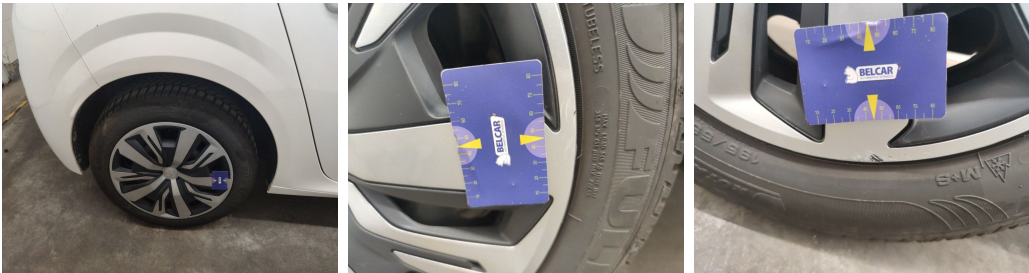
Wheel Rear Right / Wheel Cover / Replace-scratch

| Damages | Type | Acceptable |
|---|---|---|
| 334 | Wheel Rear Right / Wheel Cover / Replace | N |

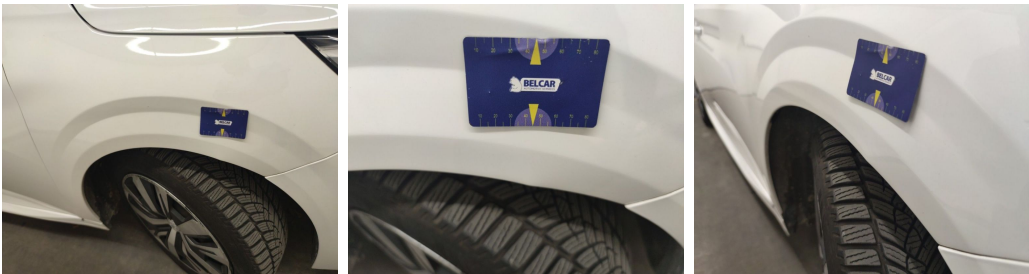
Wing Front right // Repair & Painting-dent

| Damages | Type | Acceptable |
|---|---|---|
| 234 | Wing Front right // Repair & Painting | N |

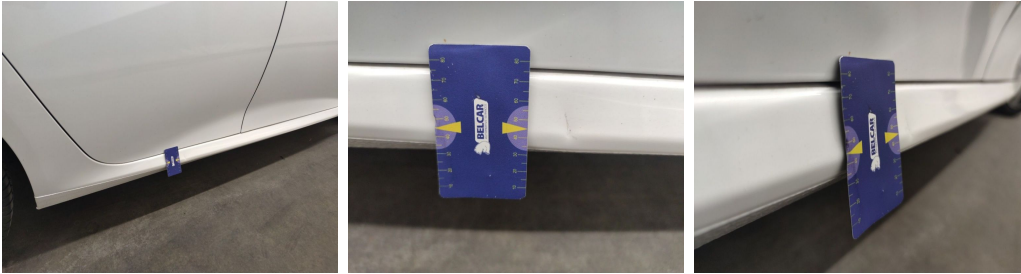
Rocker Panel Right // Repair & Painting-scratch + dent

| Damages | Type | Acceptable |
|---|---|---|
| 203 | Rocker Panel Right // Repair & Painting | N |

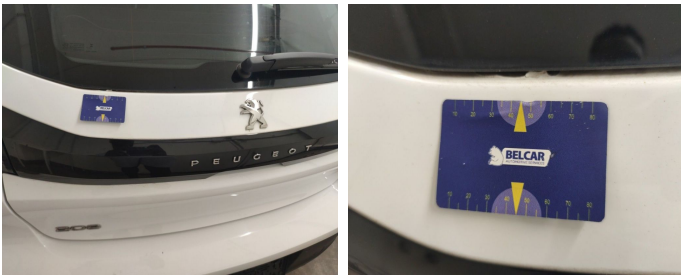
Rear Bonnet // Painting-bad repair

| Damages | Type | Acceptable |
|---|---|---|
| 153 | Rear Bonnet // Painting | N |

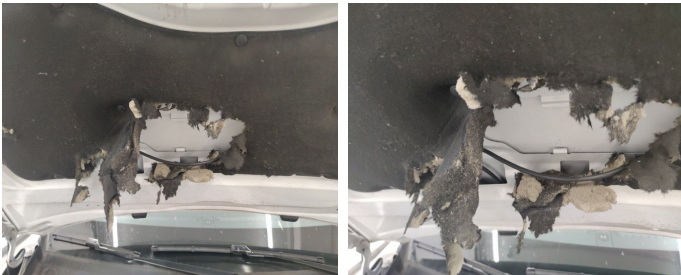
Front Bonnet / Insulation / Replace-cracked

| Damages | Type | Acceptable |
|---|---|---|
| 38 | Front Bonnet / Insulation / Replace | N |
