# INSPECTION REPORT

**End of contract**

| License plate | 1YXR802 |
| Make | Opel Comb.1.5D 75kW 2.3T L2H1 |

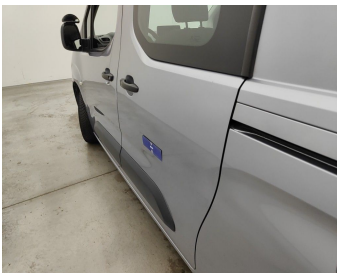
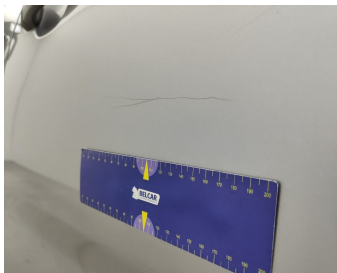
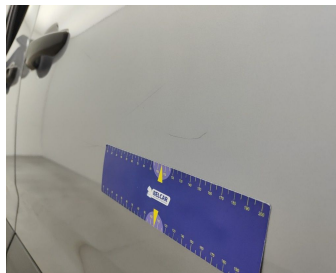
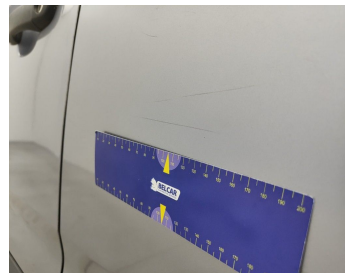
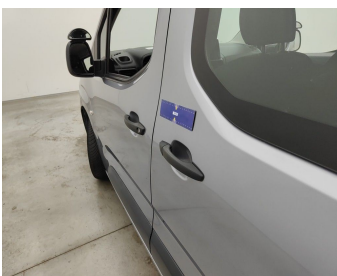
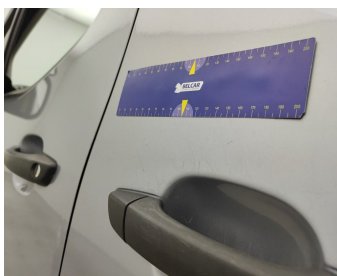
| Damages | Type | Acceptable |
|---|---|---|
| 106 | Door Rear Left // Polish | Y |

Door Rear Left // Polish-scratch

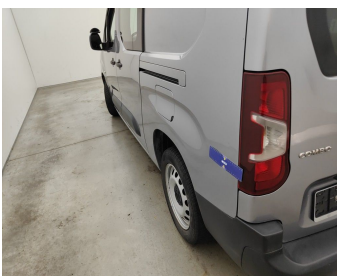
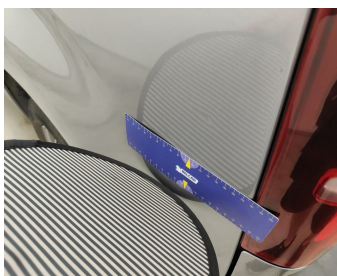
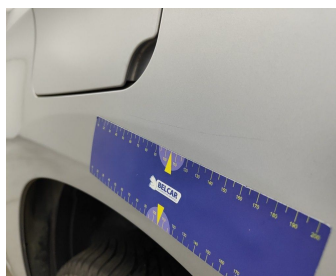
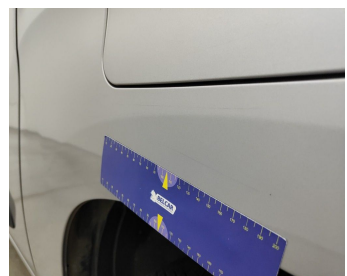
| Damages | Type | Acceptable |
|---|---|---|
| 116 | Wing Rear Left // Polish | Y |

Wing Rear Left // Polish-scratch

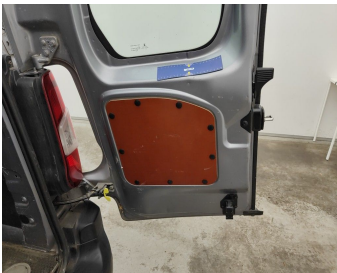
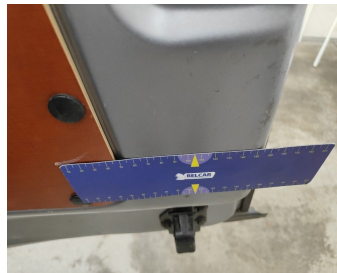
| Damages | Type | Acceptable |
|---|---|---|
| 304 | Rear Loading Door Right // Repair & Painting | N |

Rear Loading Door Right // Repair & Painting-scratch + dent

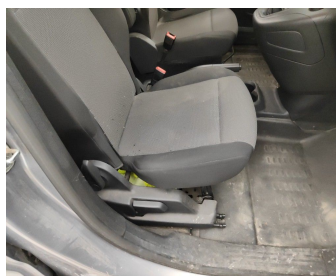
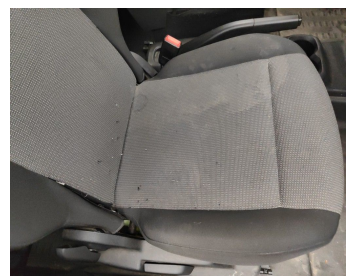
| Damages | Type | Acceptable |
|---|---|---|
| 860 | Interior Cleaning // Small | N |

Interior Cleaning // Small-stain

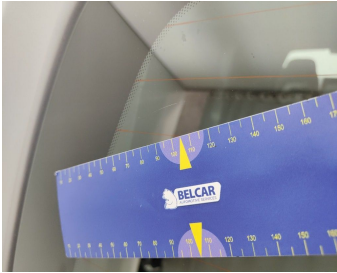
| Damages | Type | Acceptable |
|---|---|---|
| 159 | Rear Bonnet / Rear Window / Replace | Y |

Rear Bonnet / Rear Window / Replace-scratch

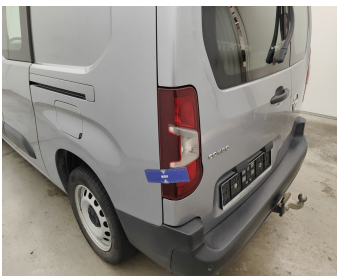
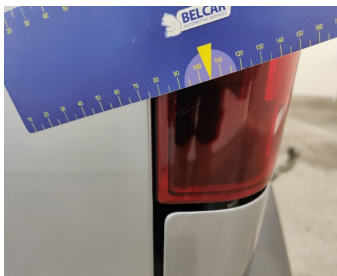
| Damages | Type | Acceptable |
|---|---|---|
| 124 | Light / Rear left / Replace | N |

Light / Rear left / Replace-scratch

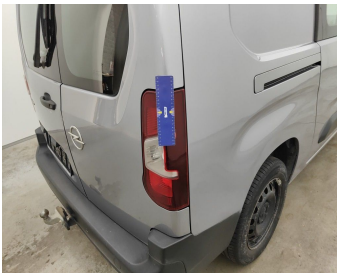
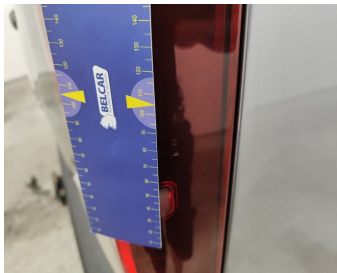
| Damages | Type | Acceptable |
|---|---|---|
| 174 | Light / Rear Right / Replace | N |

Light / Rear Right / Replace-scratch

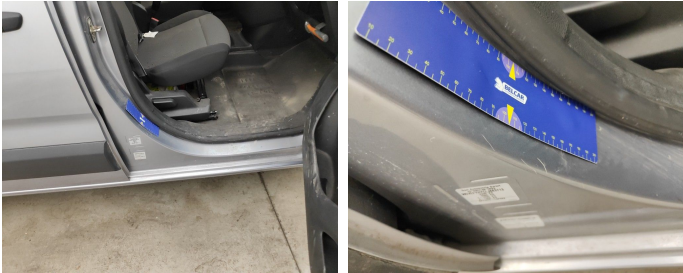
| Damages | Type | Acceptable |
|---|---|---|
| 202 | Rocker Panel Right // Painting | Y |

Rocker Panel Right // Painting-scratch
