# INSPECTION REPORT

**End of contract**

| License plate | 2FGJ016 |
| Make | Mercedes CLA 250 e AMG Line A |

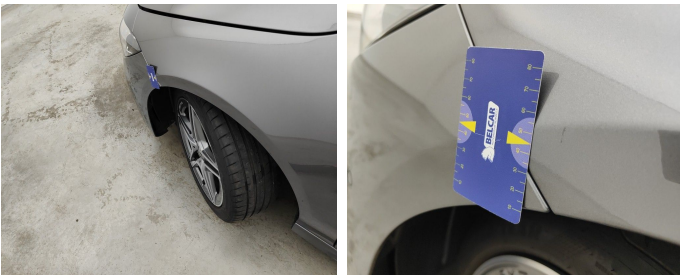
Wing Front Left // Painting-scratch

| Damages | Type | Acceptable |
|---|---|---|
| 63 | Wing Front Left // Painting | Y |

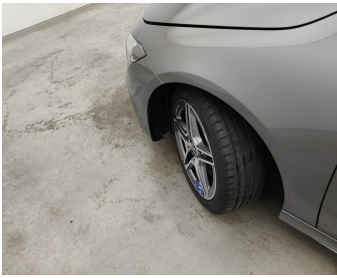
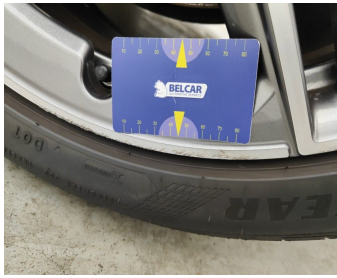
Wheel Two Tone Front Left // Repair-scratch

| Damages | Type | Acceptable |
|---|---|---|
| 310 | Wheel Two Tone Front Left // Repair | N |

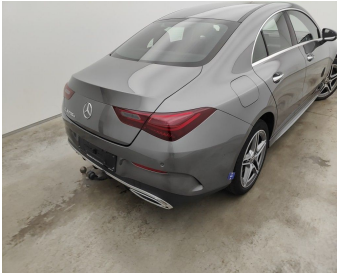
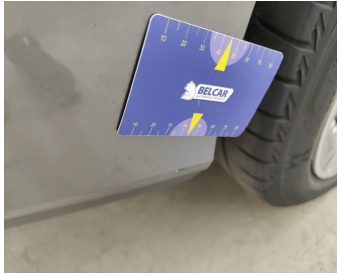
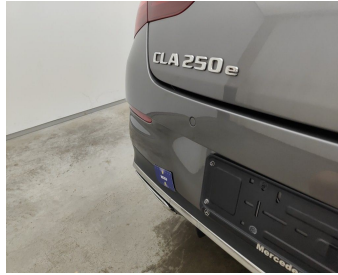
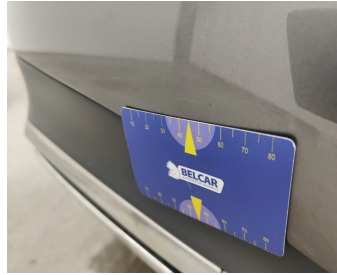
Bumper Rear // Painting-scratch

| Damages | Type | Acceptable |
|---|---|---|
| 133 | Bumper Rear // Painting | Y |

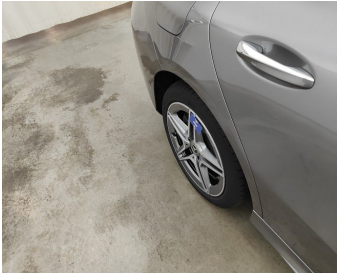
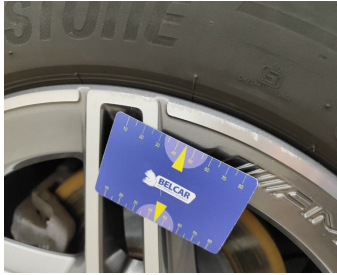
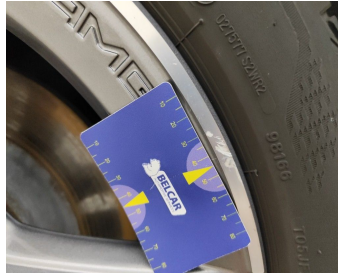
Wheel Two Tone Rear Right // Repair-scratch

| Damages | Type | Acceptable |
|---|---|---|
| 330 | Wheel Two Tone Rear Right // Repair | N |

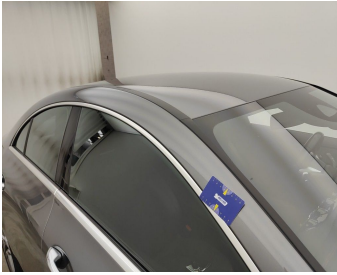
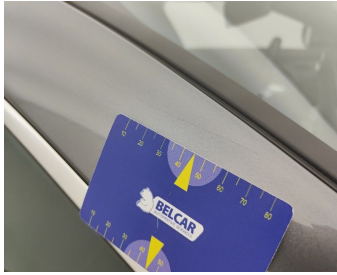
Roof // Polish-scratch

| Damages | Type | Acceptable |
|---|---|---|
| 165 | Roof // Polish | Y |

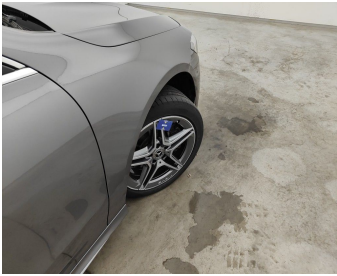
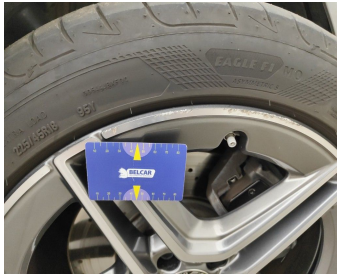
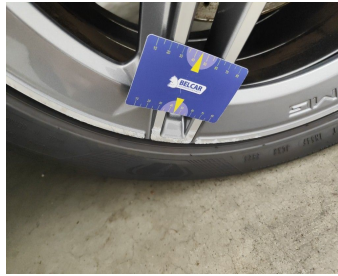
Wheel Two Tone Front Right // Repair-scratch

| Damages | Type | Acceptable |
|---|---|---|
| 340 | Wheel Two Tone Front Right // Repair | N |

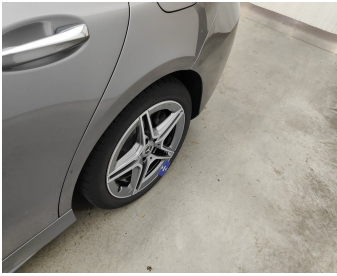
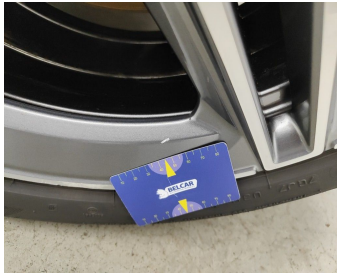
Wheel Two Tone Rear Left // Repair-scratch

| Damages | Type | Acceptable |
|---|---|---|
| 320 | Wheel Two Tone Rear Left // Repair | Y |

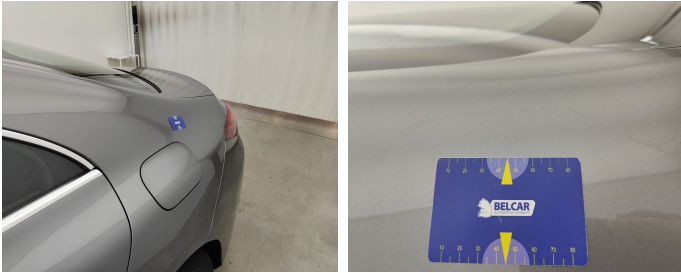
Wing Rear Left // Polish-scratch

| Damages | Type | Acceptable |
|---|---|---|
| 116 | Wing Rear Left // Polish | Y |

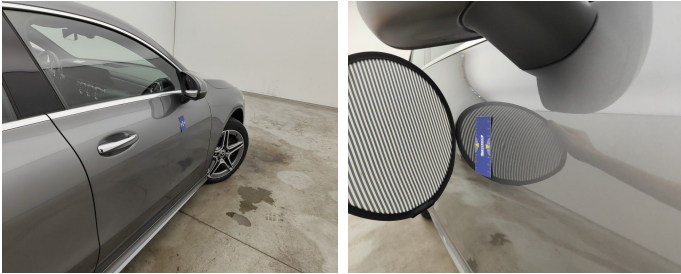
Door Front Right // Smart Repair Small-dent

| Damages | Type | Acceptable |
|---|---|---|
| 210 | Door Front Right // Smart Repair Small | Y |

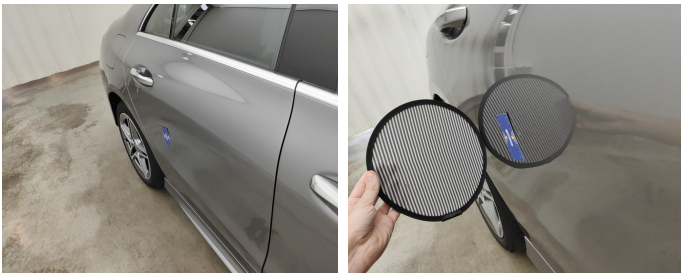
Door Rear Right // Repair & Painting-scratch + dent

| Damages | Type | Acceptable |
|---|---|---|
| 194 | Door Rear Right // Repair & Painting | Y |

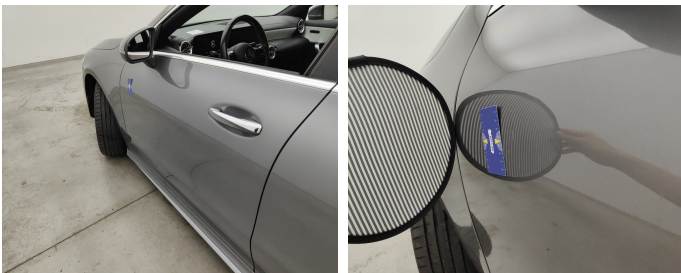
Door Front Left // Repair & Painting-scratch + dent

| Damages | Type | Acceptable |
|---|---|---|
| 84 | Door Front Left // Repair & Painting | Y |

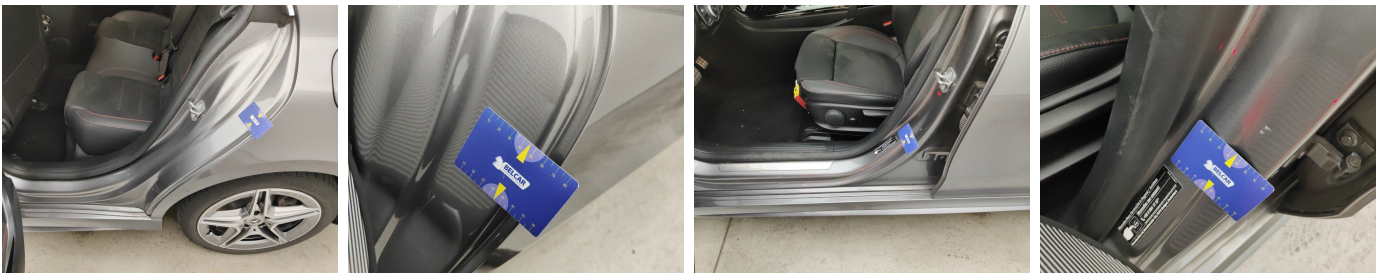
Rocker Panel Left // Smart Repair Medium-scratch + dent

| Damages | Type | Acceptable |
|---|---|---|
| 91 | Rocker Panel Left // Smart Repair Medium | N |

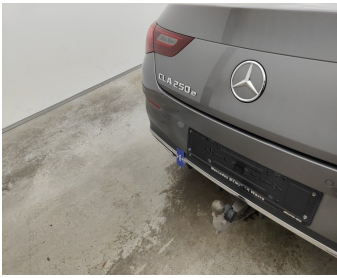
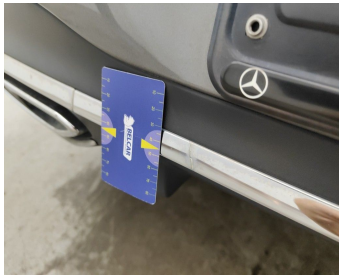
Bumper Rear / Trim Center / Replace-cracked

| Damages | Type | Acceptable |
|---|---|---|
| 282 | Bumper Rear / Trim Center / Replace | N |

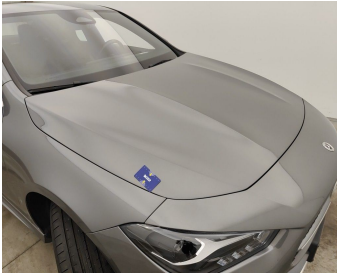
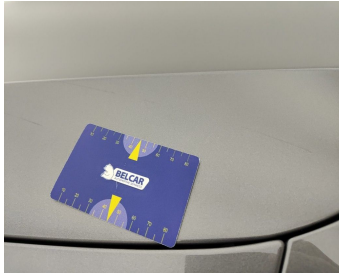
Front Bonnet // Polish-scratch

| Damages | Type | Acceptable |
|---|---|---|
| 35 | Front Bonnet // Polish | Y |

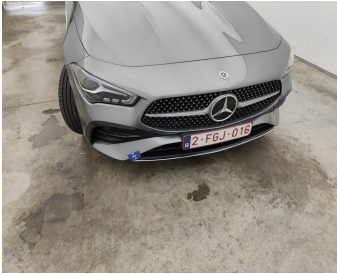
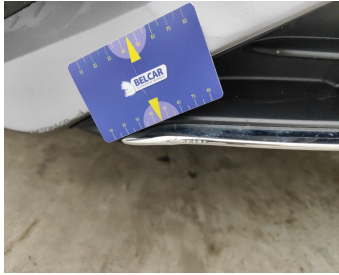
Bumper Front / Spoiler / Replace-scratch

| Damages | Type | Acceptable |
|---|---|---|
| 18 | Bumper Front / Spoiler / Replace | N |

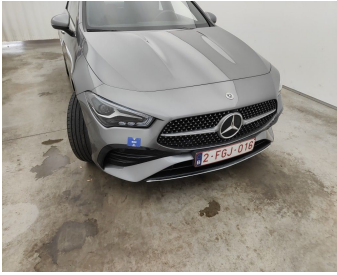
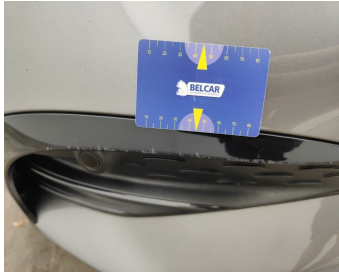
Bumper Front / Trim Right / Replace-scratch

| Damages | Type | Acceptable |
|---|---|---|
| 272 | Bumper Front / Trim Right / Replace | N |

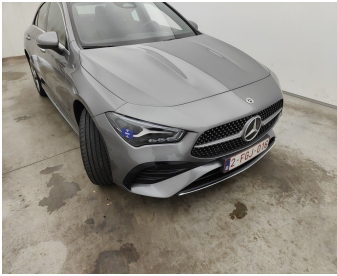
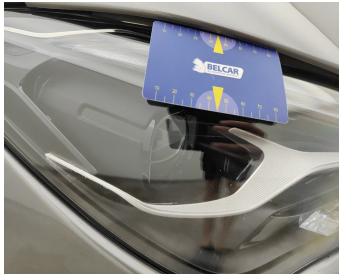
Light / Front Right / Replace-scratch

| Damages | Type | Acceptable |
|---|---|---|
| 244 | Light / Front Right / Replace | N |

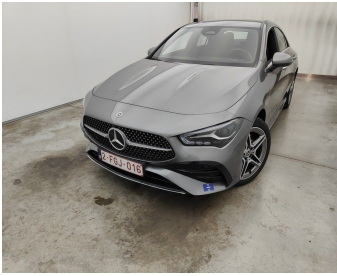
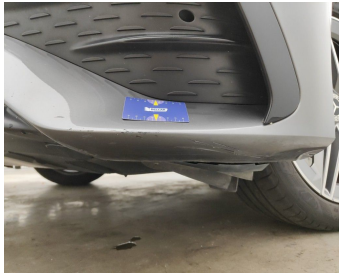
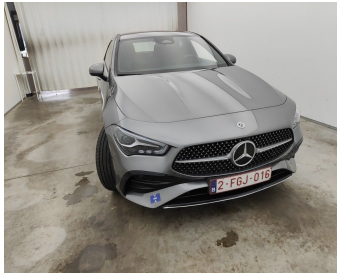
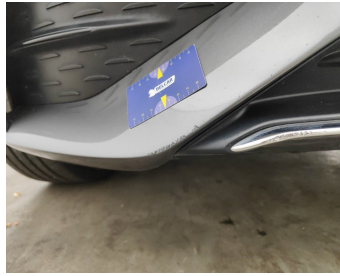
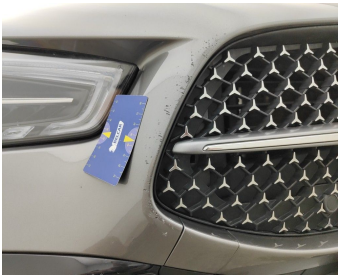
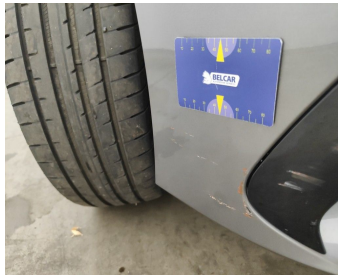
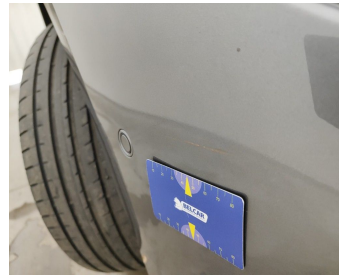
Bumper Front // Painting-scratch

| Damages | Type | Acceptable |
|---|---|---|
| 13 | Bumper Front // Painting | N |
