# INSPECTION REPORT

**End of contract**

| License plate | MN9176 |
| Make | Volvo XC90 B5 235 AWD Inscr. 7 |

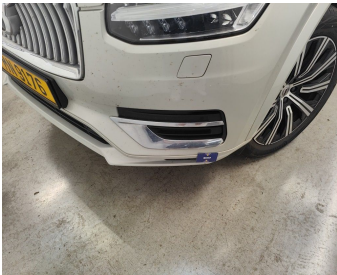
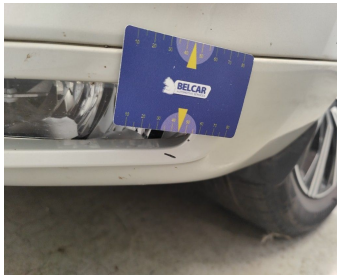
Bumper Front // Smart Repair Large-scratch

| Damages | Type | Acceptable |
|---|---|---|
| 12 | Bumper Front // Smart Repair Large | Y |

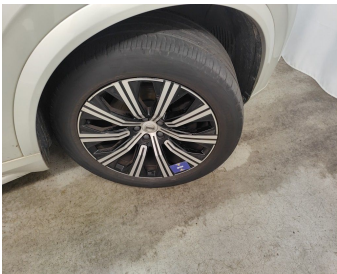
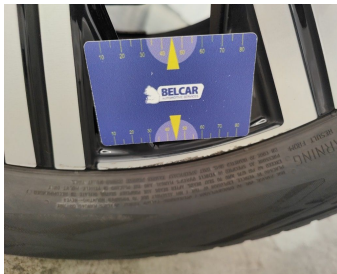
Wheel Two Tone Front Right // Repair-scratch

| Damages | Type | Acceptable |
|---|---|---|
| 340 | Wheel Two Tone Front Right // Repair | N |

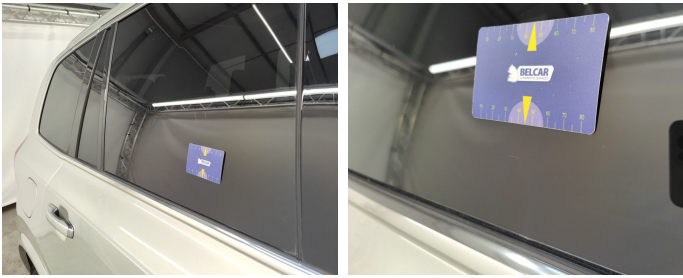
Door Rear Right / Window / Replace-scratch

| Damages | Type | Acceptable |
|---|---|---|
| 199 | Door Rear Right / Window / Replace | Y |

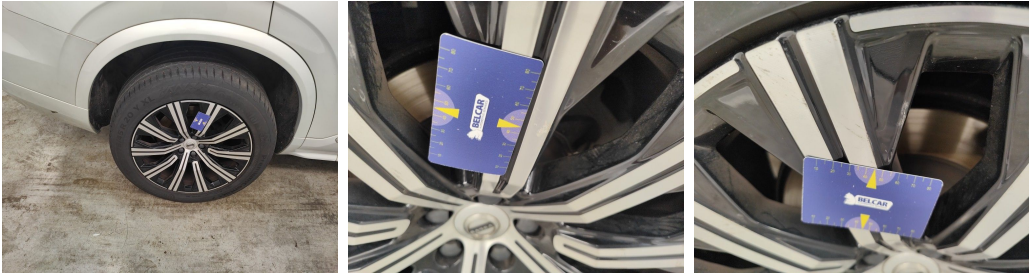
Wheel Two Tone Rear Right // Repair-scratch

| Damages | Type | Acceptable |
|---|---|---|
| 330 | Wheel Two Tone Rear Right // Repair | N |

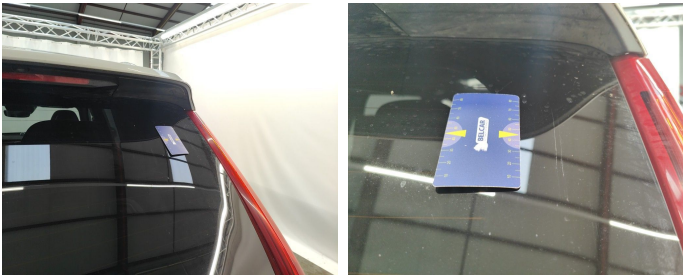
Rear Bonnet / Rear Window / Replace-scratch

| Damages | Type | Acceptable |
|---|---|---|
| 159 | Rear Bonnet / Rear Window / Replace | Y |

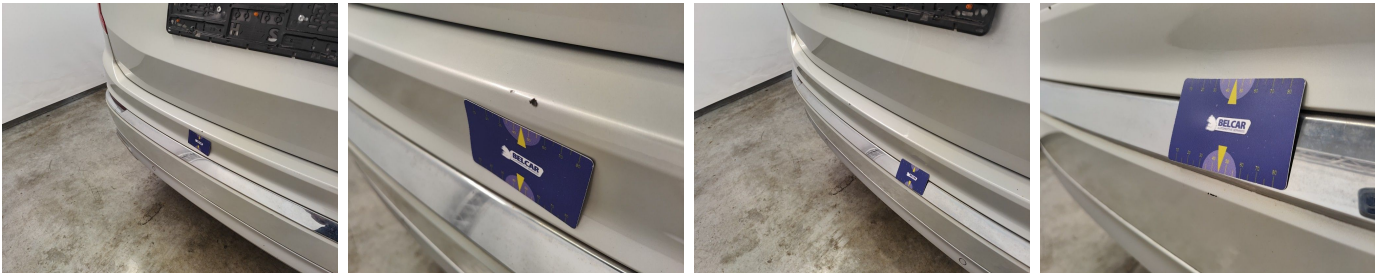
Bumper Rear // Painting-scratch

| Damages | Type | Acceptable |
|---|---|---|
| 133 | Bumper Rear // Painting | Y |

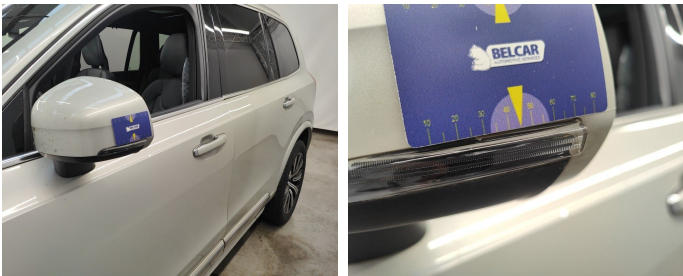
Side View Mirror Left / Direction Indicator / Replace-scratch

| Damages | Type | Acceptable |
|---|---|---|
| 78 | Side View Mirror Left / Direction Indicator / Replace | N |

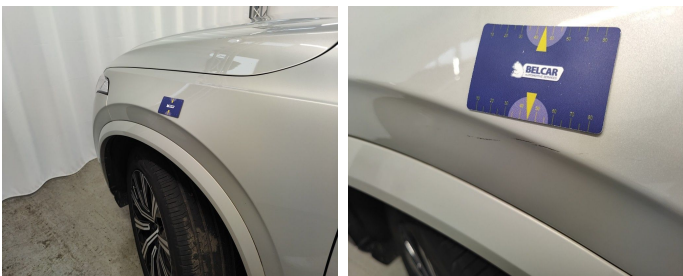
Wing Front Left // Polish-scratch

| Damages | Type | Acceptable |
|---|---|---|
| 66 | Wing Front Left // Polish | Y |

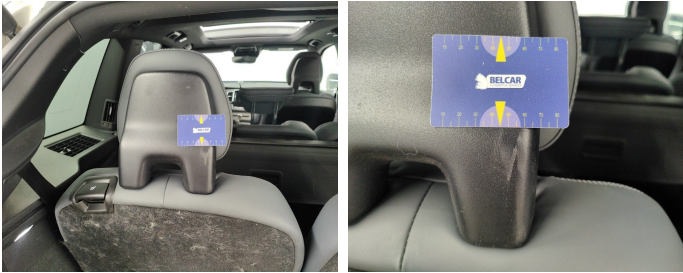
Interior // Repair 2-scratch

| Damages | Type | Acceptable |
|---|---|---|
| 541 | Interior // Repair 2 | N |

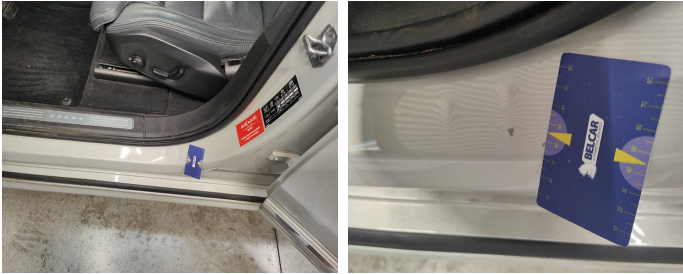
Rocker Panel Left // Smart Repair Medium-scratch + dent

| Damages | Type | Acceptable |
|---|---|---|
| 91 | Rocker Panel Left // Smart Repair Medium | N |

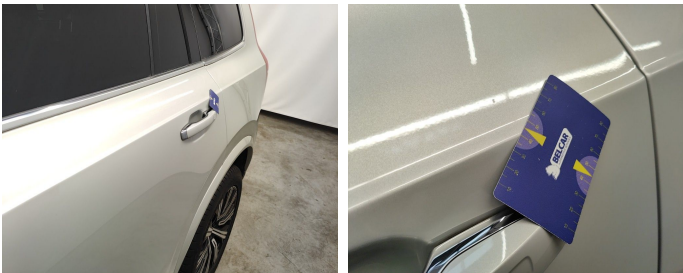
Door Rear Right // Repair & Painting-bad repair

| Damages | Type | Acceptable |
|---|---|---|
| 194 | Door Rear Right // Repair & Painting | Y |

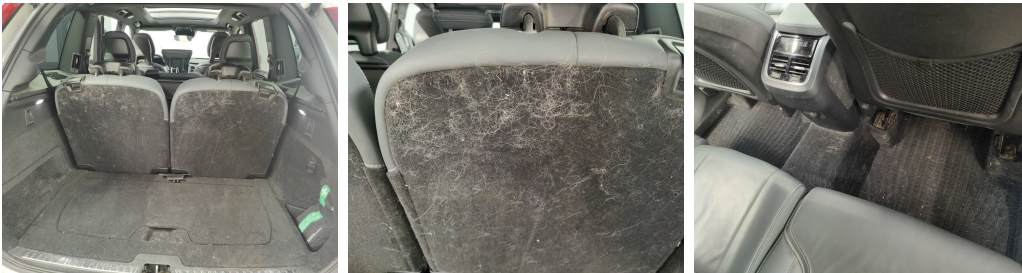
Interior Cleaning // Large-dirty

| Damages | Type | Acceptable |
|---|---|---|
| 840 | Interior Cleaning // Large | N |

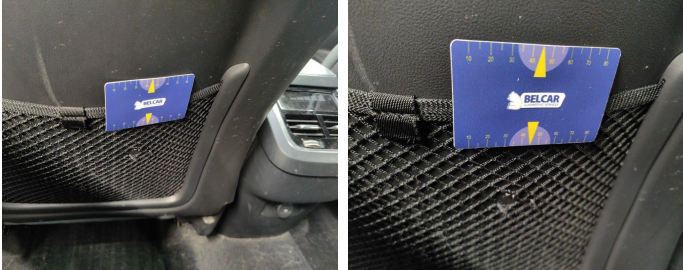
Interior // Repair 1-tear

| Damages | Type | Acceptable |
|---|---|---|
| 540 | Interior // Repair 1 | N |

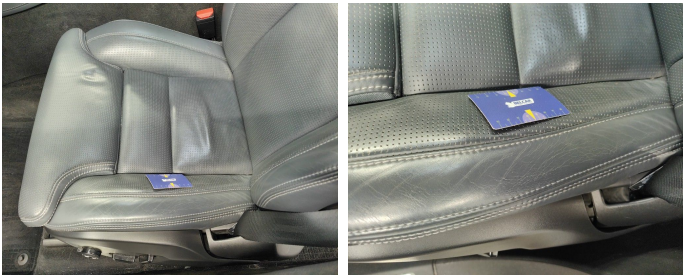
Seat Front Left / Bottom Coating / Replace-worn

| Damages | Type | Acceptable |
|---|---|---|
| 412 | Seat Front Left / Bottom Coating / Replace | Y |
